# Camden Council Business Paper

**ORD01 Proposed amendments to *Camden LEP 2010* (No.32) and *Camden DCP 2011* -  
Lot 24, DP 1086823 Crase Place,  
Grasmere**

**SPECIALIST REPORTS TO SUPPORT  
PLANNING PROPOSAL**

BUSHFIRE HAZARD ASSESSMENT FOR PROPOSED  
REZONING OF 10 CRASE PLACE, GRASMERE

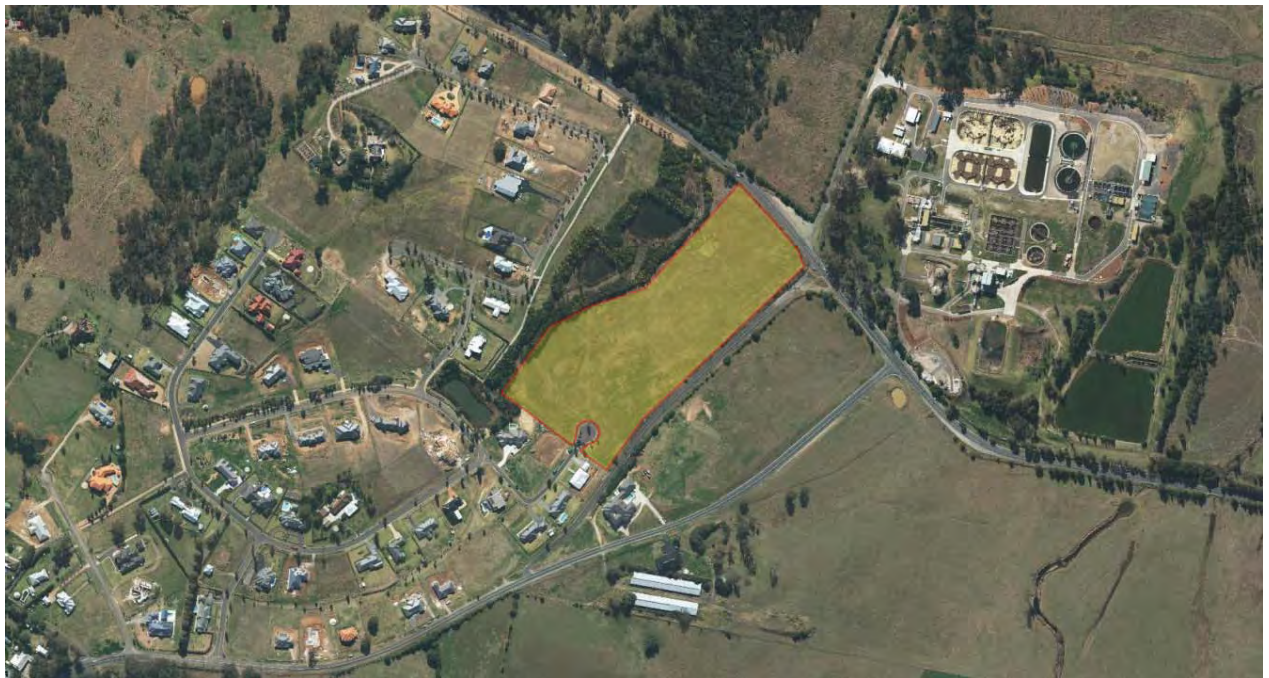
Figure 1 Location of property

The subject site (Lot 24 DP 1086823) is located approximately 2 kilometres west of Camden and is accessed off Harben Vale Circuit. The whole south eastern boundary adjoins The Old Oaks Road. The north eastern boundary adjoins Werombi Road. The Camden Sewerage Treatment Plant is located on the other side of Werombi Road directly north east of the site. The northern boundary adjoins a series of water storage dams.

The general location is shown on Figure 1 and a broad scale aerial photograph is shown in Figure 2. Figure 3 provides a street map.

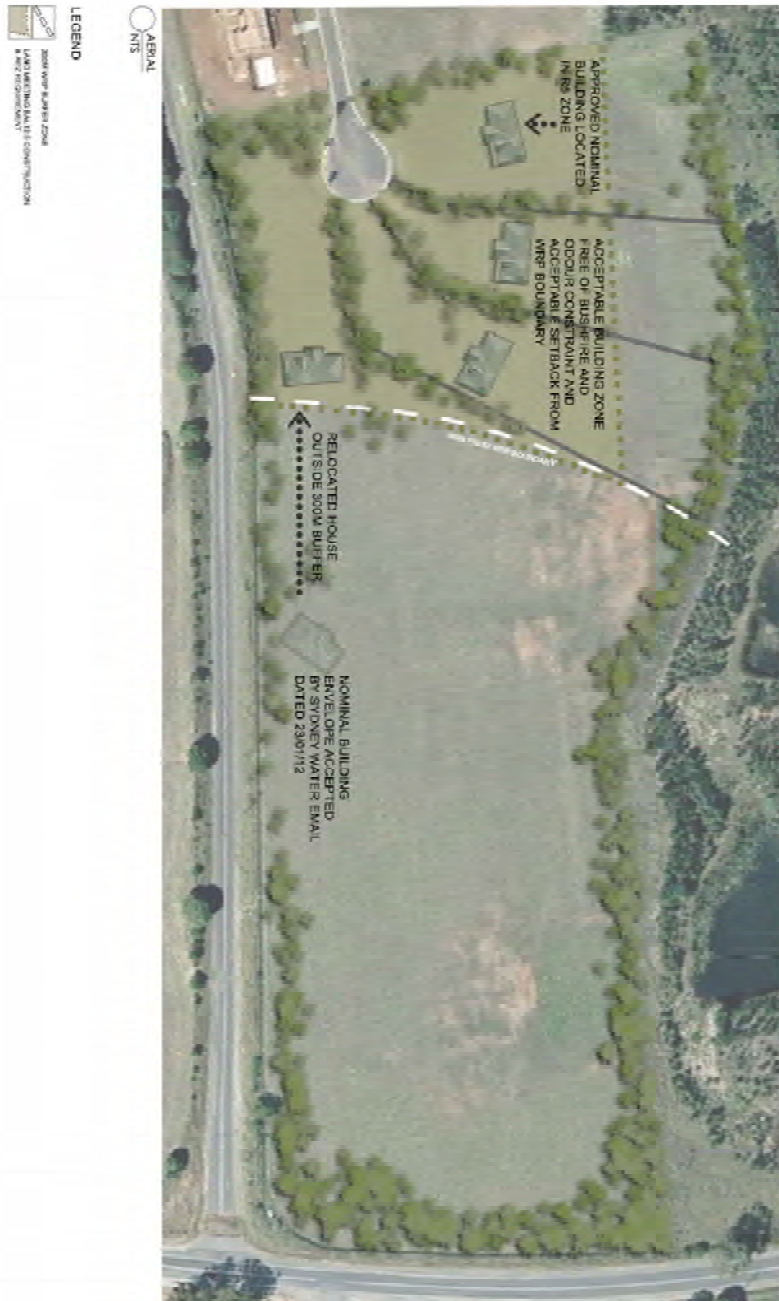
Figure 4 Proposal

Lot 24, DP 1086823 is currently zoned RU1 Rural Landscape under the current Camden Local Environment Plan, and is proposed to be rezoned to R5 - Large Lot Residential. Indicative house lot layouts are identified in Figure 4 below to show how the proposal can comply with bushfire protection requirements. Final details of landscaping and boundaries will be determined when a DA is lodged.

The subject lot faces the north west. The landform is undulating and slopes gently down towards the drainage line and three large water supply dams on the north westerly boundary. The house sites will be located on land close to the cul-de-sac on the south western side of the subject lot. See Figure 4.

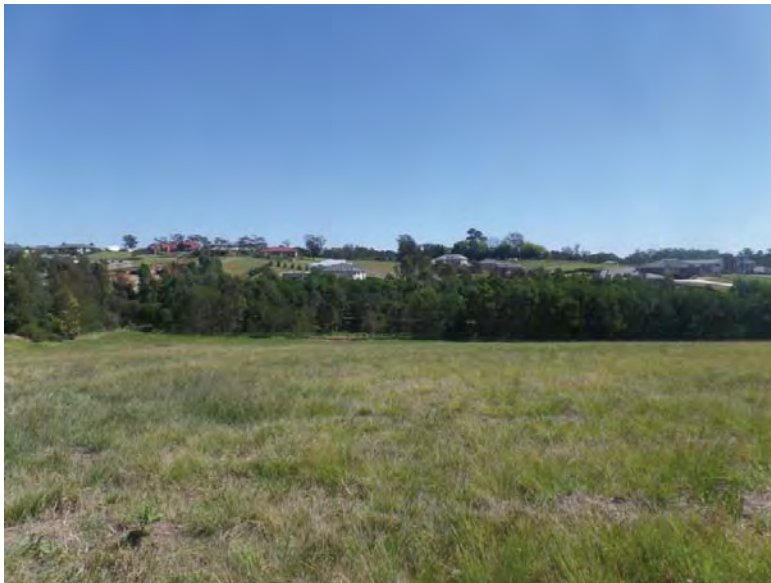
Photo 1 View of grassland and riparian corridor on north western elevation

Figure 6 shows the bushfire prone land within 100m of the area identified suitable for dwellings. The dominant vegetation formation is characterised as grassland. The only trees near to the site are located within the nature strip where the creek and water supply dams are, as shown in Photo 1. There is also a bike track within this riparian corridor. For bushfire assessment purposes, the trees in the riparian corridor are considered "Rainforest", as the total width measures approximately 40m and the PBP 2006 page 52, allows "*Riparian areas are those areas of vegetation which are no greater than 20m in width and are found on either bank of a river, creek or stream identified on a bush fire prone land map and treated the same as rainforest*". These trees are still juvenile as shown in Photo 2.

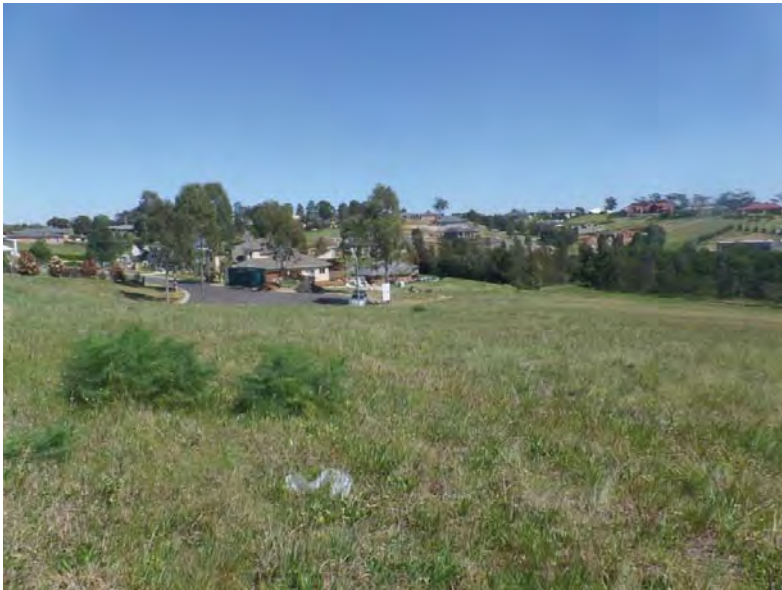
Photo 3 View looking west

The subject lot is located on an undulating side slope with a north westerly orientation. This assessment found that the slope influencing bushfire behavior on the north west falls into the PBP (2006) category of “downslope 5-10 degrees”. Photo 3 shows the downslope looking directly west from proposed indicative dwelling footprints. The east and south elevations falls into the PBP (2006) category of level/upslope. Photo 4 shows the upslope looking east from indicative dwelling footprints.

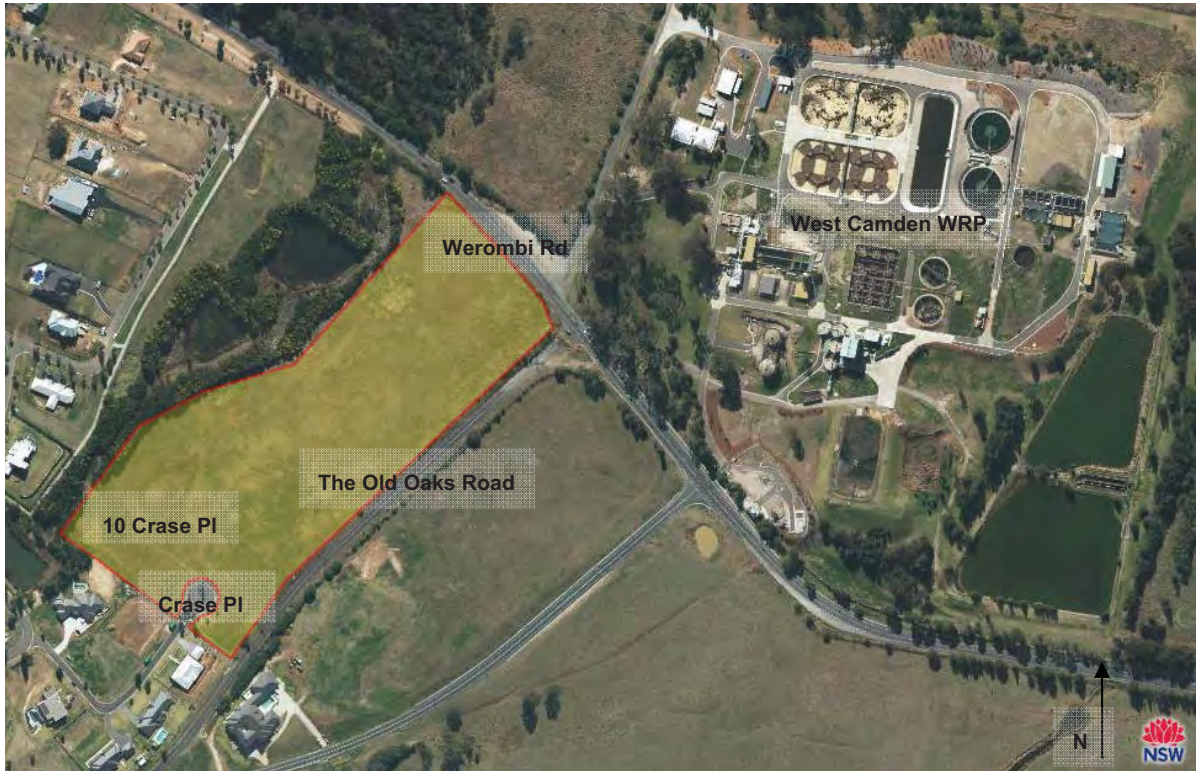
The subject property is located at the end of Crase Place, Grasmere in the Camden Local Government Area (LGA). The property is bound by Werombi Road to the north, The Old Oaks Road to the east, existing residential development to the south and an unnamed watercourse to the west. The West Camden WRP is located to the north-east of the site (refer to **Figure 1**).

**Figure 1: Extent of the property at 10 Crase Place, Grasmere**

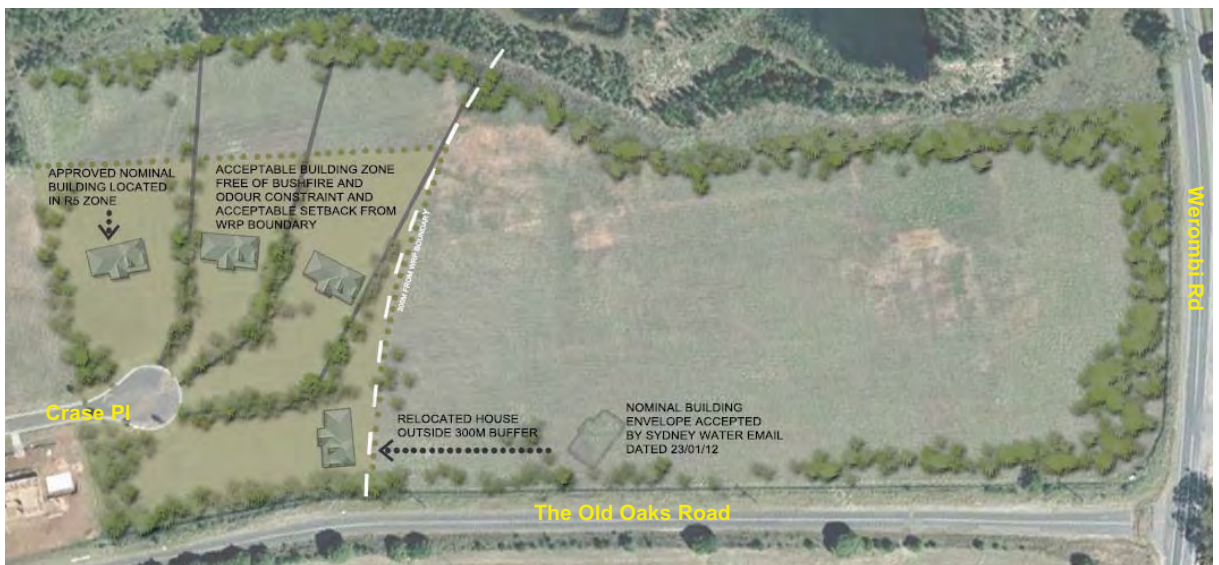
**Figure 2: Indicative proposed development layout**

Site Plus is currently preparing a rezoning application for the property to accommodate up to four low density residential dwellings outside the 300 metre odour control buffer for West Camden WRP. The indicative layout of these dwellings is shown below in **Figure 2**.

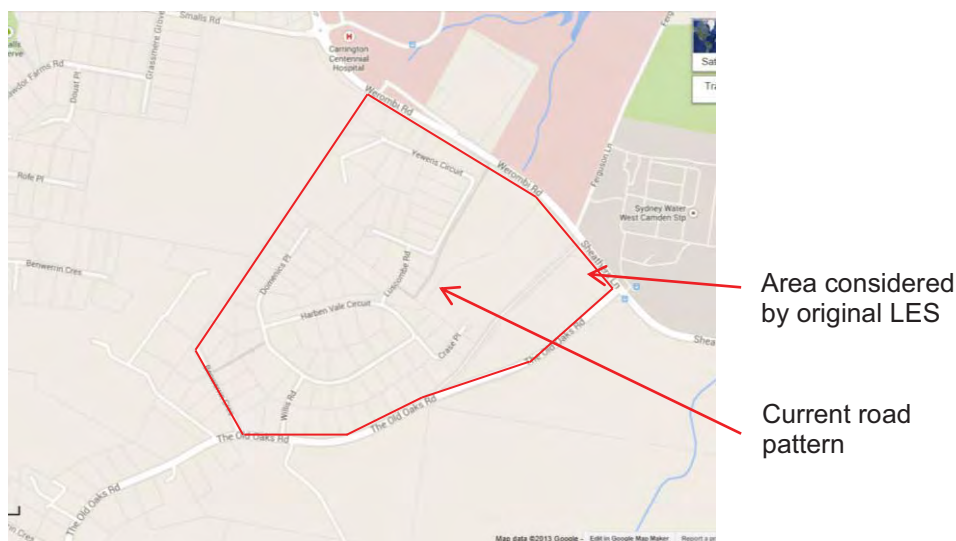
**Figure 2.1 Area Investigated for 2001 re-zoning proposal**

In 2001 a Local Environmental Study (LES) was prepared by Planning Workshop Australia to support a rezoning of (five) 5 properties to permit residential zonings in Grasmere. The land area comprising these five properties in the LES is outlined in red in Figure 2.1. The Planning Proposal received support and the current road pattern is a result of the rezoning and re-subdivision of the site as shown in Figure 2.1.

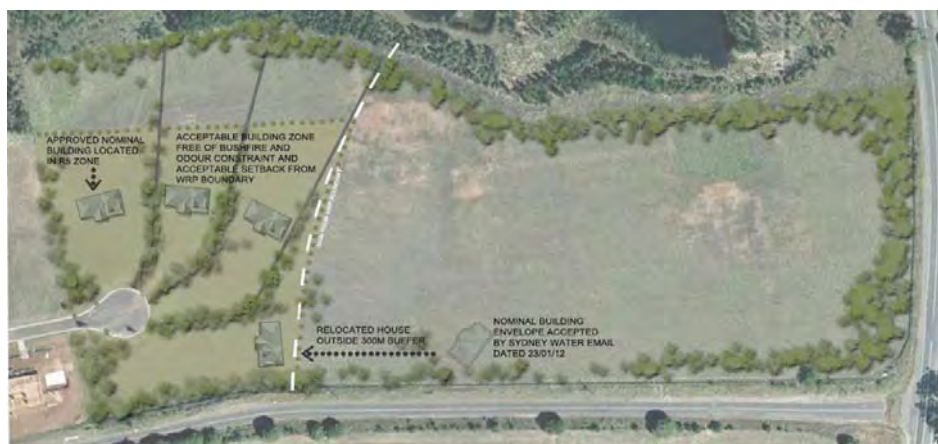
**Figure 3.2 Indicative Subdivision Plan**

Development of the site is currently limited by an odour buffer boundary. The plans shown in Figure 3.2 have been derived from an iterative process. Initially plans had been prepared for Sydney Water following the upgrade of the WRP which showed the 'odour boundary' could be adjusted. Sydney Water advised they had no issue with the development of the site if development occurred beyond 300m of the boundary of the WRP. Sydney Water's response essentially amends the odour buffer from 400m to 300m. This enables the indicative development envisaged in Figure 3.2 from which all investigations have occurred.

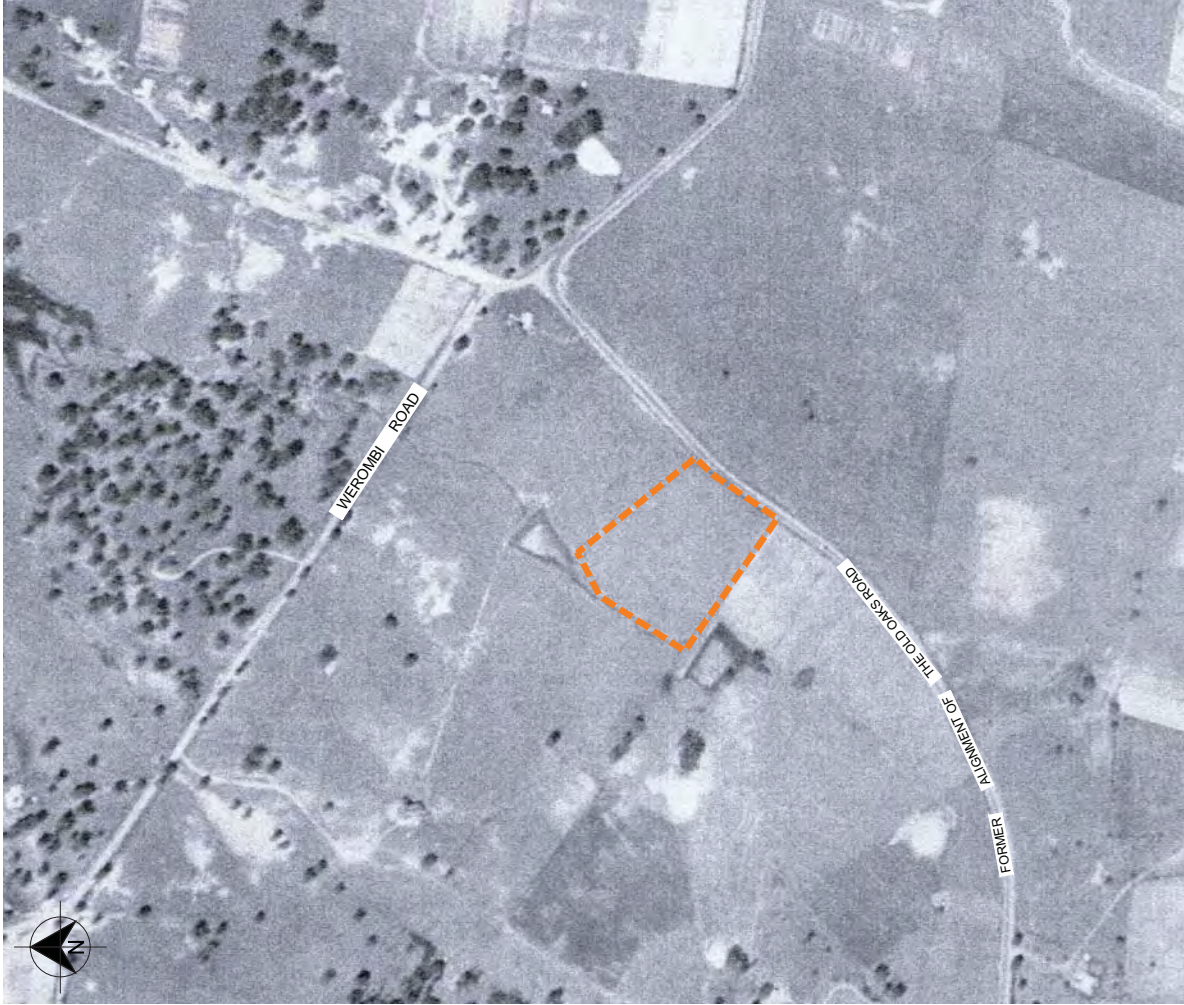
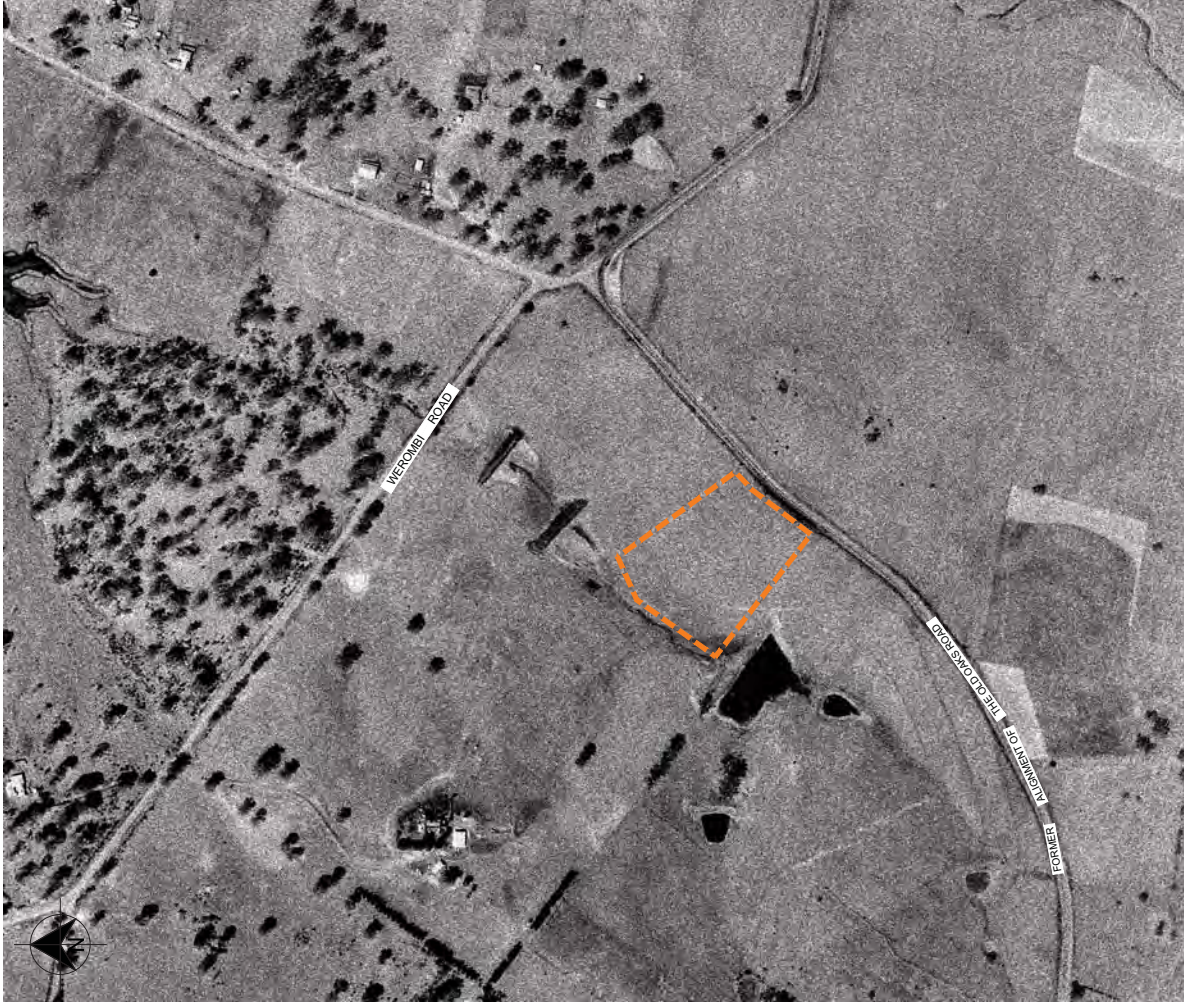
client:	SITE PLUS
project:	PHASE 1 CONTAMINATION ASSESSMENT & SALINITY ASSESSMENT PART LOT 24 DP-1086623, 10 CRASE PLACE, GRASMERE, NSW
title:	AERIAL PHOTOGRAPHS - 1954 AND 1965
project no:	ENAUWOLL04150AA-R01
figure no:	C-1

AERIAL PHOTOGRAPH 1954

AERIAL PHOTOGRAPH 1965

In the 1954 aerial photograph, a structure and driveway was evident in the northeastern corner of Lot 24, but had been removed by 1965. Other evidence of activities on the remaining parts of Lot 24 was not observed until 2007. In 2007, two patches of exposed soils were observed north of the site. Although some grass cover has re-established across these areas since 2007, exposed soil is still evident.

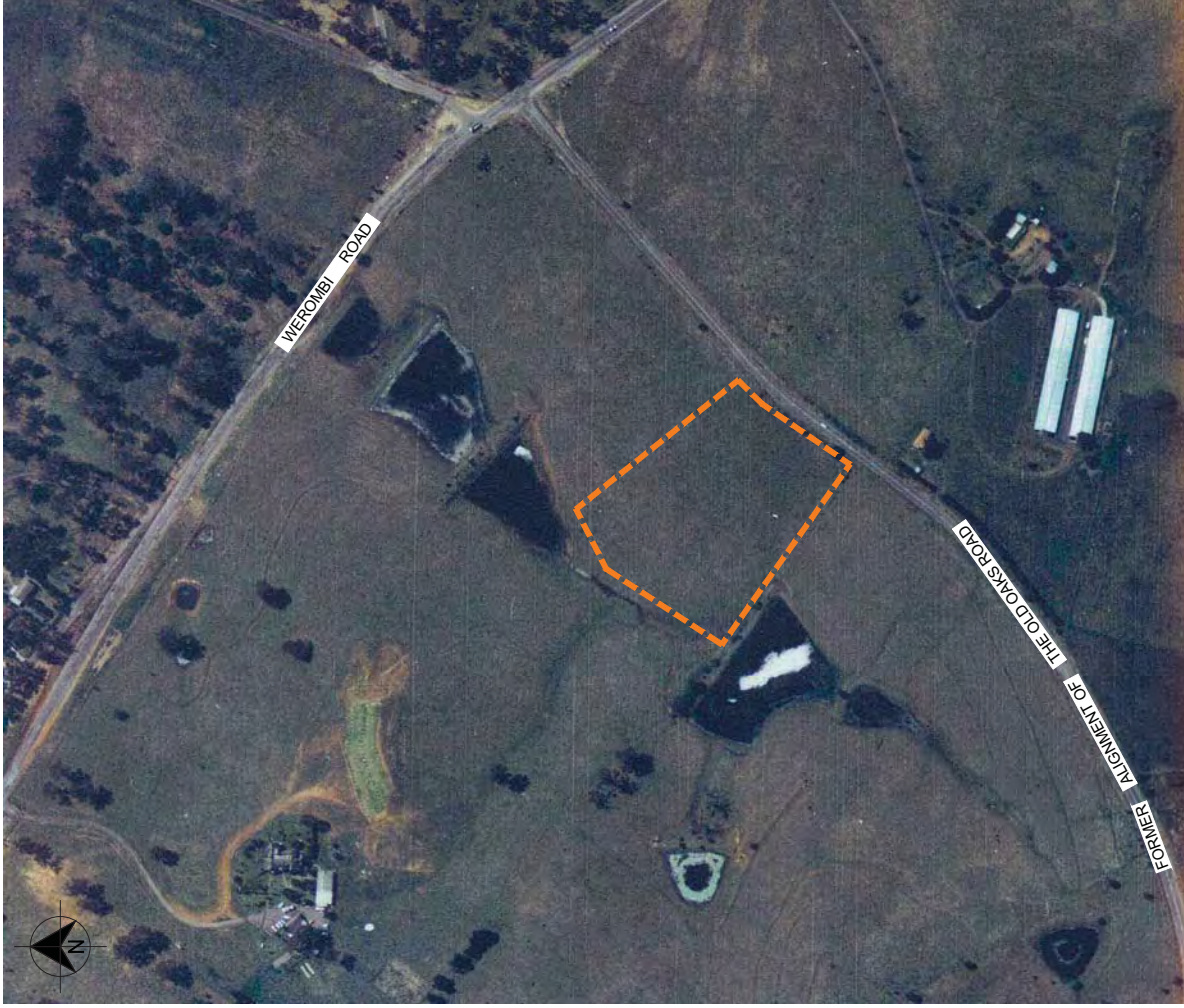
AERIAL PHOTOGRAPHY 1974

client: SITE PLUS  
 project: PHASE 1 CONTAMINATION ASSESSMENT & SALINITY ASSESSMENT  
 LOT 24 DP1086823, CRASE PLACE, GRASMERE, NSW  
 title: AERIAL PHOTOGRAPHS - 1974 AND 1984  
 project no: ENAUWOLL04150AA-R01 figure no: C-2

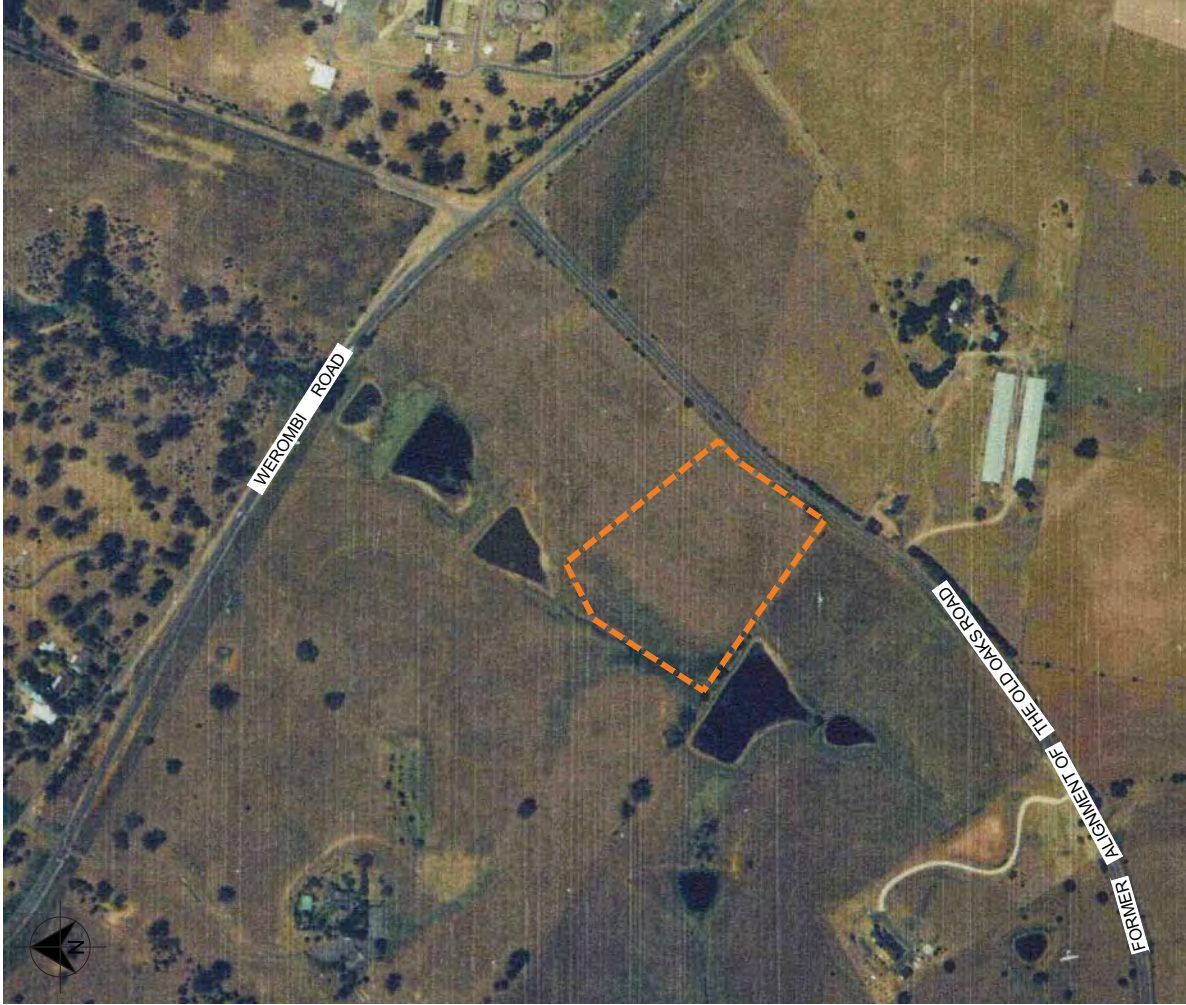
AERIAL PHOTOGRAPH 1994

client:		SITE PLUS	
project:		PHASE 1 CONTAMINATION ASSESSMENT & SALINITY ASSESSMENT PART LOT 24 DP-1086623, 10 CRASE PLACE, GRASMERE, NSW	
title:		AERIAL PHOTOGRAPHS - 1994 AND 2002	
project no.:	ENAUWOLL04150AA-R01	figure no.:	C-3

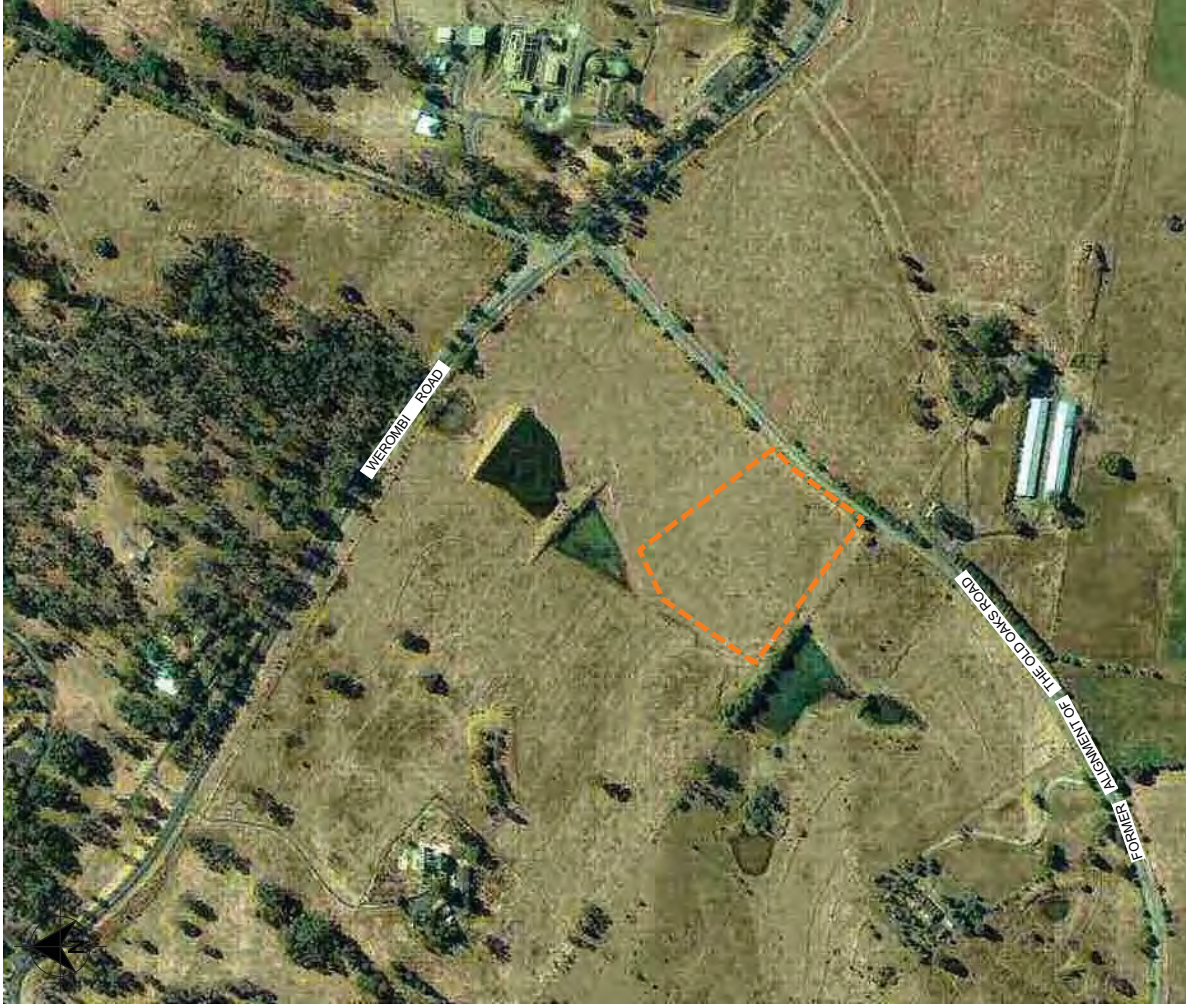
AERIAL PHOTOGRAPH 2002  
 AERIAL IMAGE SOURCE: GOOGLE EARTH PRO 6.0.1  
 AERIAL IMAGE © SINCLAIR KNIGHT MERZ 2013

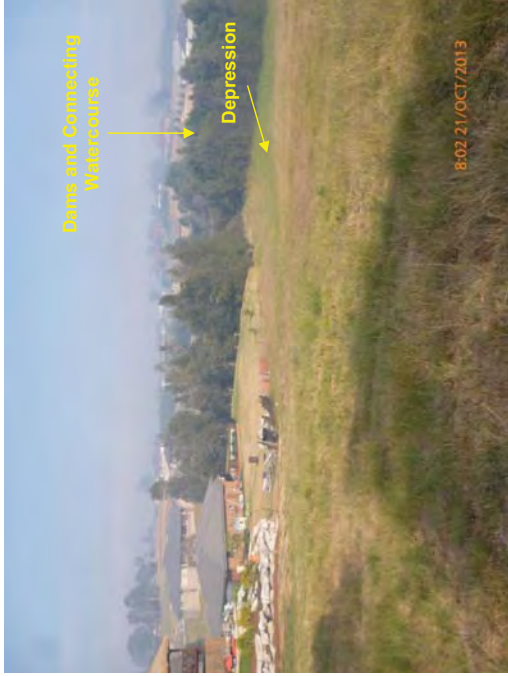
Plate 1: Looking west towards residential properties (left) and dams. (21/10/2013)

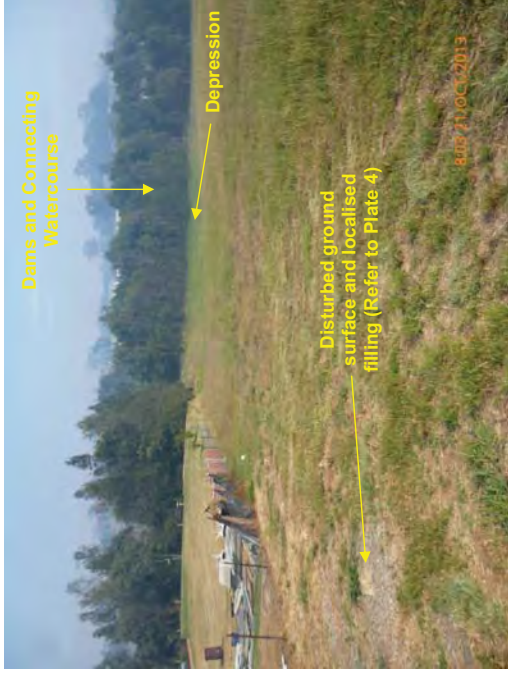
Plate 2: Looking west along the southern site boundary. Note area of disturbed soils and localised filling adjacent to the southern boundary. (21/10/2013)

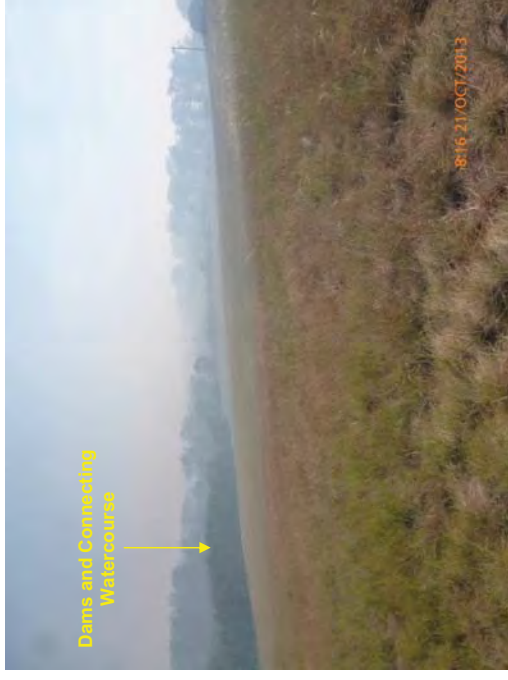
Plate 3: Looking north at the site and remaining parts of Lot 24 (background). (21/10/2013)

The Site and remaining parts of Lot 24 are situated on the western slope of a local rise (Plate 3). The ground surface has a moderate downward slope (ranging between 5% and 10%) mostly towards the west with some cross slope towards the north (Plate 3). At the base of these slopes were a series of local depression, which at the time of the site visit were dry and firm underfoot (Plates 1, 2 and 5). During periods of heavy rain, water is likely to accumulate in these areas causing saturated ground conditions. These areas generally correlated with darker green zones observed on aerial photographs.

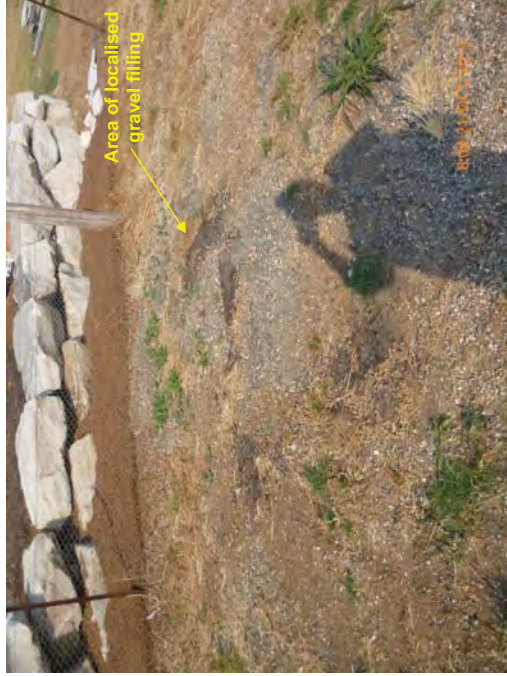
Plate 4: Close up of localised filling along the southern site boundary adjacent to recently constructed residential dwellings. (21/10/2013)

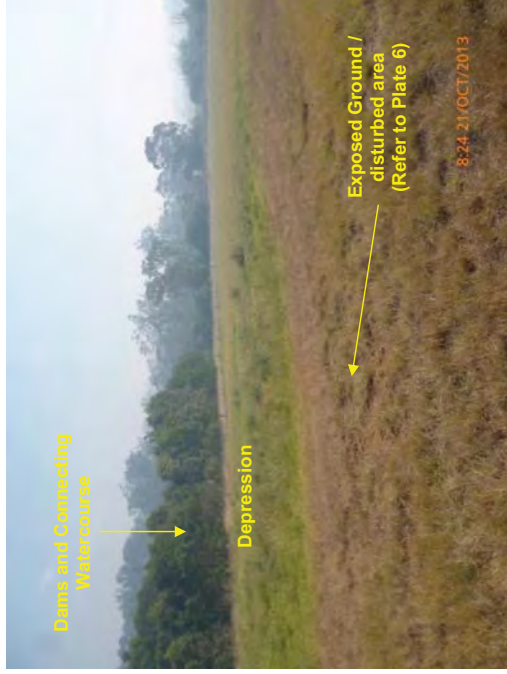
Plate 5: Looking northwest towards one of the depressions in Lot 24 (offsite) near the western lot boundary and exposed soil area. (21/10/2013)

The Site and remaining parts of Lot 24 were generally grass covered with some patches of exposed soil (Plates 2 and 5). One of these patches was located adjacent to the southern boundary and may be associated with the construction of the adjoining residential dwelling (Plates 2 and 4). Some gravel fill was observed in this area. The other two patches of exposed soil were located north of the site and corresponded to exposed ground observed in the 2007 aerial photograph (Plate 5). At the time of the site walkover some grass cover had re-established in these areas. Some brick fragments were observed suggesting these exposed areas may have been associated with a localised filling event during construction of nearby residential dwellings (Plate 6).

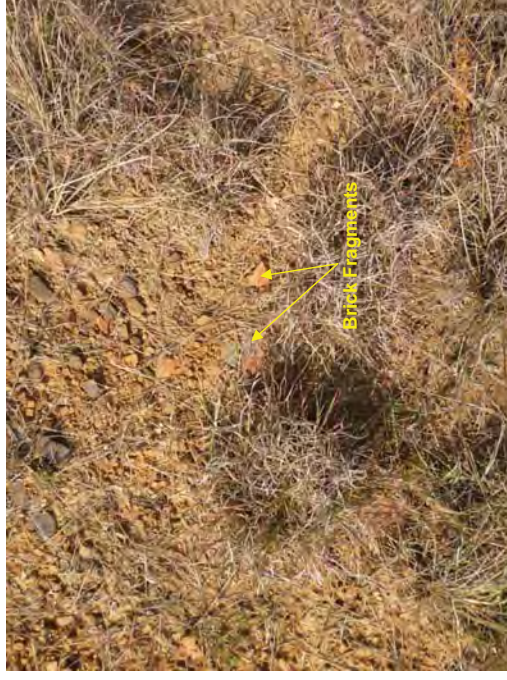
Plate 6: Close up of localised filling north of the site. Note brick fragments. (21/10/2013)
