<b>ORD01</b>	<b>Planning Proposal - Lot 102 DP 1193881, 182 Raby Road, Gledswood Hills</b>	
	<b>Attachment 1:</b> Draft Planning Proposal for Lot 102 DP 1193881, 182 Raby Road, Gledswood Hills .....	4
	<b>Attachment 2:</b> additional information - Planning Proposal.....	58
	<b>Attachment 4:</b> Ecological Assessment - 182 Raby Rd.....	67
	<b>Attachment 5:</b> Visual Impact Assessment - 182 Raby Road.....	77
	<b>Attachment 6:</b> LFA Landscape & Visual Analysis Central Hills- 2005 .....	86
	<b>Attachment 7:</b> LFA Landscape & Visual Analysis Appendices Central Hills- 2005.....	98
	<b>Attachment 8:</b> Potential Contamination Investigation - 182 Raby Rd .....	124
<b>ORD02</b>	<b>Investment Monies - August 2018</b>	
	<b>Attachment 1:</b> Investment Report - August 2018 .....	246
<b>ORD04</b>	<b>Minutes of the 28 June 2018 Business Assurance and Risk Committee Meeting</b>	
	<b>Attachment 1:</b> Minutes - Minutes of Business Assurance and Risk Committee - 28 June 2018 .....	255

# Lot 102, 182 Raby Road, Gledswood Hills

Planning Proposal

March 2018 | Revised Final

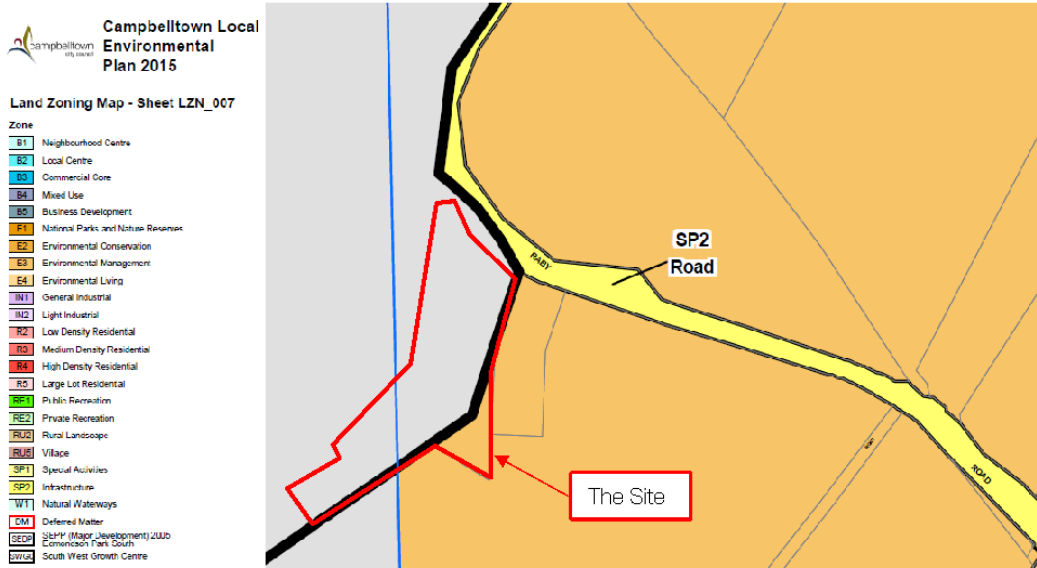
Figure 6: Zoning Extract from Campbelltown LEP 2015

Part of the site including the adjoining land to the east is zoned E3 Environmental Management, under the Campbelltown Local Environmental Plan 2015 as indicated in Figure 6.

Prior to the gazettal of the Turner Road Precinct under the Growth Centres SEPP, this area was zoned 7(d) Environmental Protection (Scenic Hills) which stretched westward to Camden Valley Way. A considerable proportion of the 7(d) Environmental Protection zone within the Camden LGA has since been eroded by the SEPP and subsequent and proposed re-zonings.

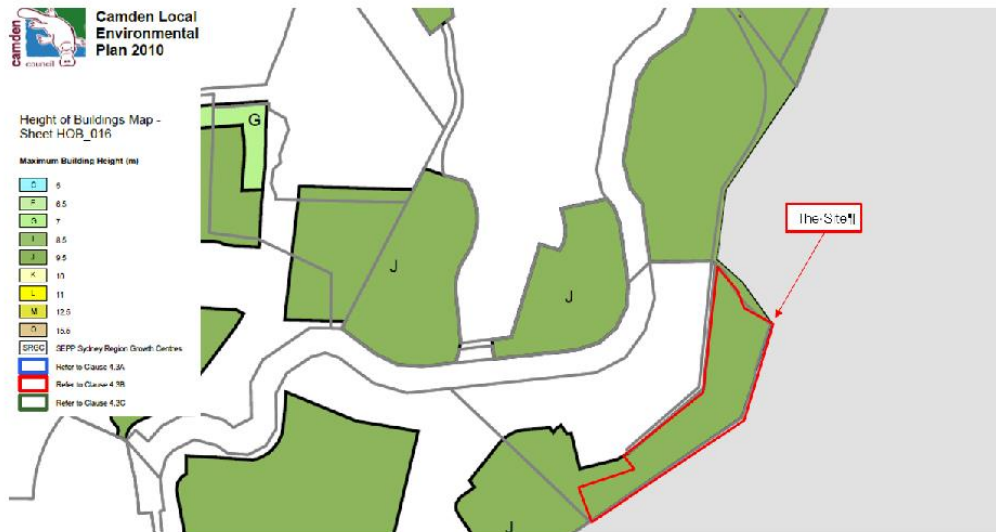
Figure 8: Height of Buildings Map Extract from Camden LEP 2010.

A building height restriction of 9.5 metres currently apply to the site (as shown in Figure 8).

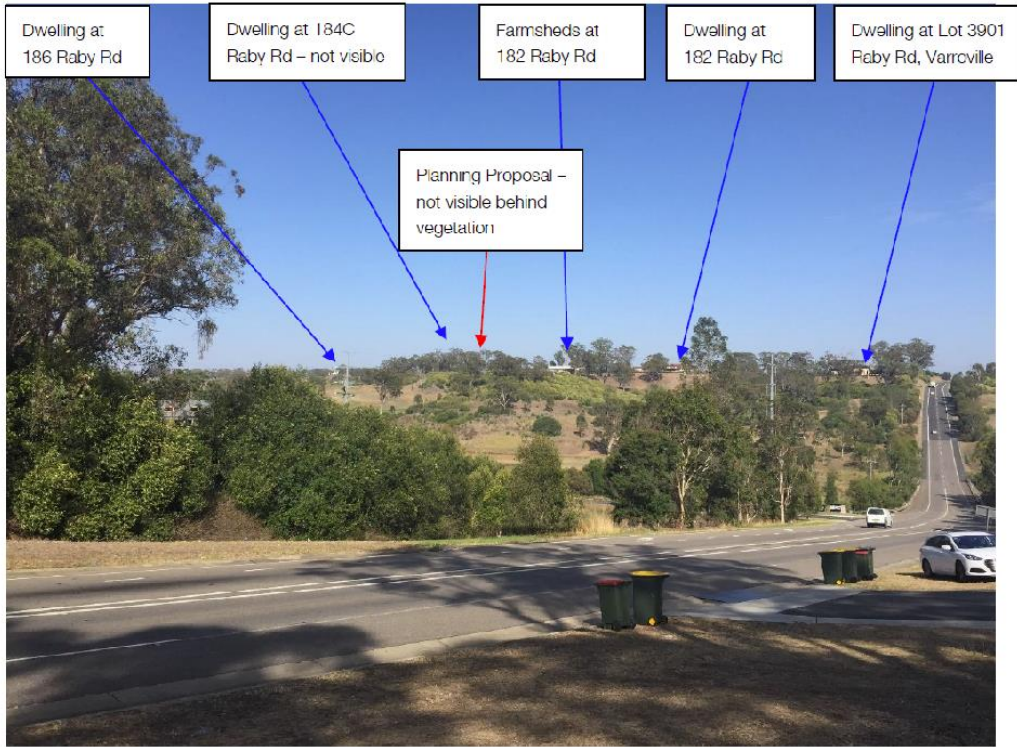
Figure 13: View looking west from Raby Road adjacent to 68 Raby Road, Varroville

Furthermore, it is evident from further visual analysis that the site of the PP will not be visible from the "Scenic Hill" ridgeline of Raby Road to the east of the site due to existing vegetation which screens this view.

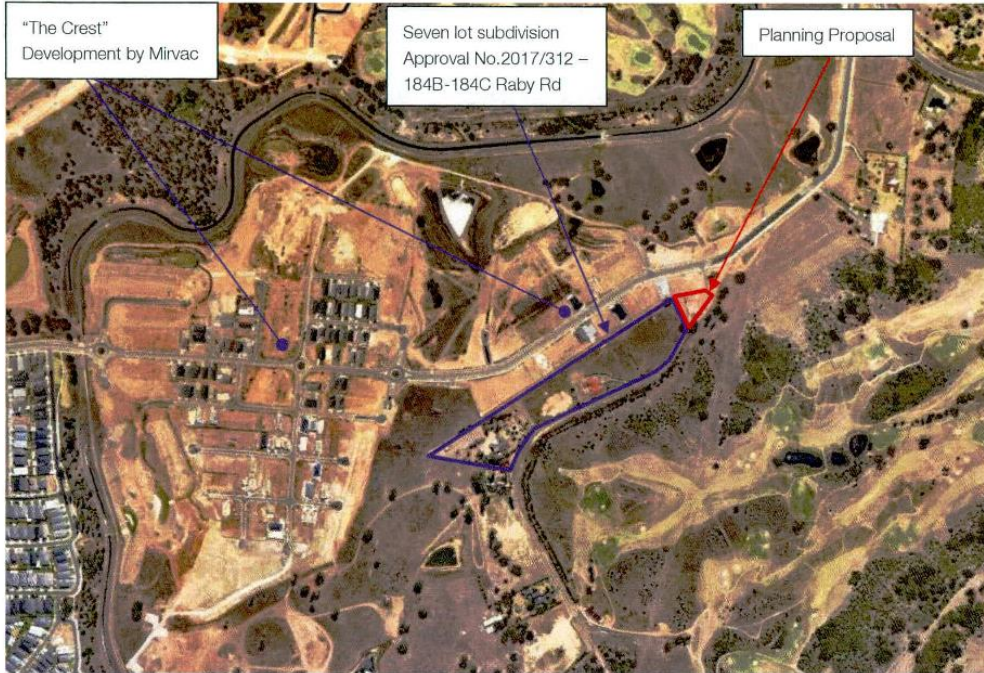
Figure 2: Aerial photograph dated 21 January 2018 (Source: maps.au.nearmap.com)

Furthermore, the timber paling fence of the adjoining R2 Low Density Residential abuts part of the site along the western boundary. This is illustrated in Figure 2.

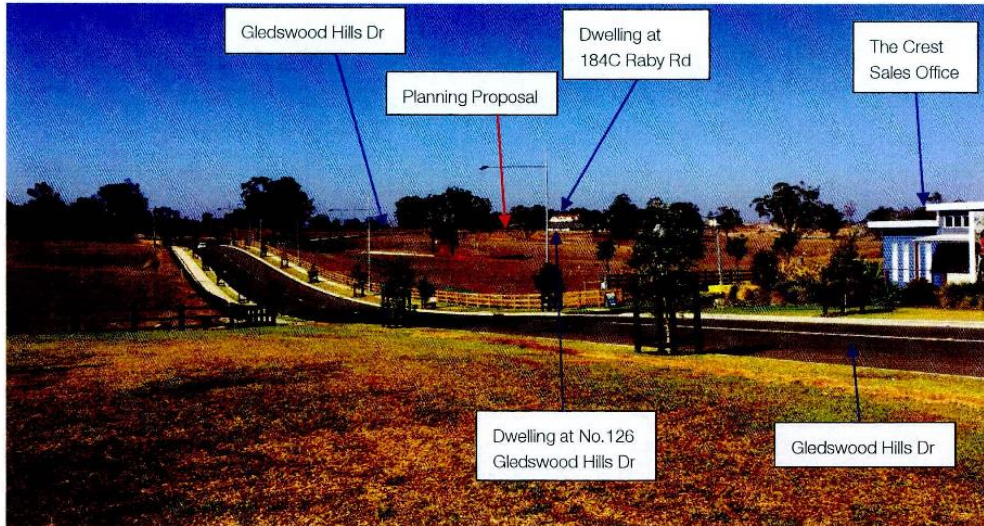
Figure 5: View looking south from the intersection of Gledswood Hills Drive and Raby Road

When viewing the site from the north, adjacent to the Gledswood Hills Drive and Raby Road intersection, Council staff requested a diagram or sketch identifying the existing building and location of the future building on approved subdivisions. The photograph at Figure 5 illustrates the view from this current location.

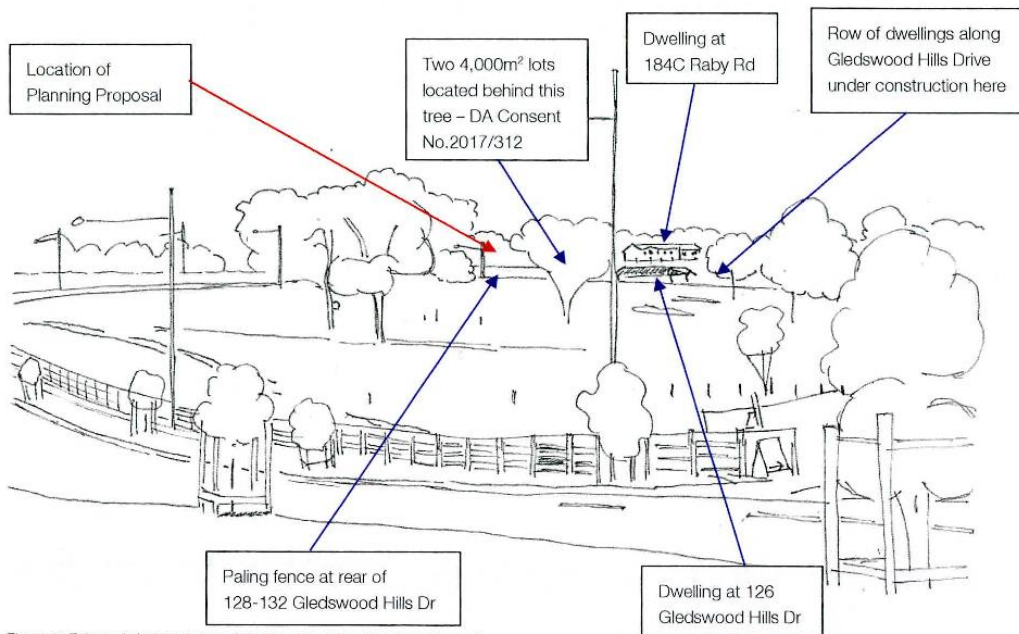
Figure 6: Enlarged sketched view of the location of the Planning Proposal

The sketch at Figure 6 highlights these key features and the location of the Planning Proposal. The sketch has not endeavoured to show a dwelling on the site of the Planning Proposal, nor the two future dwellings to be built on the two new lots approved between the dwelling at No.184C Raby Road and the site of the Planning Proposal, as these dwellings will largely be obscured from view by the existing tree and paling fence that sit forwards of this land.

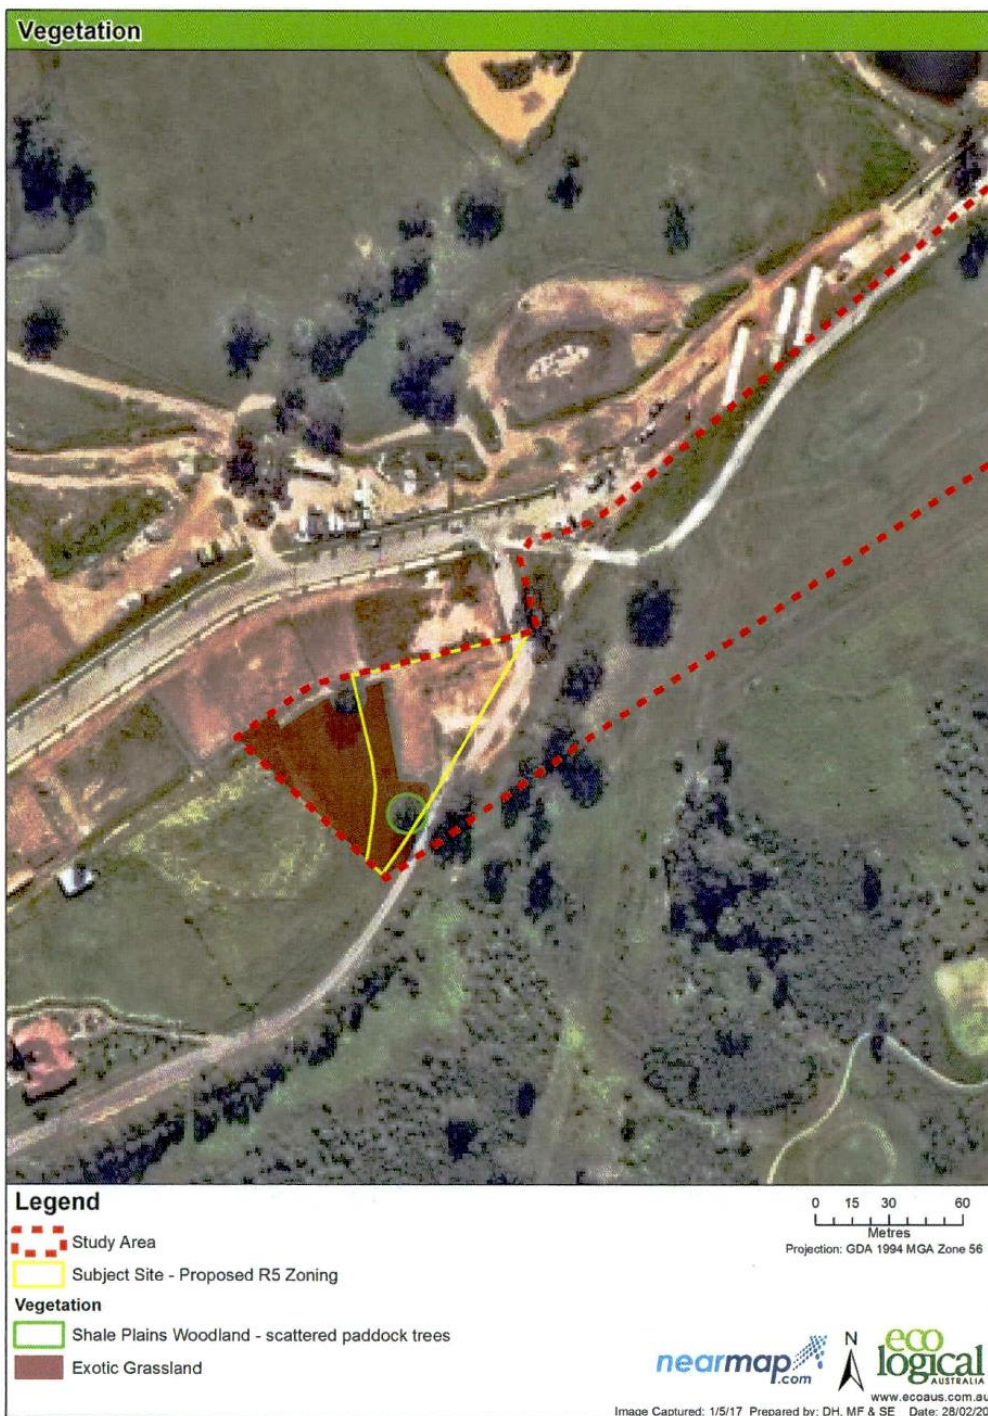
Figure 5: Vegetation map for the subject site.

Previous assessment of the site by ELA (2008) mapped the vegetation within 182A Raby Road as exotic with patches of Shale Hills Woodland (condition TX) and classified the Shale Hills Woodland as a moderate ecological constraint. Under the Camden Natural Assets Policy (CNAP), this vegetation was mapped as "Core-Local" and "Support for Core". Based on the CNAP, ELA (2010) calculated the vegetation offsets required for the El Caballo Blanco / Gledswood rezoning. As part of the biodiversity certification process for the ECBG study area, the vegetation adjacent to the subject site was remapped by ELA (2015) as Shale Plains Woodland.

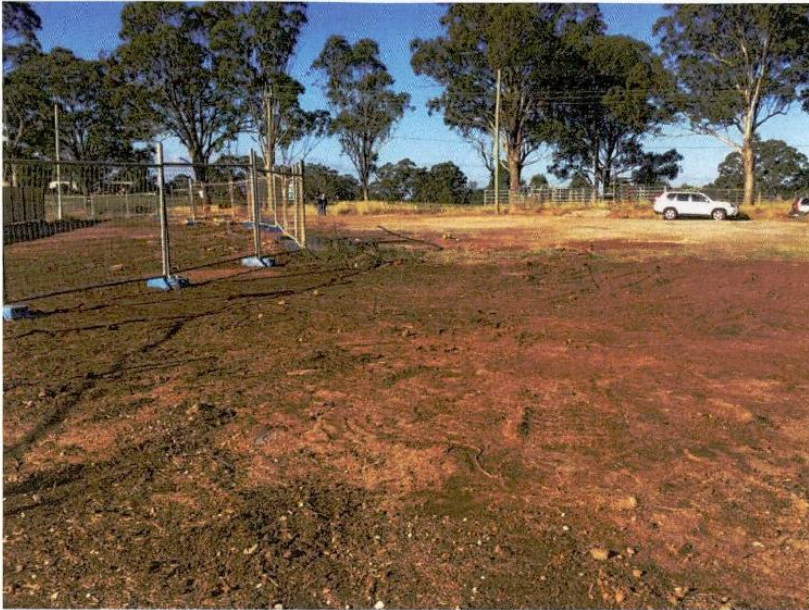
Plate 1: Subject site of proposed rezoning – facing north. The majority of the site is cleared.

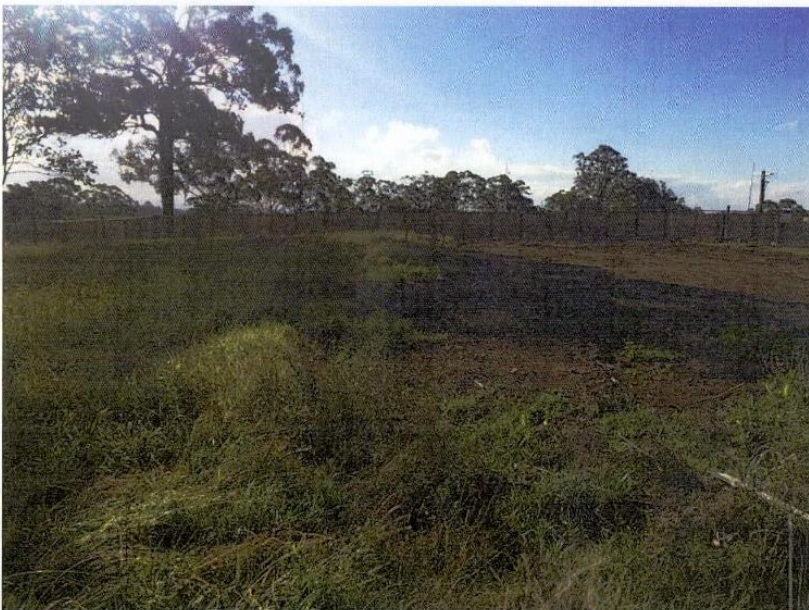
Plate 2: Subject site facing west towards the Mirvac development. The tree shown (*Eucalyptus crebra*) is just outside the subject site.

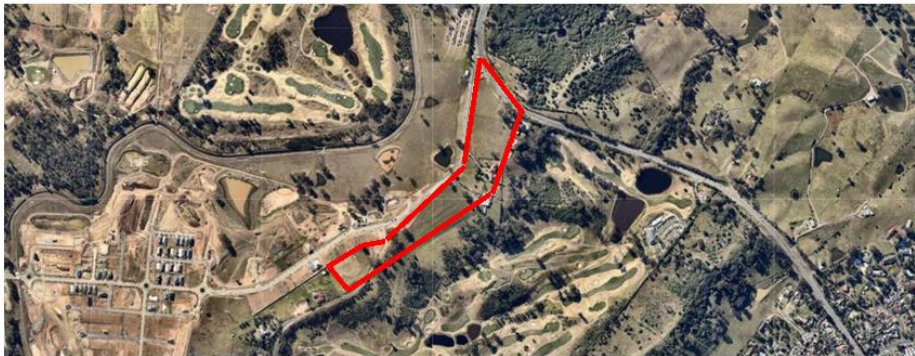
**Figure 2** Location of the subject property, edged red, with its northern boundary on Raby Road. (Source: *nearmap*, 9 August 2017)

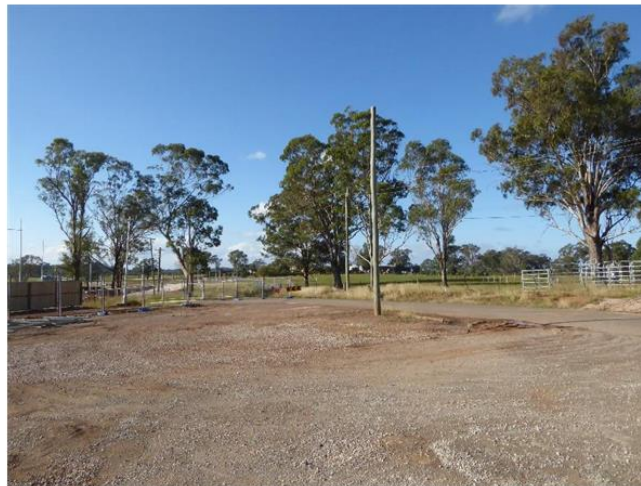
**Figure 3** View north from the southern end of the subject property, showing part of the sound attenuation barrier along Gledswood Hills Drive at far left. (Photo: Chris Betteridge, 16 June 2017)

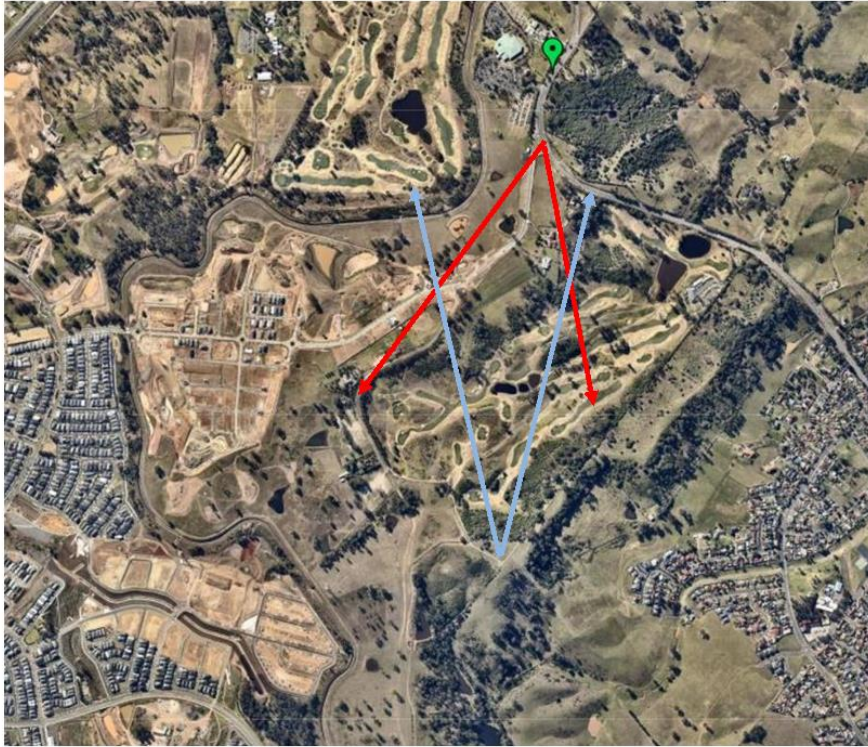
**Figure 4** Arcs of view over the subject property from Raby Road (red) and a high point on the ridge southeast of The Grange golf course (blue). (Source: *nearmap / MUSEcape*)

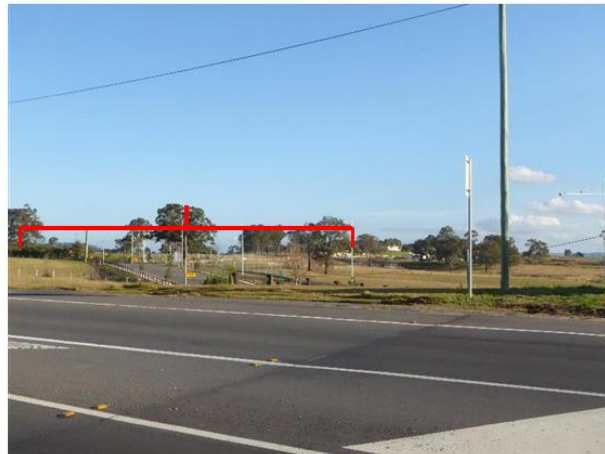
**Figure 5** View from the eastbound carriageway of Raby Road over the northern part of Gledswood Hills Drive towards the subject property, within the area marked red. (Photo: Chris Betteridge, 13 June 2017)

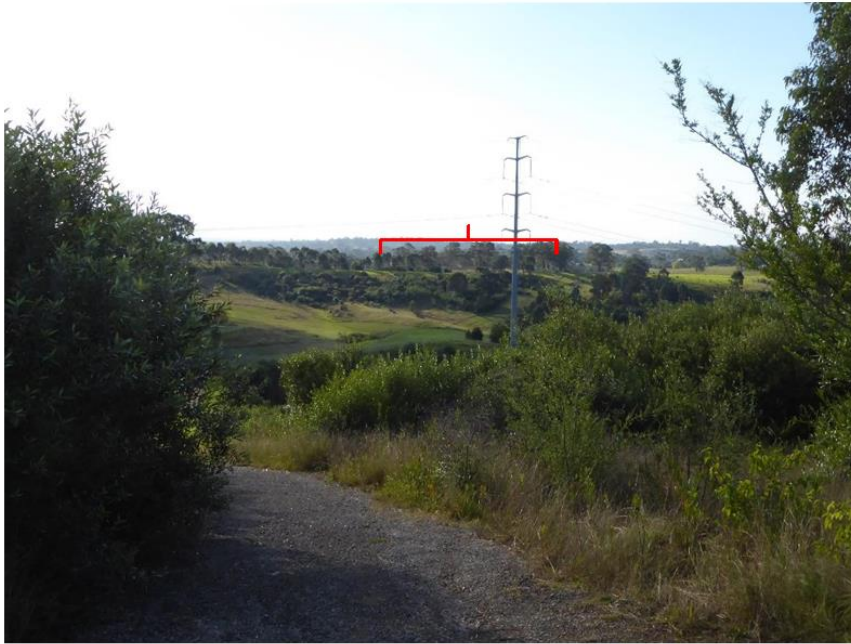
**Figure 6** View from high point southeast of The Grange golf course towards the subject property, marked red. (Photo: Chris Betteridge, 13 June 2017)

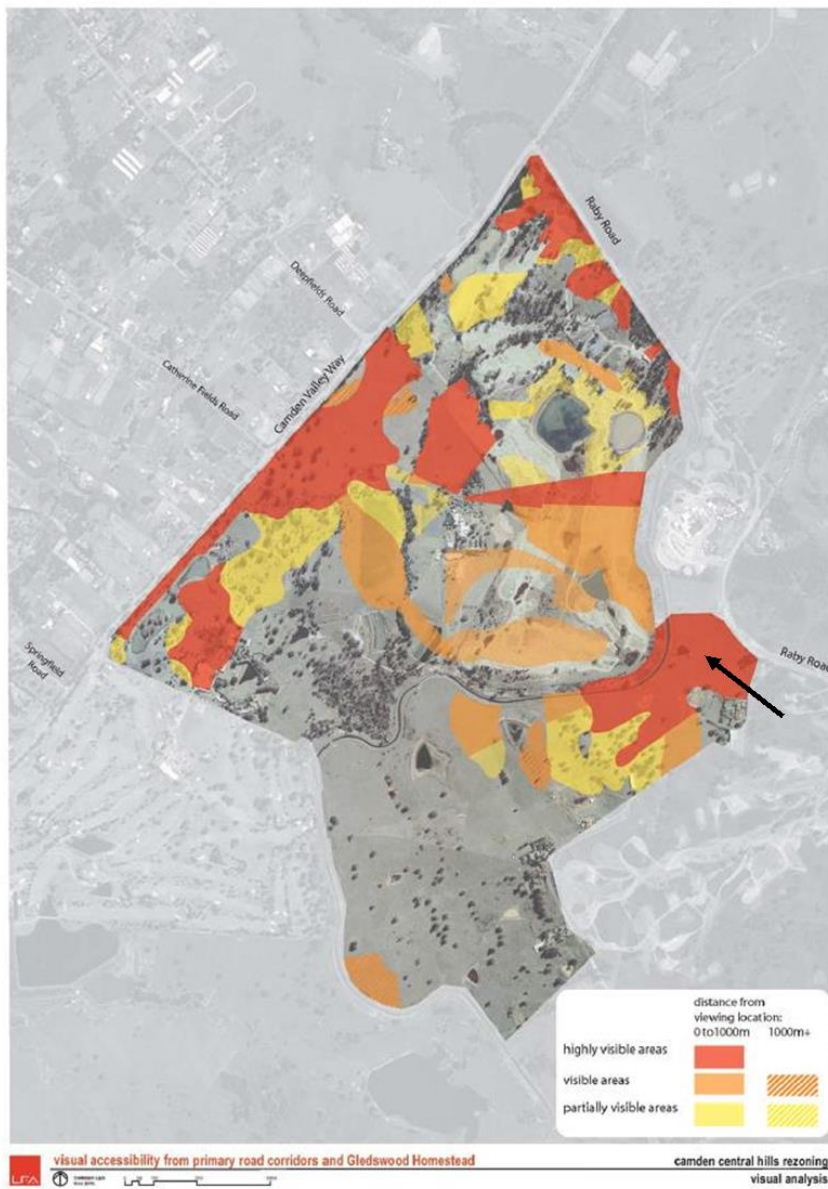
**Figure 7** Visual accessibility from primary road corridors and Gledswood Homestead, showing the location of the subject property, arrowed black. (Source: LFA (Pacific) Pty Ltd)

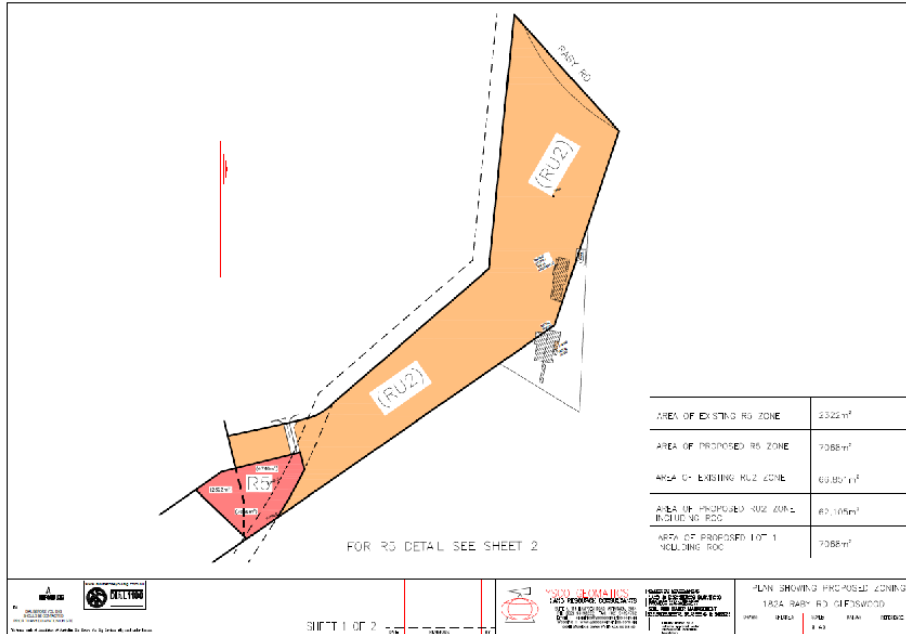
The proposal is detailed in the diagram below.

**Figure 8** The subject property showing the current zonings and the areas of existing and proposed zonings. (Source: YSCO Geomatics Land Resource Consultants)

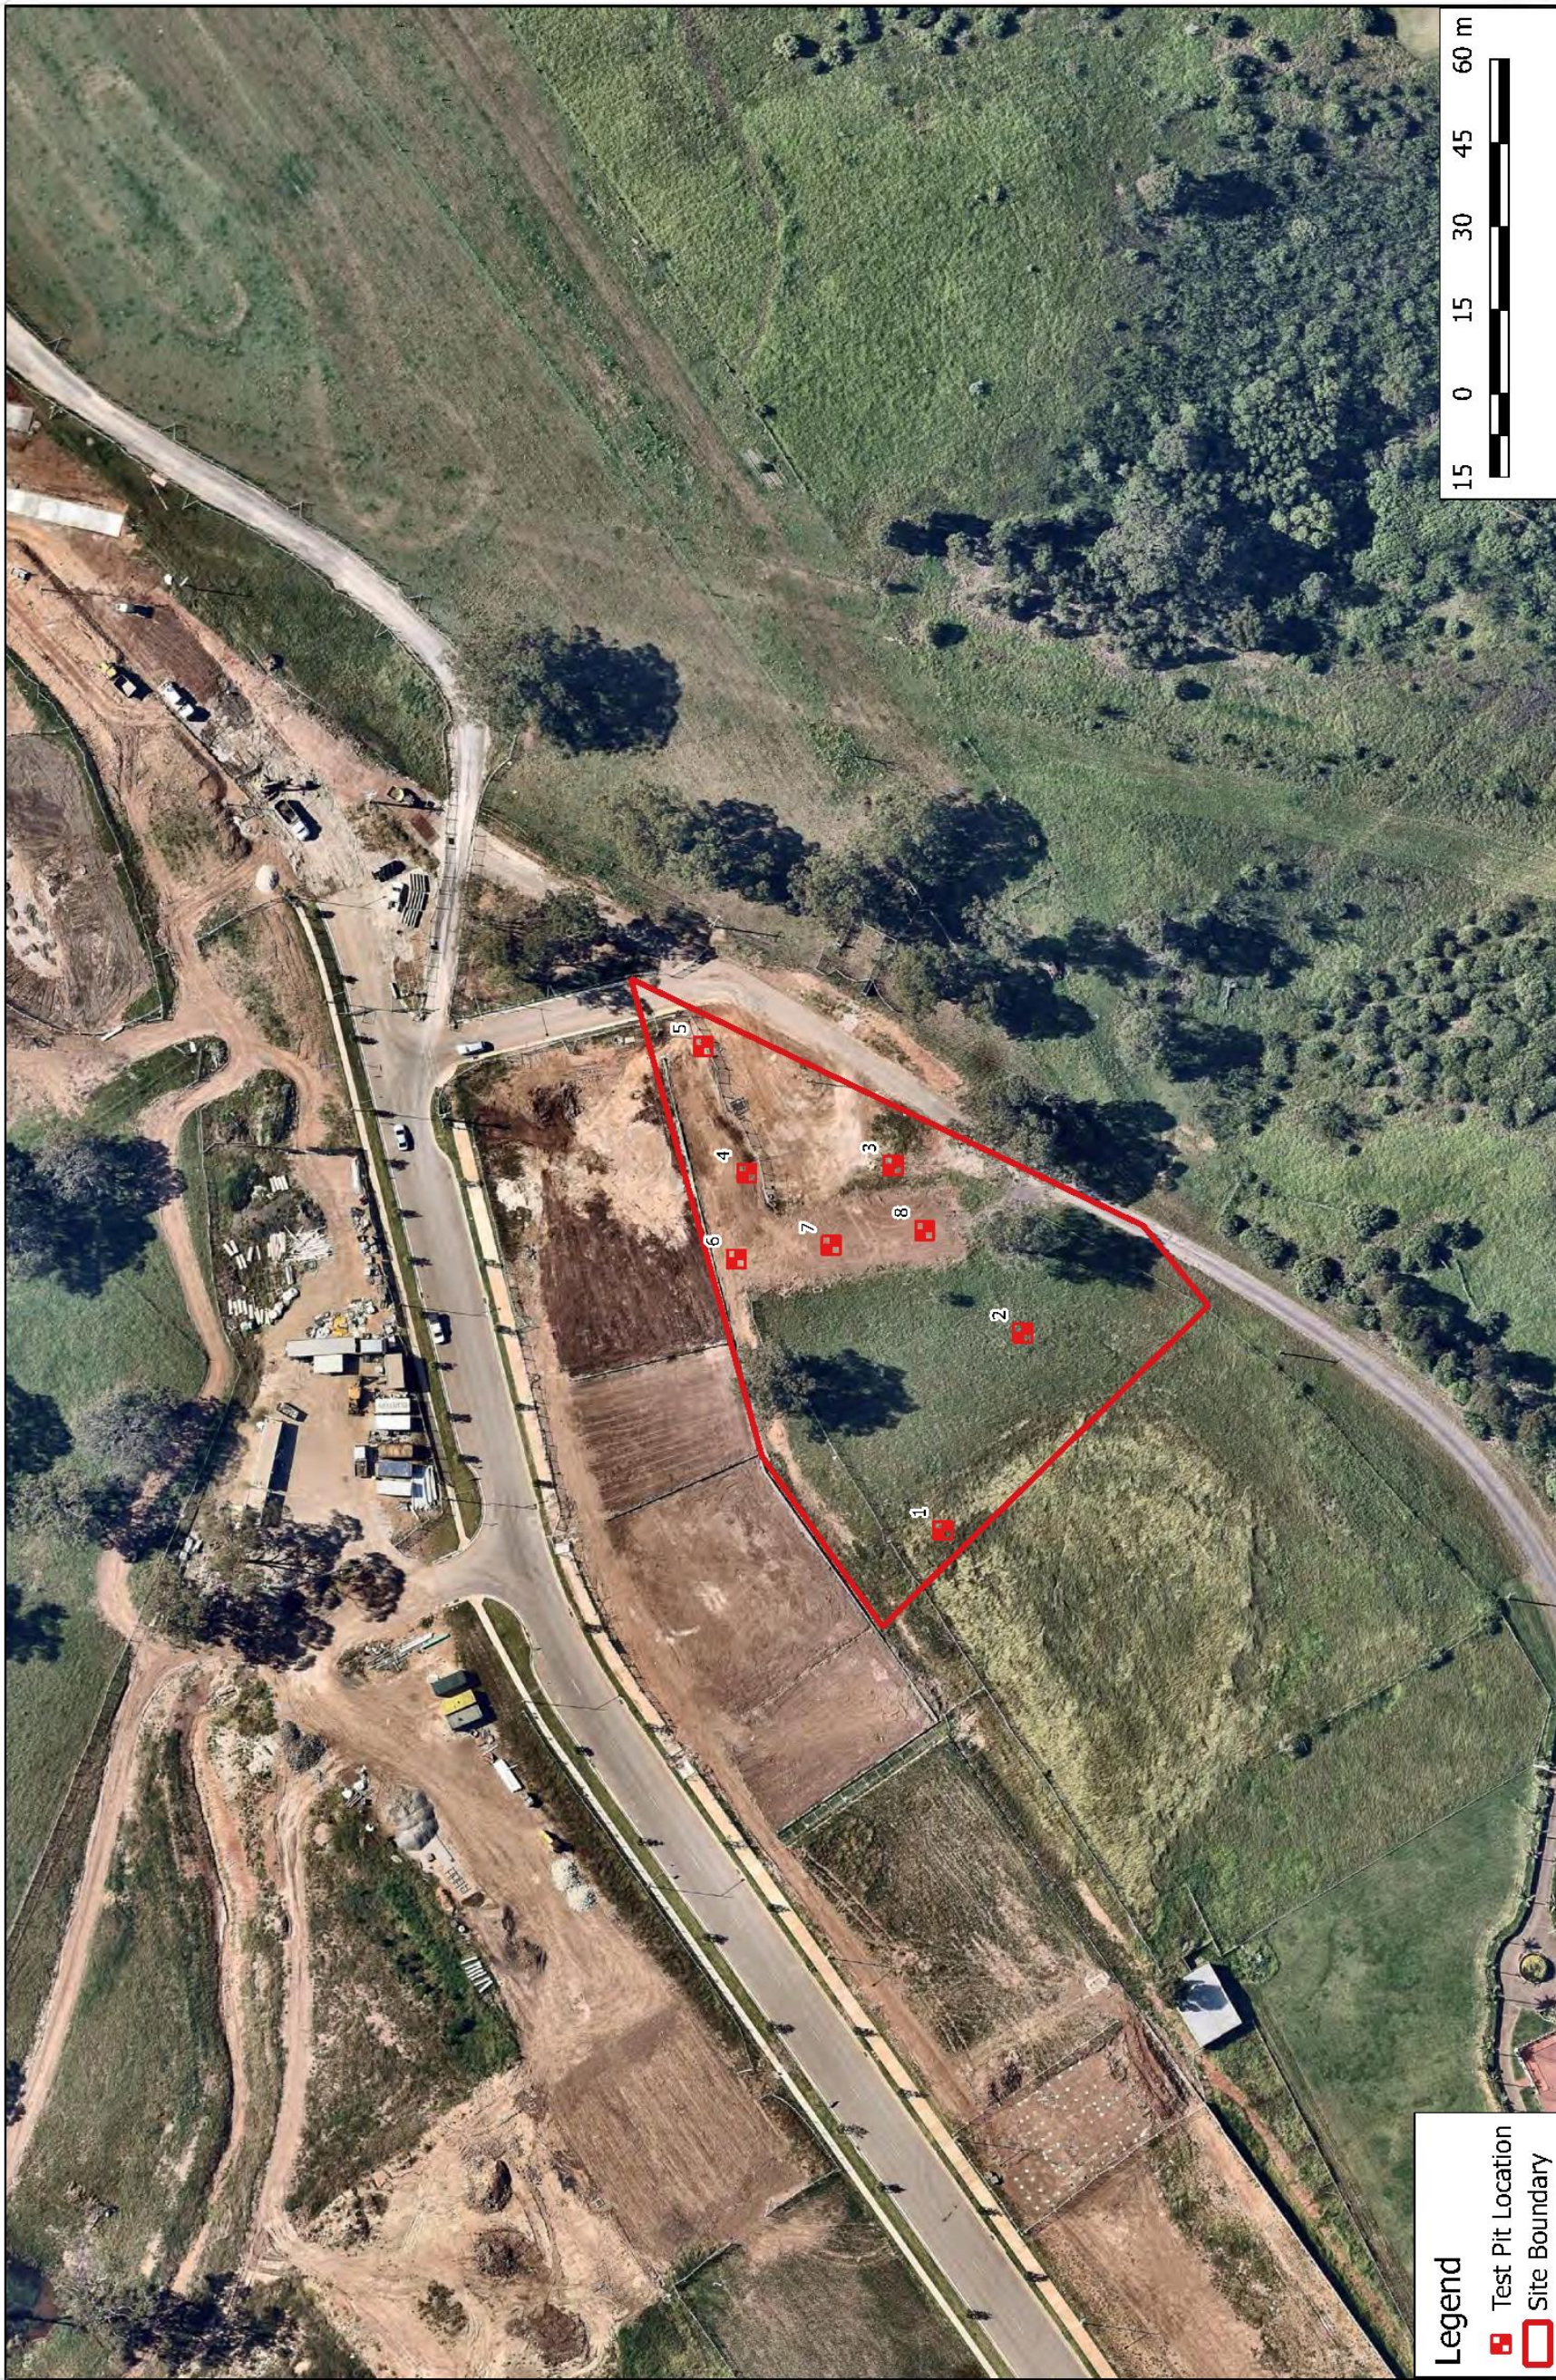
**Legend**  
 ■ Test Pit Location  
 □ Site Boundary

CLIENT: TN Consulting Pty Ltd OFFICE: Macarthur SCALE: As shown	DRAWN BY: SJL DATE: 21/06/2017	TITLE: <b>Sample Plan Layout</b> <b>Proposed Residential Subdivision</b> <b>182 Raby Road, Gledswood Hills, NSW</b>	PROJ: 92228.00 DRAWING No: 2 REVISION: A

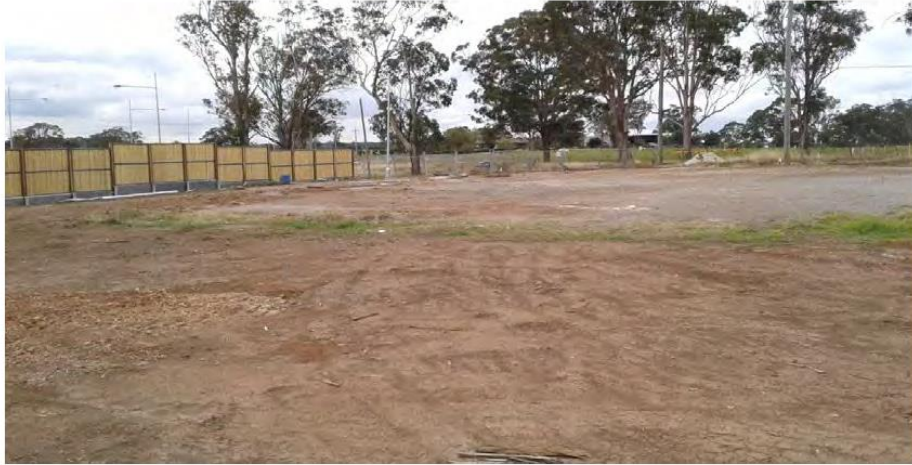
Photograph 1 - North eastern portion of the site with Mayfield Place and rural residential properties beyond.

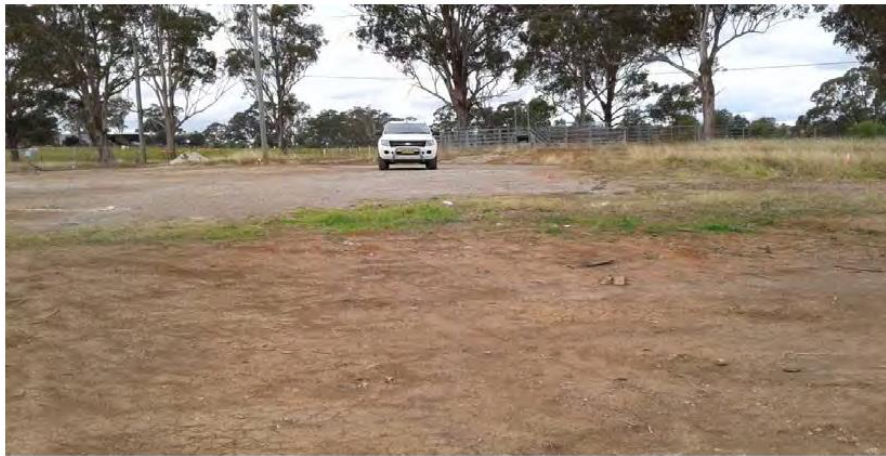
Photograph 2 - Eastern portion of site.

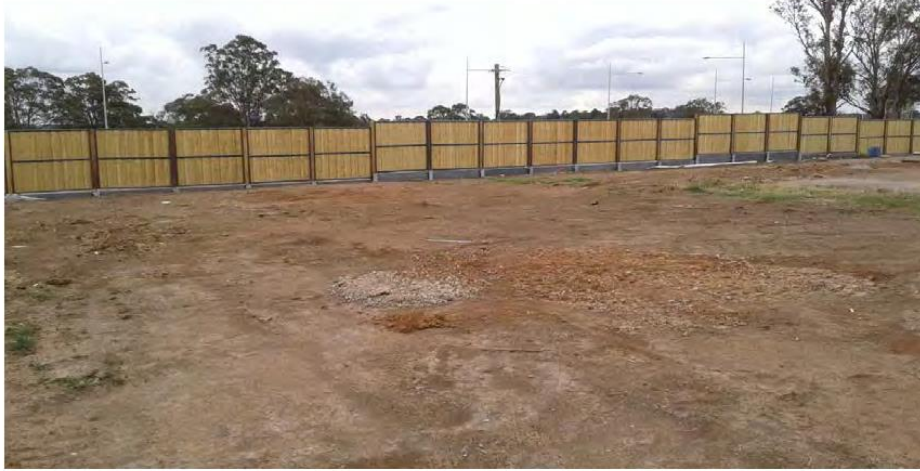
Photograph 3 - Northern portion of site with timber fence along northern boundary.

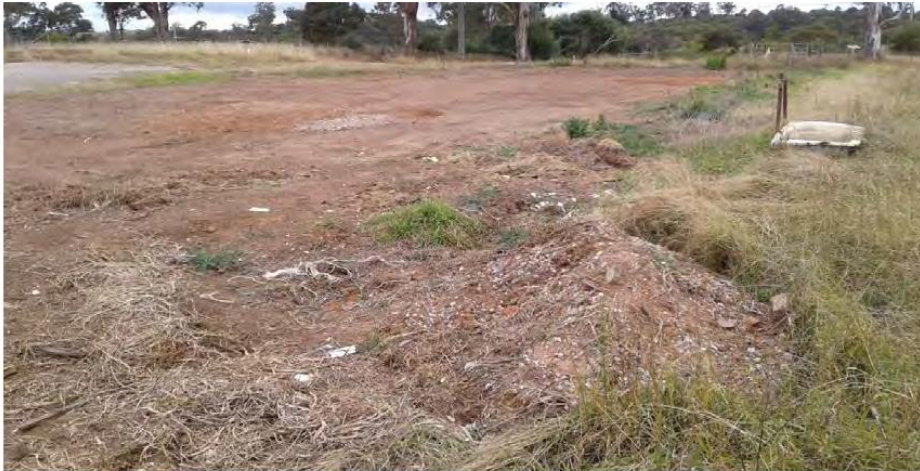
Photograph 4 - Soil / building waste stockpile located in central northern portion of site. Several fragments of fibrous cement material observed in vicinity of stockpile.

- An ACM fragment identified on surface soils in the north eastern portion of the Site which was removed from site at time of sampling; and
- Several fibrous cement fragments (suspected ACM ) observed near a small soil/building waste stockpile in the central northern portion of the Site.

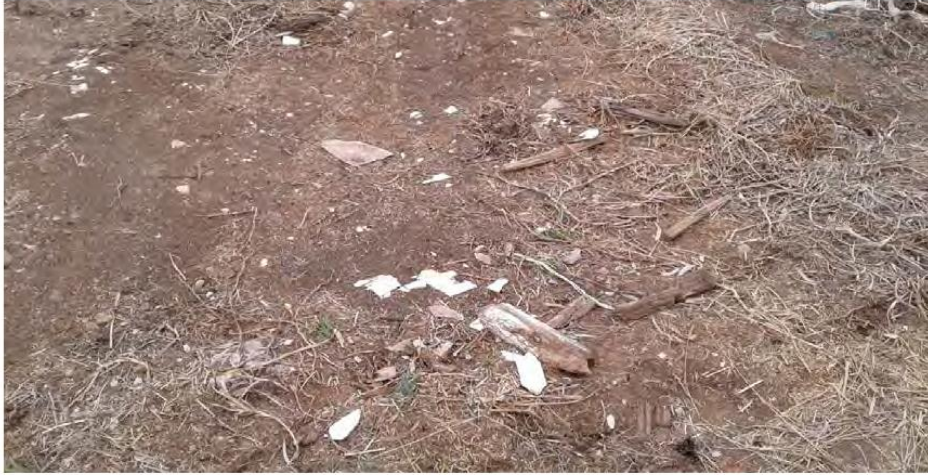
Photograph 5 - Fragments of fibrous cement material in the immediate vicinity of stockpile in central northern portion of site.

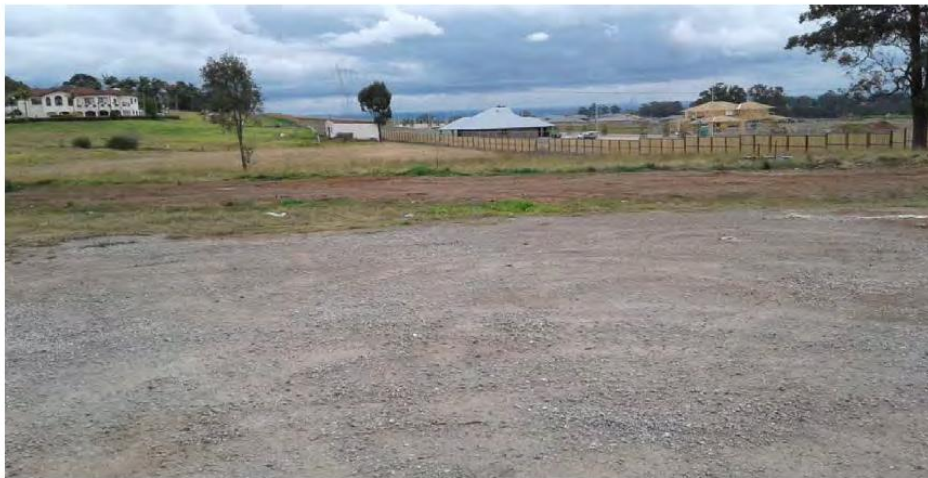
Photograph 6 - Western portion of site.

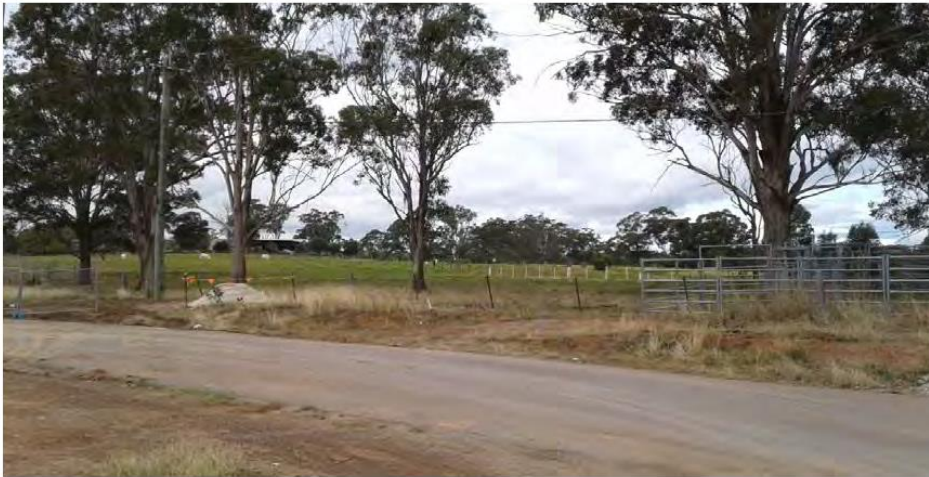
Photograph 7 - Mayfield Place with rural residential properties beyond to the southeast of the site.

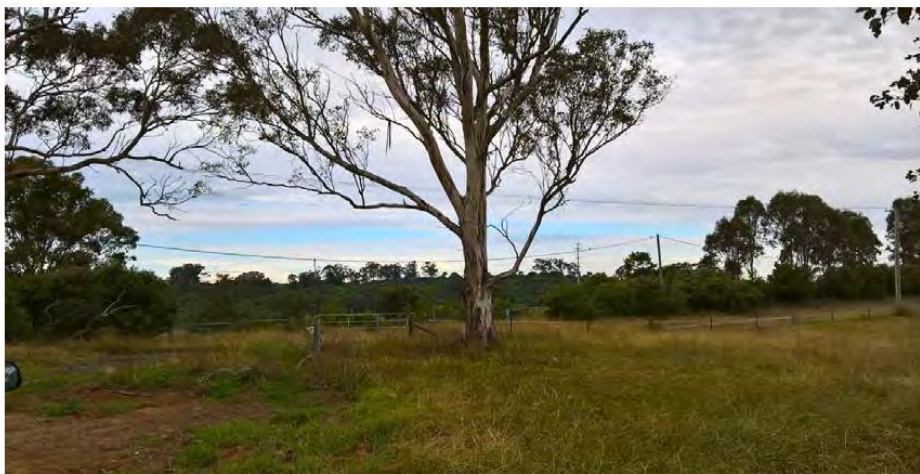
Photograph 8 - South eastern portion of site.

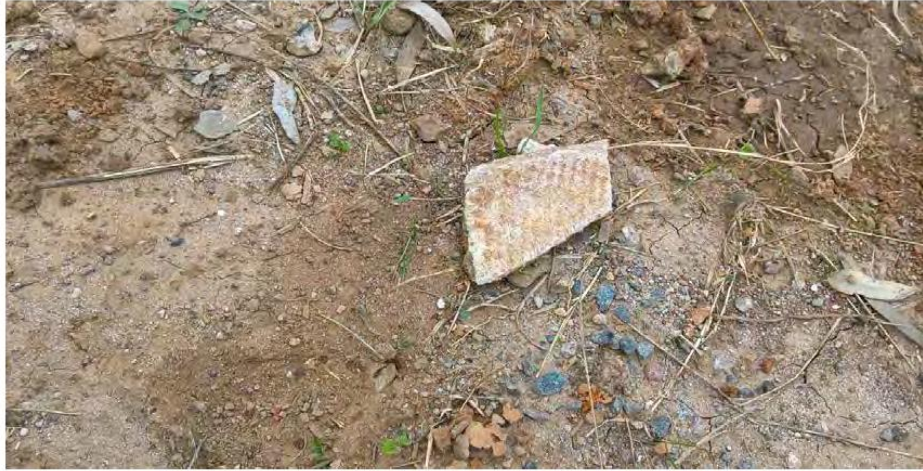
Photograph 9 - Fragment of ACM on surface soils in north eastern portion of site.

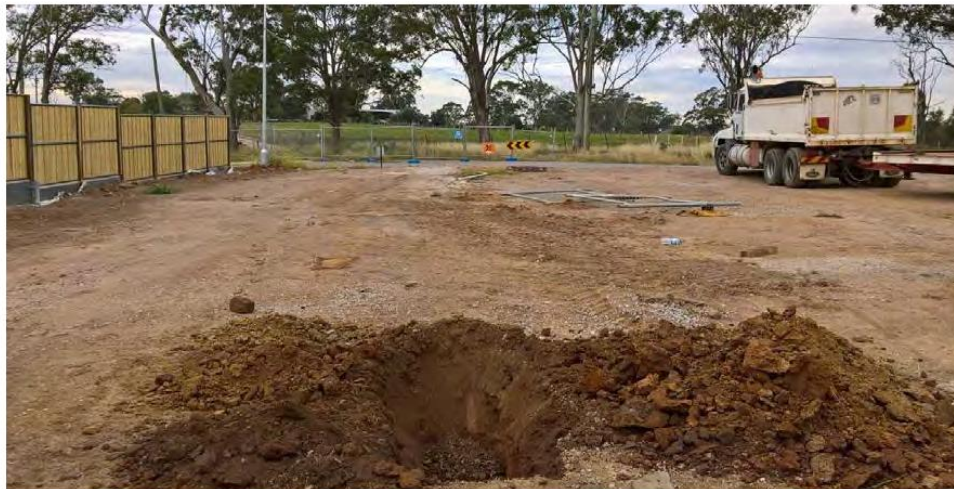
Photograph 10 - Test pit 4 completed in north eastern portion of site.

No free groundwater was observed in any of the test pits during excavation or for the short time that they were left open.
