## **Bank Rehabilitation Works at 6 Sites Along the Nepean River**

Review of Environmental Factors

Client: Camden Council

Reference: PA3130-RHD-AU-WM-RP-EN-0002

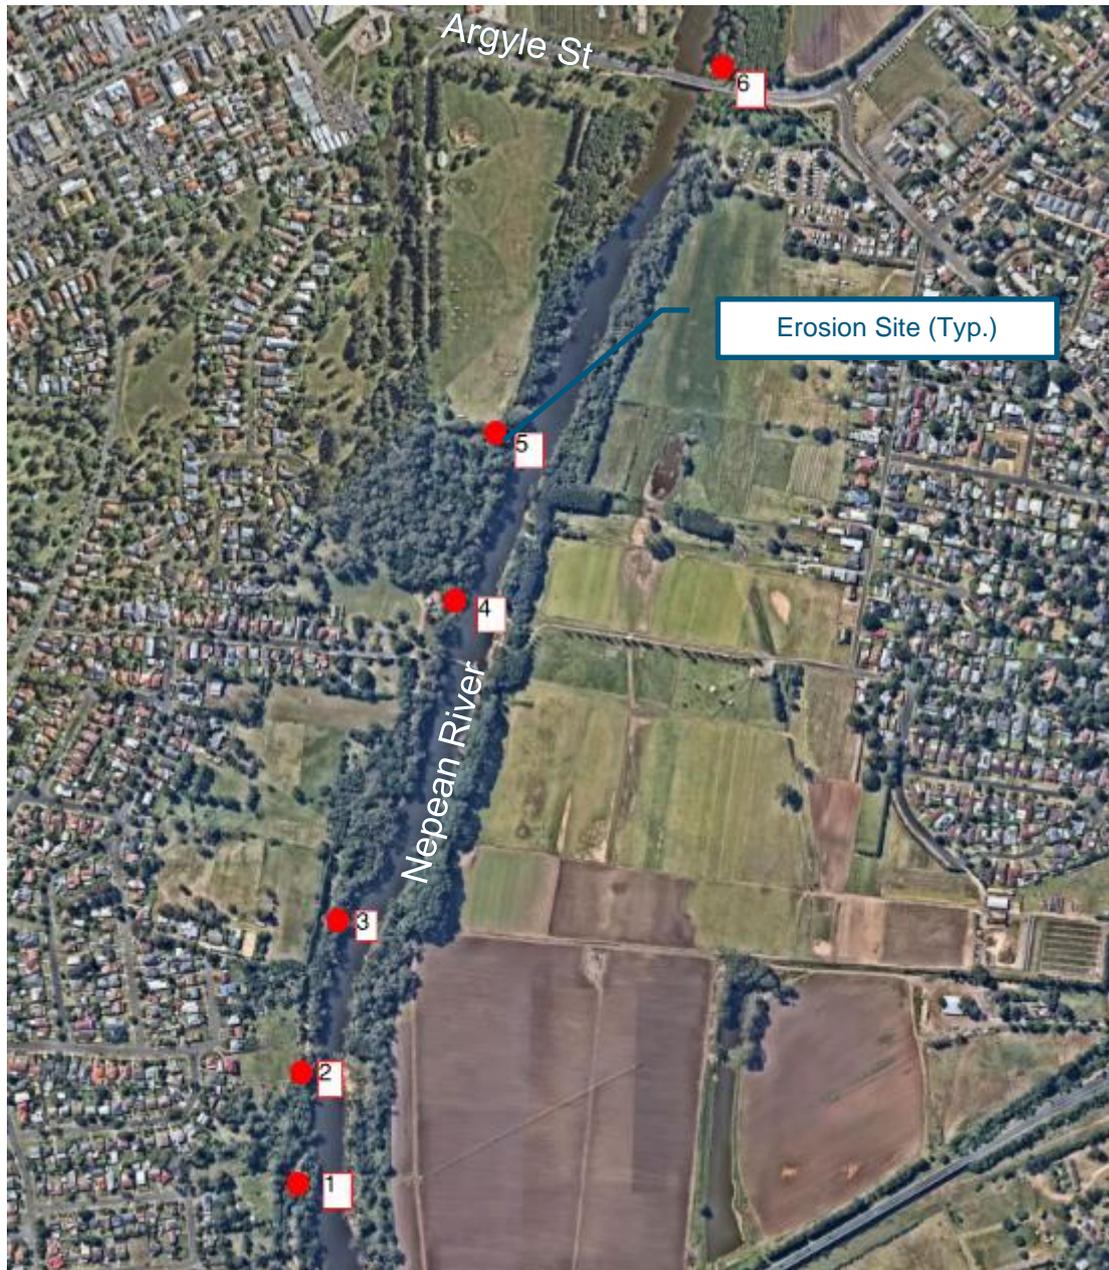
Figure 1-2 Location of Six Erosion Sites Along the Nepean River

The location of the subject sites in the context of the Greater Sydney metropolitan area is shown in **Figure 1-1**. The location plan showing the position of the six sites along the Nepean River is shown in **Figure 1-2**.

Camden Council has engaged Soil Conservation Services to prepare design documentation for the stabilisation of a six erosion sites along the Nepean River at Camden. The location of the erosion sites is shown in **Figure 1-2**.

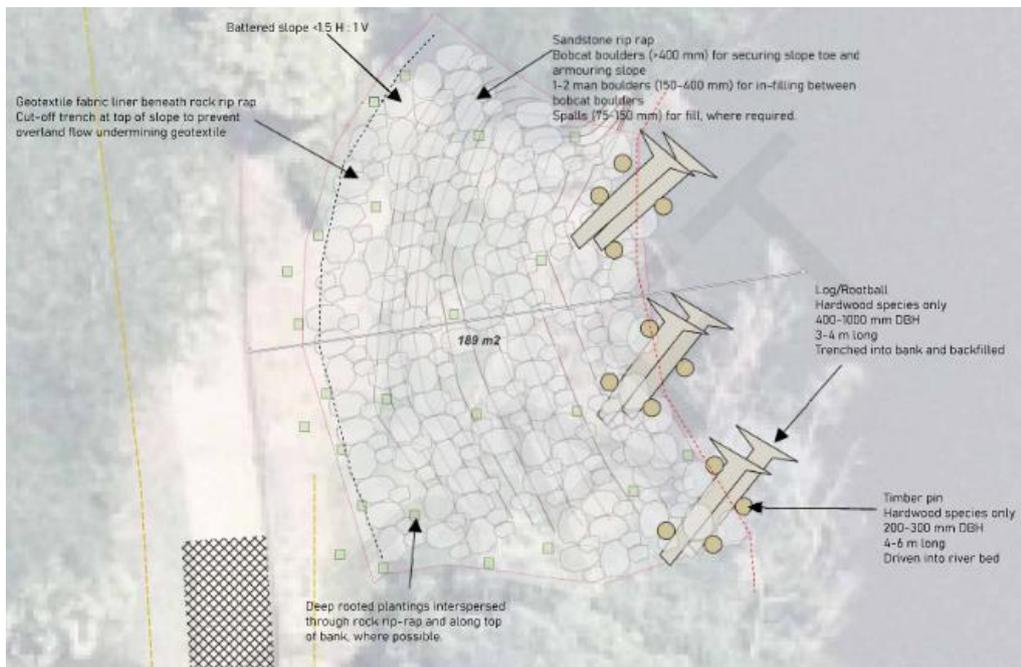
Figure 2-1 Example Design for Stabilisation of River Bank Erosion Sites

Concept Designs have been developed for the six sites in question. The general design for each site comprises a combination of log/rootballs 3 to 4 metres in length embedded at the water level of the eroded section of river bank. The logs are aligned 45 degrees to the direction of flow, pointing in a downstream direction. An example of the design is shown below in **Figure 2-1**.

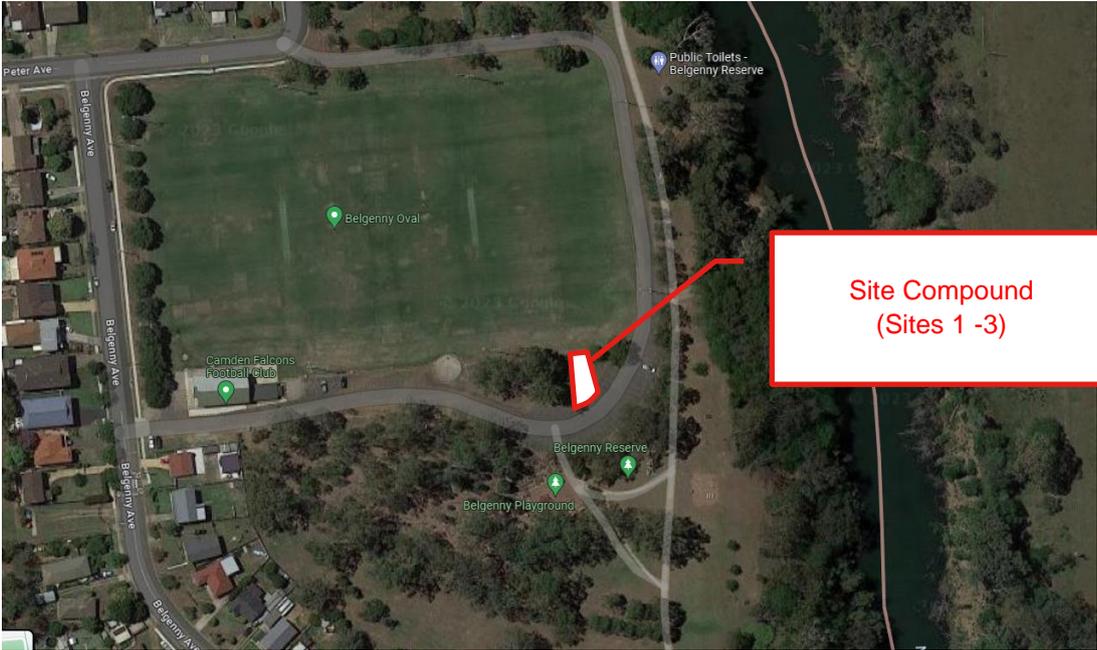
Figure 2-2 Contractor Compound Location for Sites 1, 2 and 3

- For Sites 1, 2 and 3, the location is shown below in **Figure 2-2**. The contractor's compound with storage areas and worker facilities is proposed to be located in Belgenny Reserve off Peter Avenue. The compound must be located outside of any sportsfield. The compound should be located to avoid any damage to trees.
- For Site 4, the compound location is shown below in **Figure 2-3**. The compound is proposed to adjoin the car park in Chellaston Reserve. The compound should be placed to avoid damage trees. It will be necessary to temporarily close the playground for the duration of the works.
- For Site 5, the compound location is shown below in **Figure 2-4**. The compound is proposed to be located towards the southern end of Cowpasture Reserve.
- For Site 6, the compound location is shown in **Figure 2-5**. It will be in the cleared area immediately adjoining the works zone.

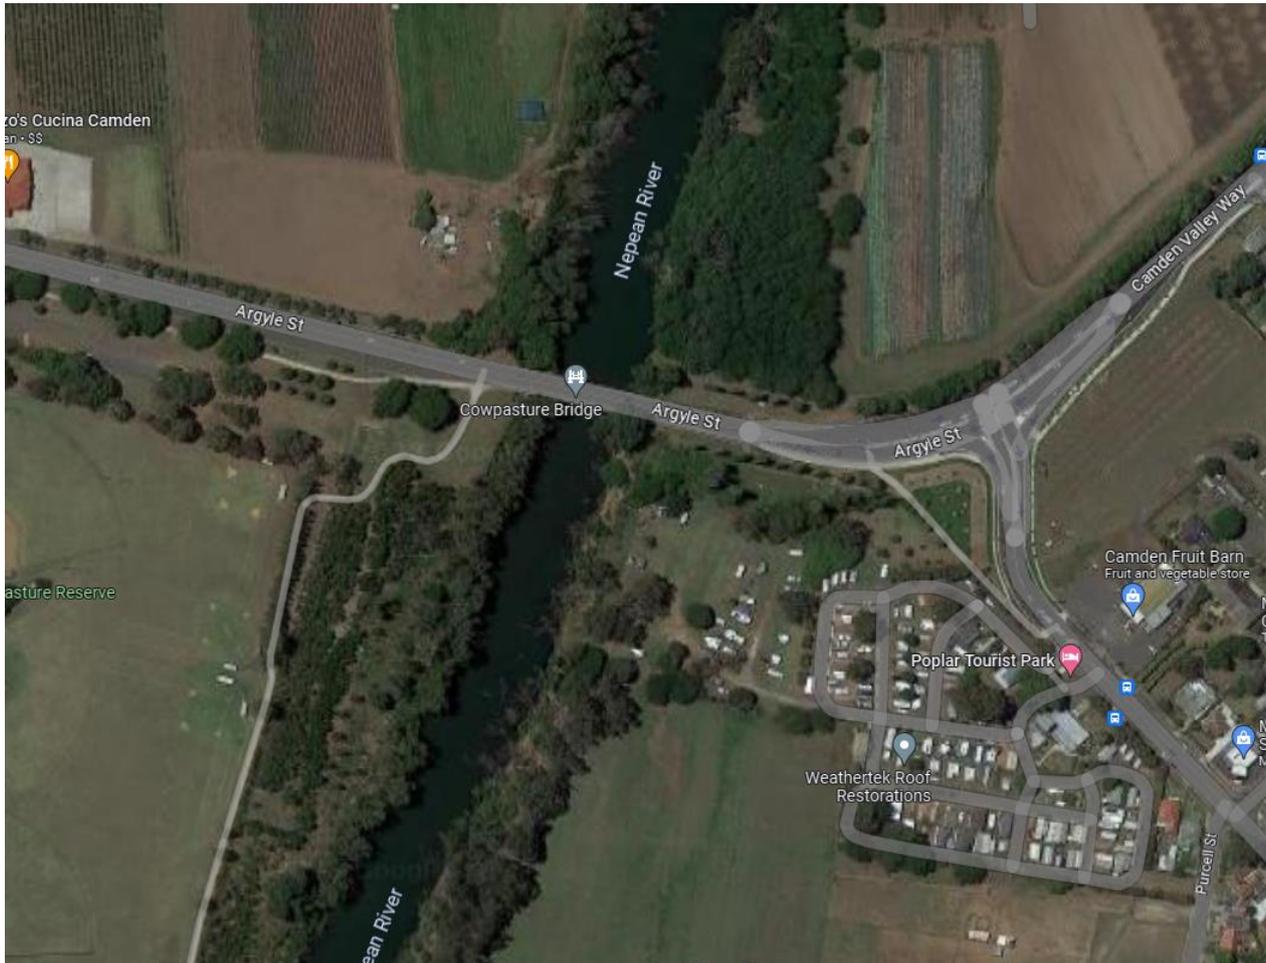
Figure 4-2 Vegetated riverine corridor on the eastern bank near site 6

In the area of the proposed bank stabilisation works, the landward zone is principally a vegetated riverine corridor extending approximately 50m in width. Behind sites 1 to 5, a Council reserve of cleared grassed land is located behind the riverine corridor (refer **Figure 4-1**) within which, it is proposed to locate the contractor's work compound. Landward of Site 6 is a narrow zone of vegetation, followed by farmland (refer **Figure 4-2**).

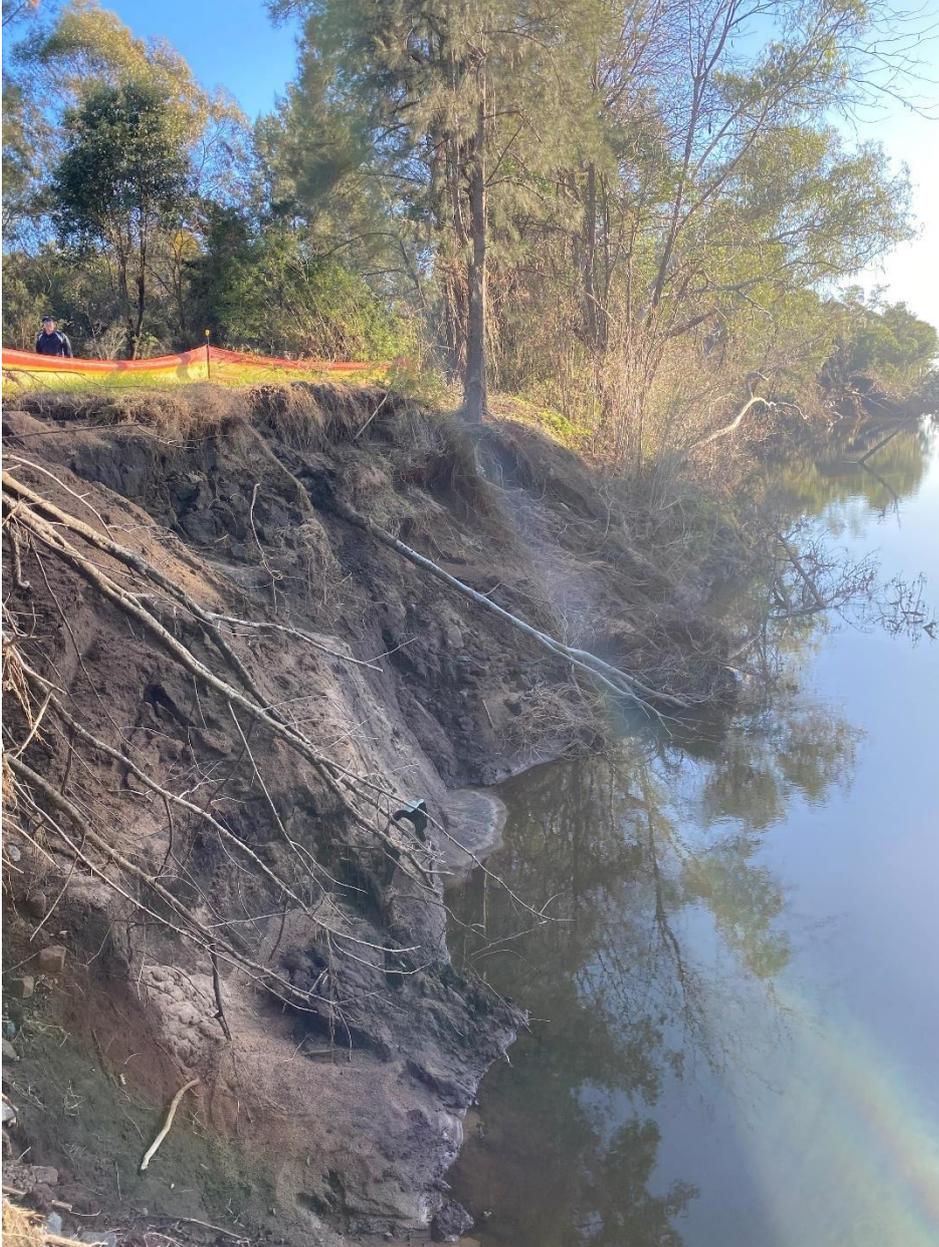
Figure 4-3 Example of vegetation occurring near Site 3

The riverine vegetation comprises grasses, weeds, small casuarinas and small eucalypts. Taller trees are located towards the top of the bank. An example of the vegetation encountered at two of the sites is shown in **Figure 4-3** and **Figure 4-4**.

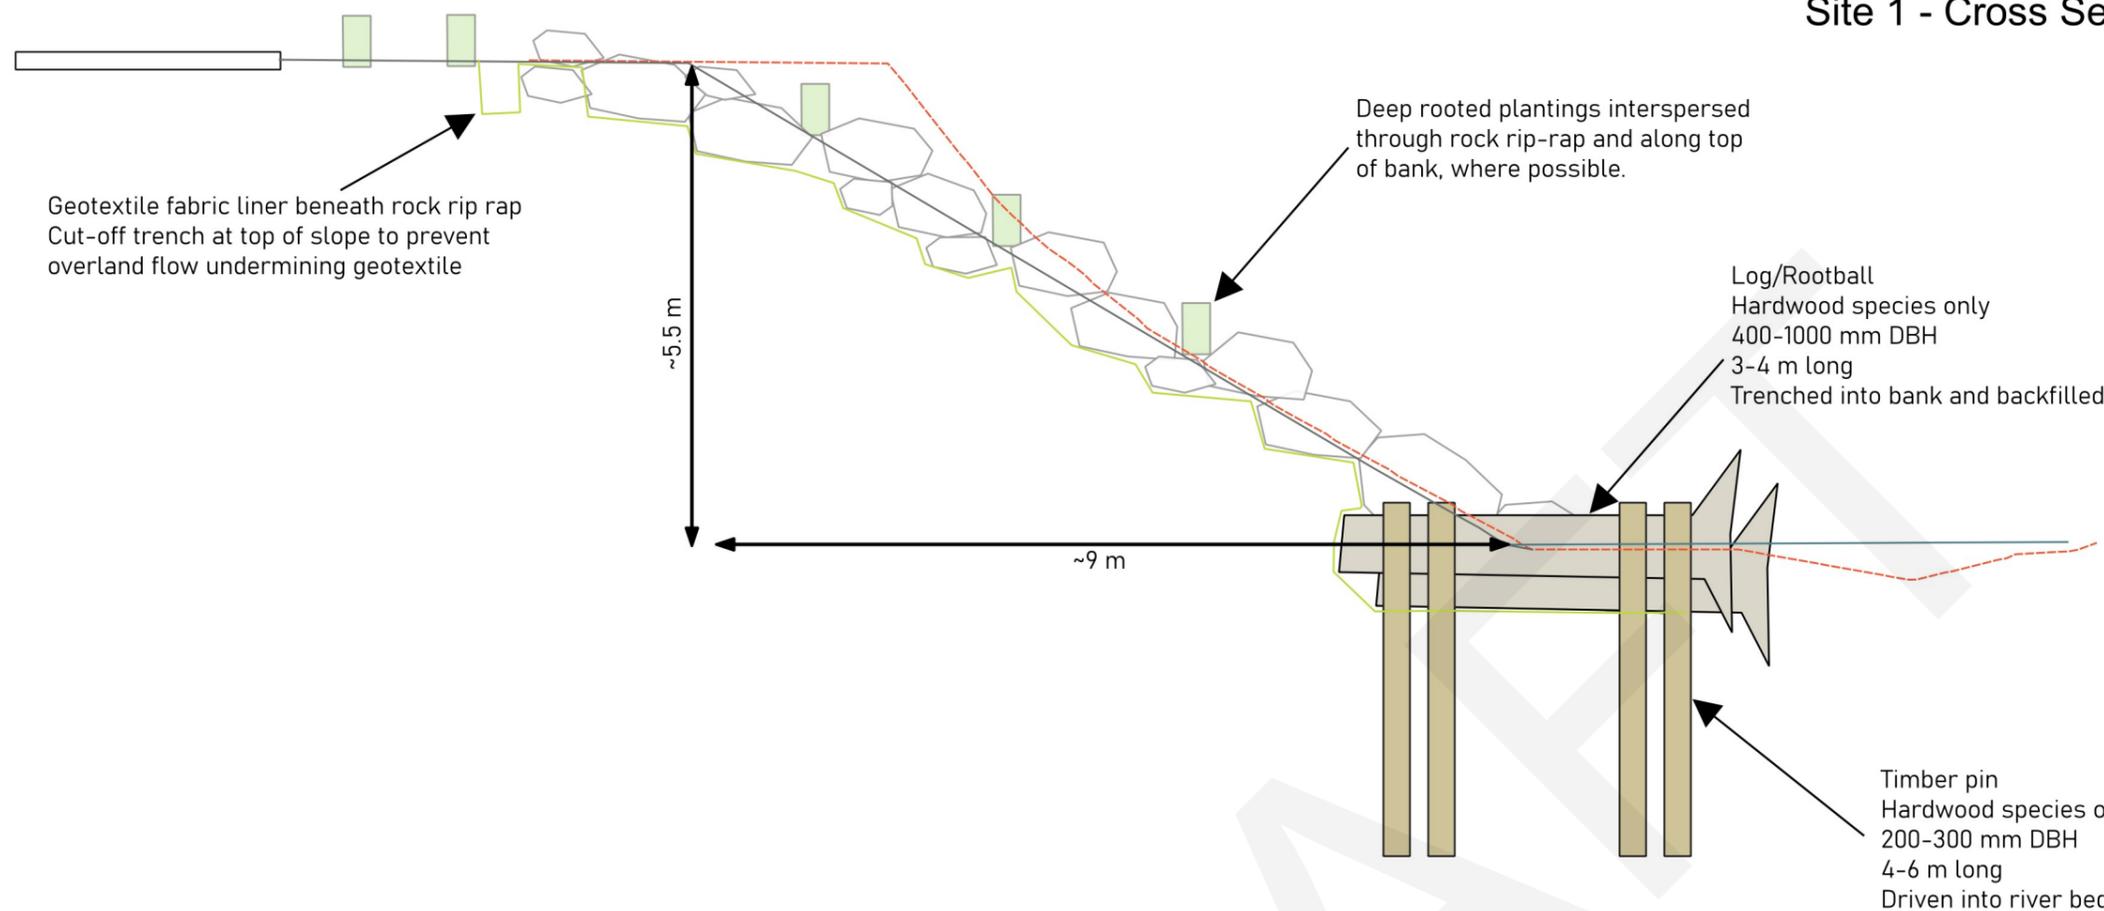
### Site 1 - Cross Section 1

- Current ground level
- Battered slope
- Water Level
- Geotextile fabric
- █ Hardwood pin
- █ Hardwood log/rootball
- Rock
- █ Planting
- Existing path

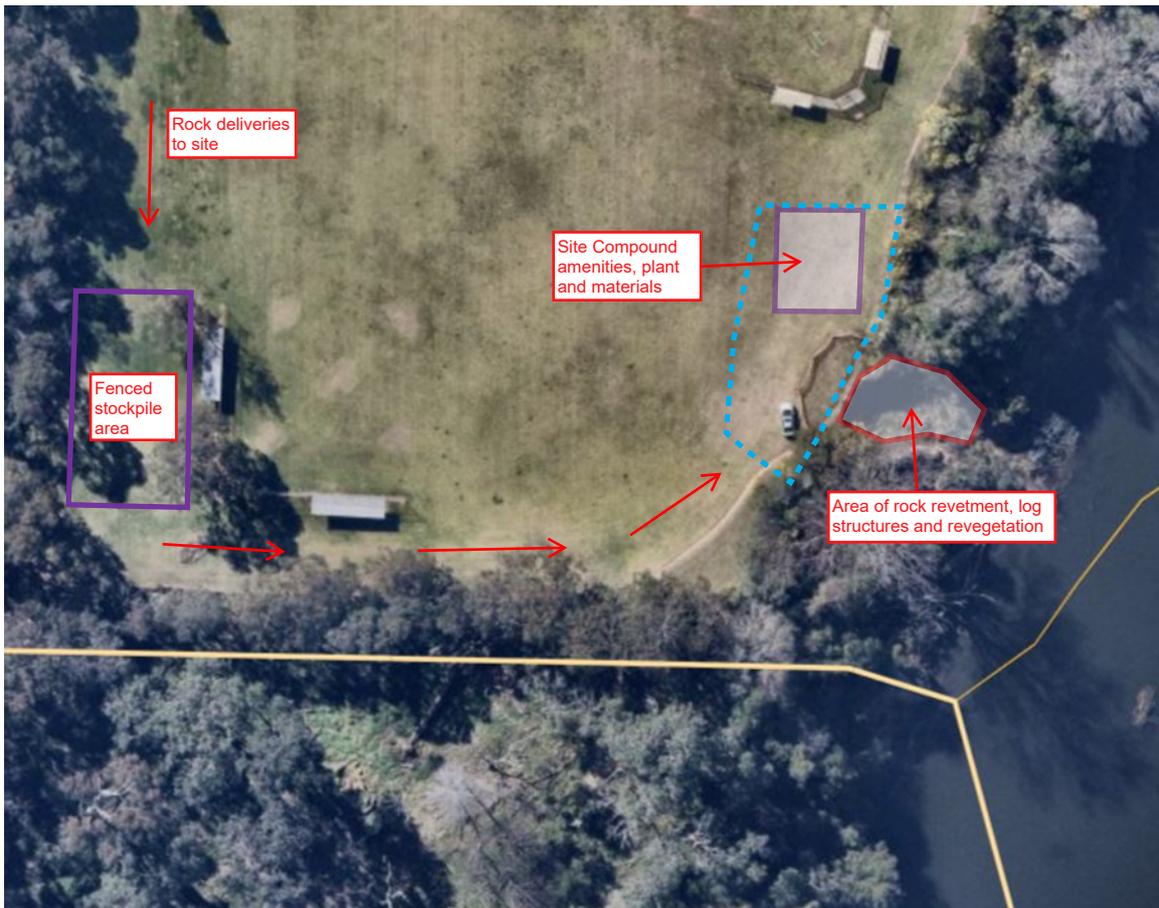
## Nepean River Scour Site 5 – Cowpasture Reserve

High Priority site due to proximity to playing fields and pathway.

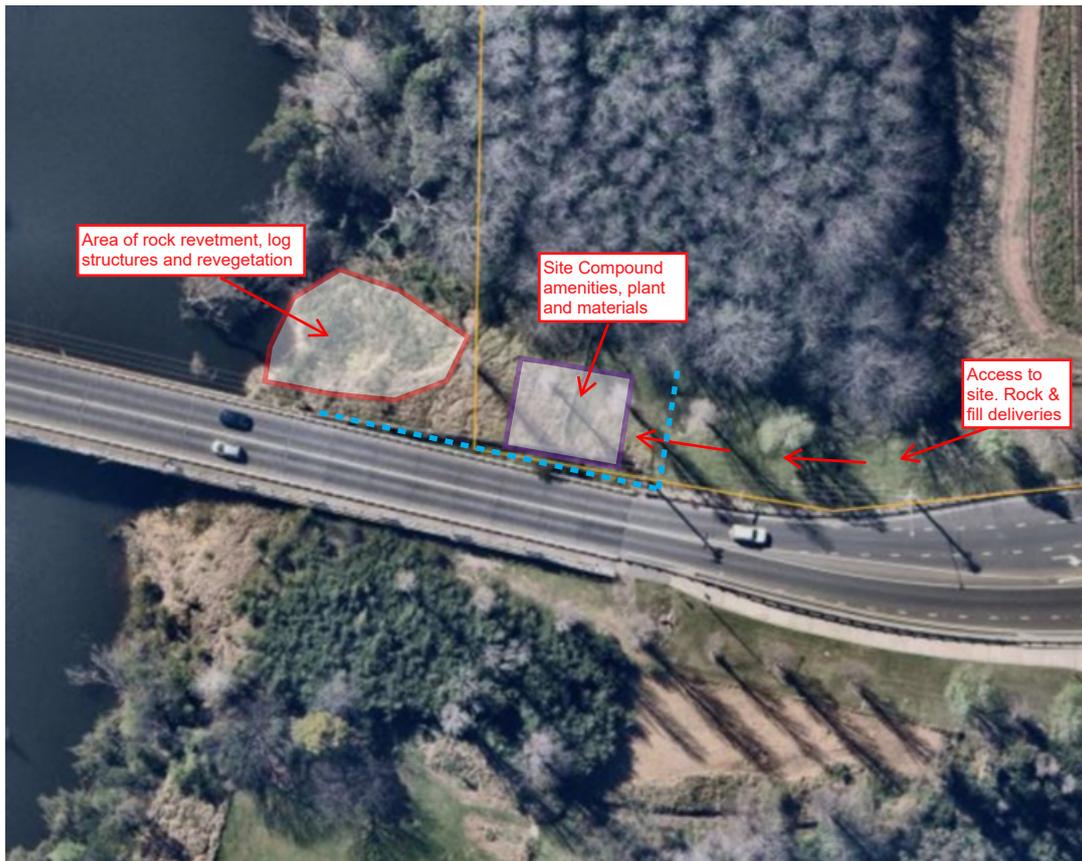
## Nepean Scour Site 6 – Cowpasture Bridge

Site 6 – Works involve filling of bank scour area, installation of rock revetment, log structures at river edge and planting. Following concept design is indicative and detailed design will have to be undertaken.

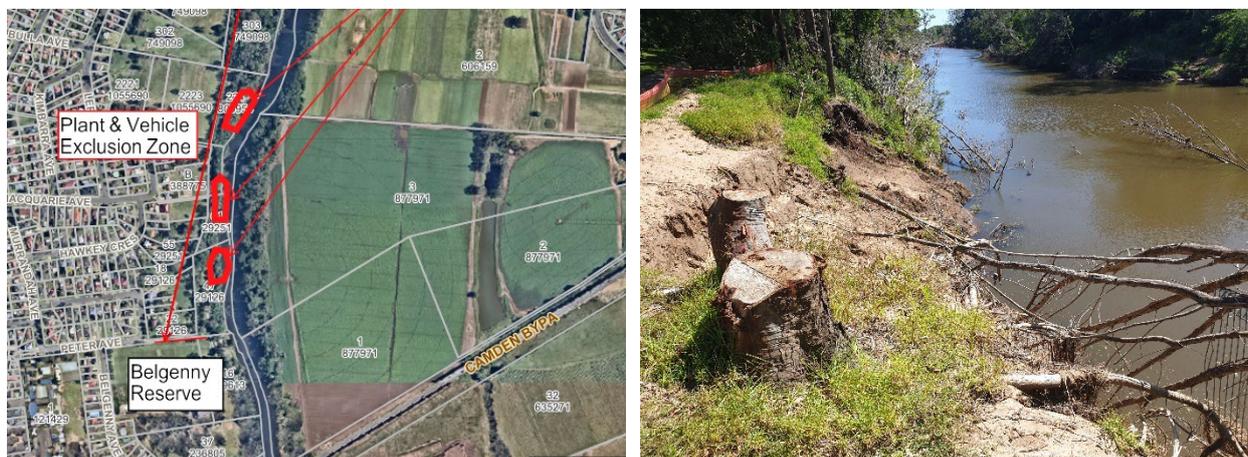
Camden Council have identified three priority areas of riverbank on the Nepean River that have experienced substantial scour/mass failure following a sequence of floods in 2021/2022. The sites require remediation to stabilise the riverbank, prevent on-going erosion or mass failure and protect adjacent public assets. The three sites are situated between Chellaston St (John Peat Reserve) and Peter Ave (Belgenny Reserve), as highlighted below (left). An example of the riverbank scour/mass failure is shown below (right).

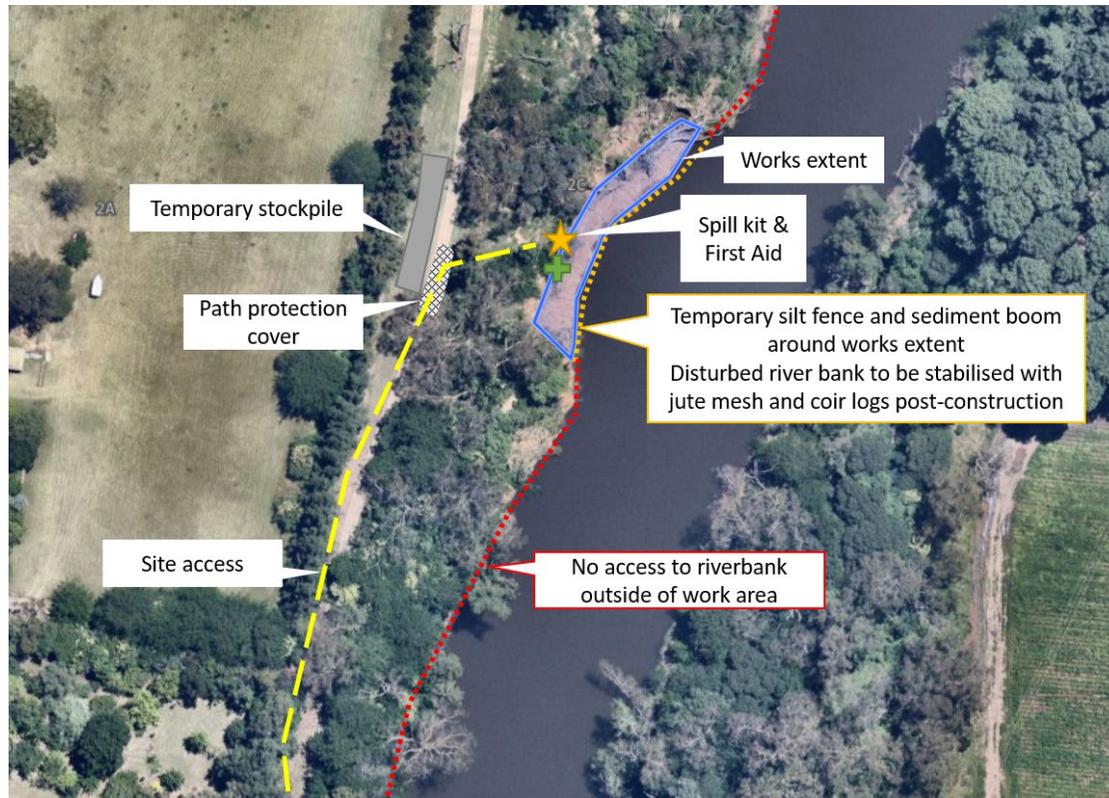
<b>NEPEAN RIVER SCOUR REMEDIATION - BELGENNY RESERVE</b>	Sheet 1 of 4
	<b>EROSION AND SEDIMENT CONTROL PLAN</b>	Revision 1.0
	Site Overview (North)	Not to scale

- Sediment boom should be inspected regularly during the works to ensure no low points are allowing 'seepage' of contaminants/pollution/sediment laden water.
- The location of the sediment boom is indicative and will be finalised on site.

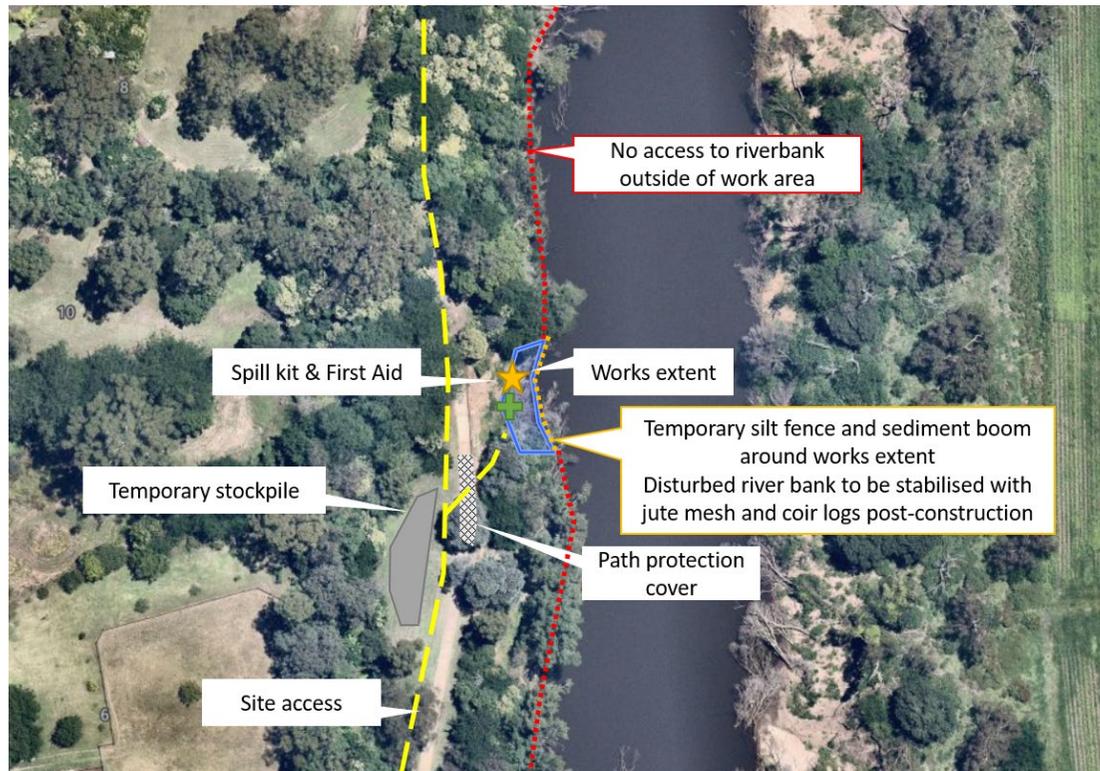
<b>NEPEAN RIVER SCOUR REMEDIATION – BELGENNY RESERVE</b>	Sheet 3 of 4
	<b>EROSION AND SEDIMENT CONTROL PLAN</b>	Revision 1.0
	Site Overview (South)	Not to scale

- Sediment boom should be inspected regularly during the works to ensure no low points are allowing 'seepage' of contaminants/pollution/sediment laden water.
- The location of the sediment boom is indicative and will be finalised on site.

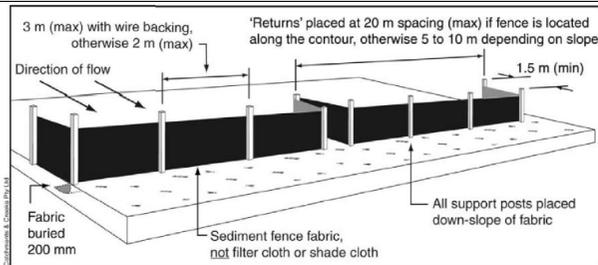
**Silt/Sediment Fences**

Sediment fence is a temporary permeable textile barrier which captures sediment on site whilst allowing water to flow off-site. Sediment fence is installed in a trench (or buried by clean fill) and supported by vertical posts.

- Do not use sediment fence in concentrated flow
- Install across the contour and include returns at max. 20 m intervals
- Ensure the bottom edge of the sediment fence is sufficiently buried in soil or clean fill by at least 200 mm
- Compact the trench after backfilling
- Anchor the sediment fence to the vertical posts using staples or wire
- Multiple fences can be installed parallel to each other if high volumes of sediment or discharge are expected. An additional sediment barrier can be placed upslope of the sediment fence using coir logs, straw bales or similar to capture the bulk of sediment prior to it reaching the sediment fence.
- Sediment fences must be checked regularly, maintained if damaged and sediment build-up removed regularly.

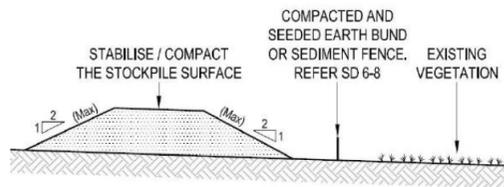
**Stockpiles**

Stockpiles should be situated away from existing vegetation, concentrated water flow lines, roads and sensitive areas. Stockpiles should be low with battered sides and positioned across the contour where possible.
