**Gateway Determination - Camden Local Environmental Plan 2010
Amendment No.32 – Lot 24 DP 1086823 Crase Place, Grasmere**

Response to Gateway Conditions
Crase Place, Grasmere
Land Capability Assessment
Project No 14154 – December 2014

LAND CAPABILITY ASSESSMENT
RESPONSE TO GATEWAY CONDITIONS
AT LOT 24 DP1086823
CRASE PLACE, GRASMERE

**Phase 1 Contamination Assessment and Salinity Assessment
Part Lot 24 DP1086823, 10 Crase Place,
Grasmere, NSW**

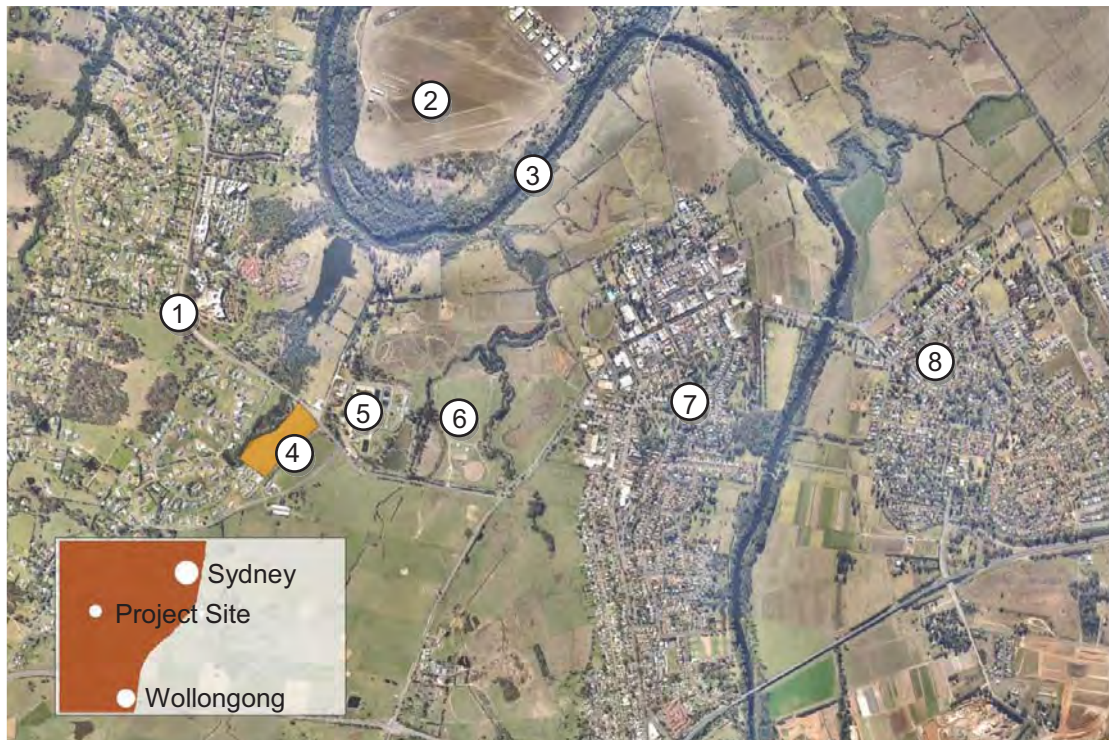
Figure 1.2 Regional Context Overview

The West Camden WRP is located to the north east of the subject property. Figure 1.2 shows the proposed site and its context.

1. Grasmere
2. Camden Airport
3. Nepean River
4. Subject Site
5. West Camden Water Recycling Plant
6. Camden Bicentennial Equestrian Park
7. Camden
8. Elderslie

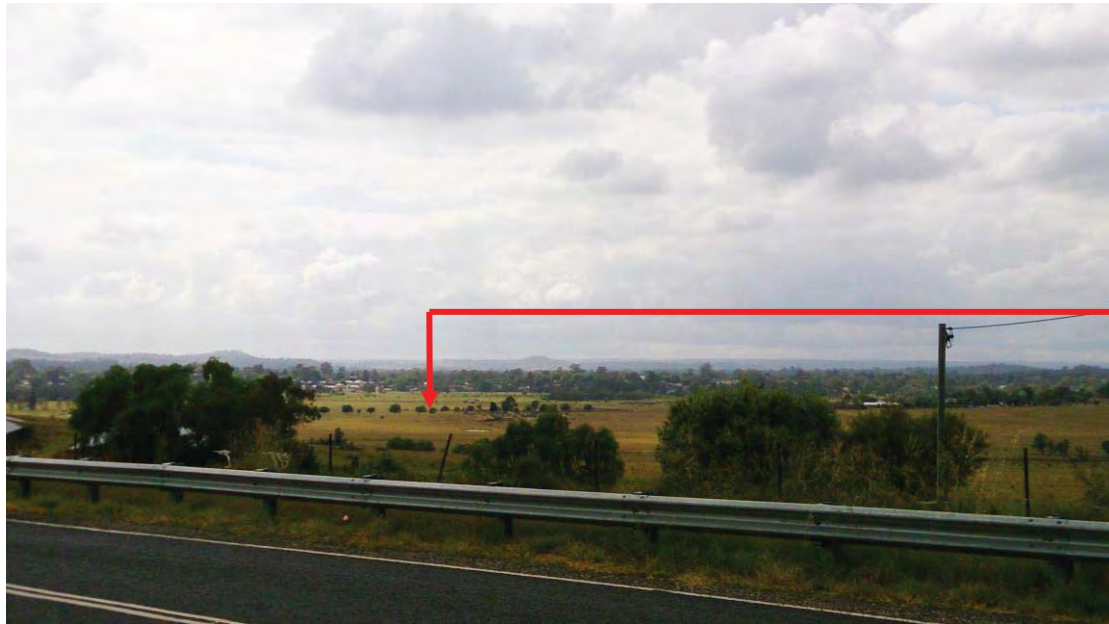
Figure 2.2 – Viewpoint 1

View from Old Oaks Road looking East showing primary production and rural residential land surrounding the site.

Typical landscape character – looking towards east of subject site

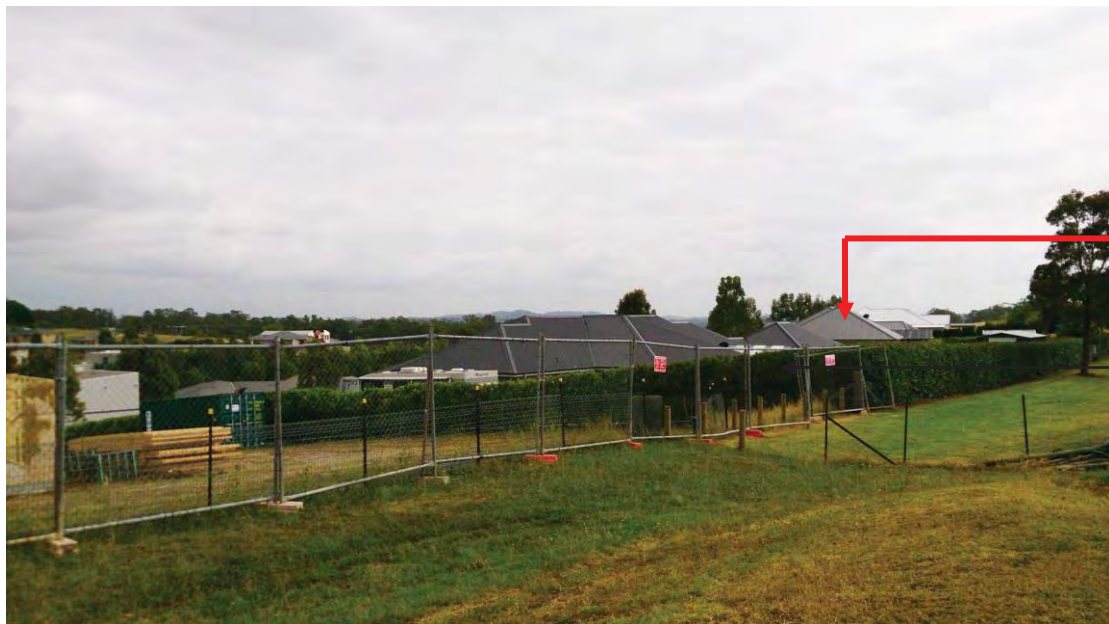
Figure 2.3 – Viewpoint 2

View from Old Oaks Road overlooking existing rural residential subdivision. Project site and potential future subdivision hidden behind buildings and vegetation.

Subject Site

Existing rural residential subdivision

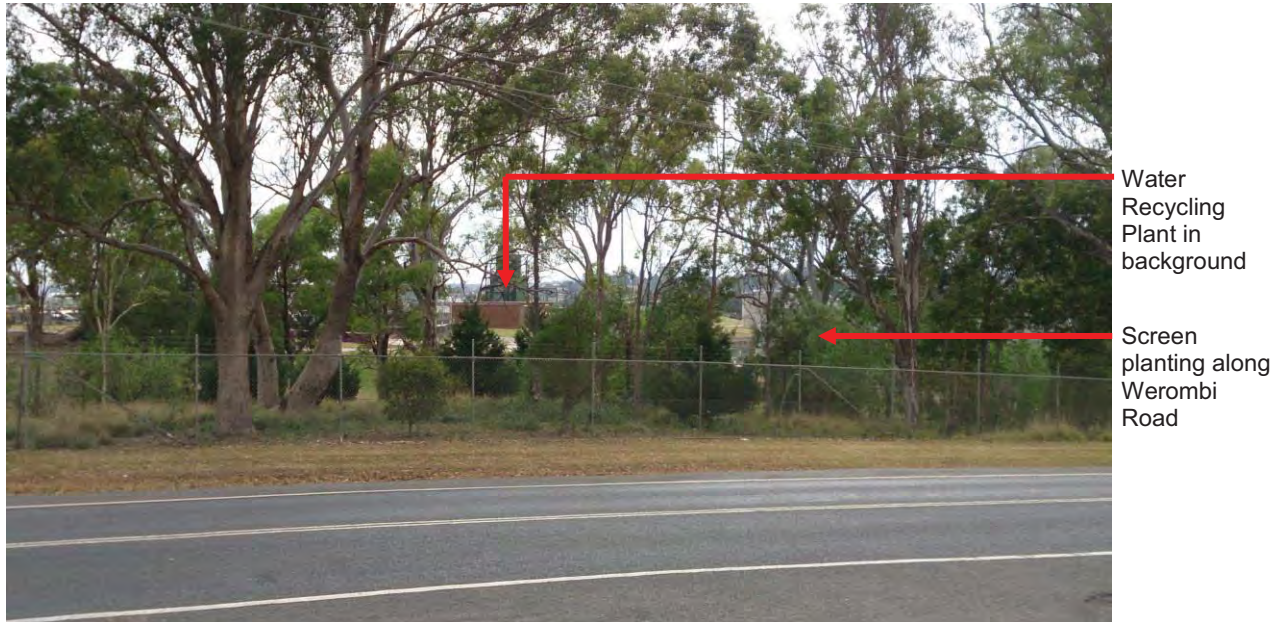
Figure 2.3 - Viewpoint 3

View from intersection of decommissioned Old Oaks Road / Werombi Road looking towards West Camden Water Recycling Plant. Plant is hardly visible because of tree / shrub screen planting.

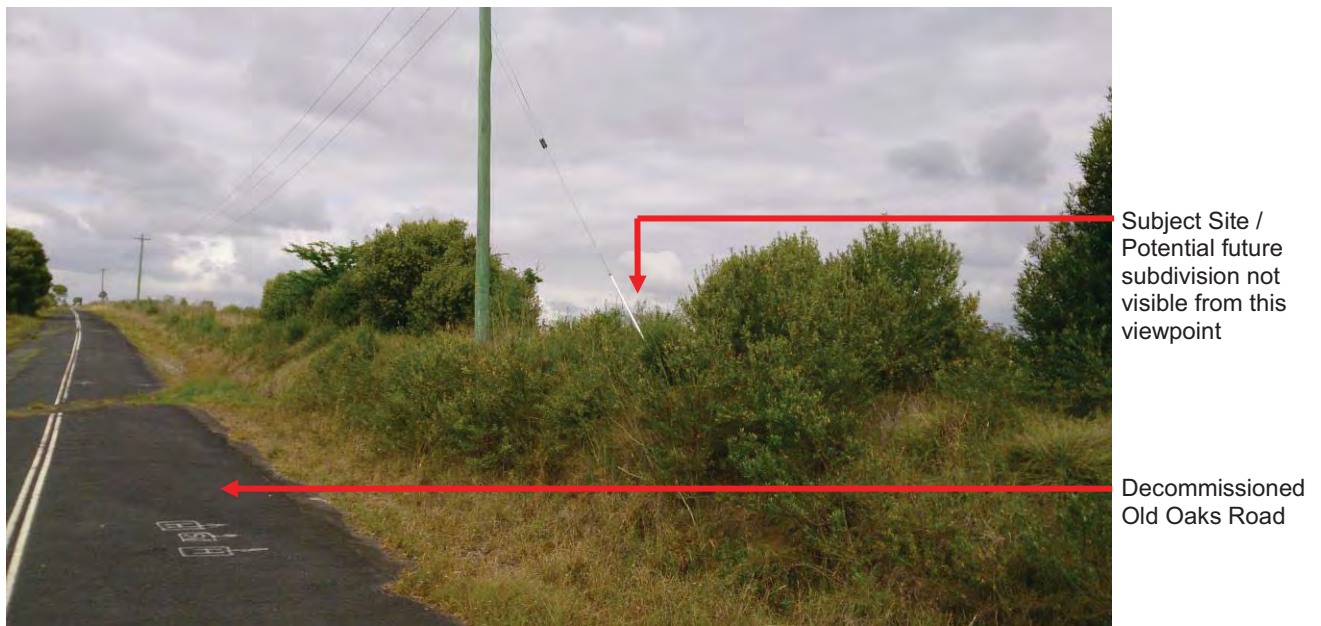
Figure 2.4 - Viewpoint 4

View along decommissioned Old Oaks Road with the potential future subdivision / subject site to the west. Existing topography doesn't allow for views into the site from this viewpoint.

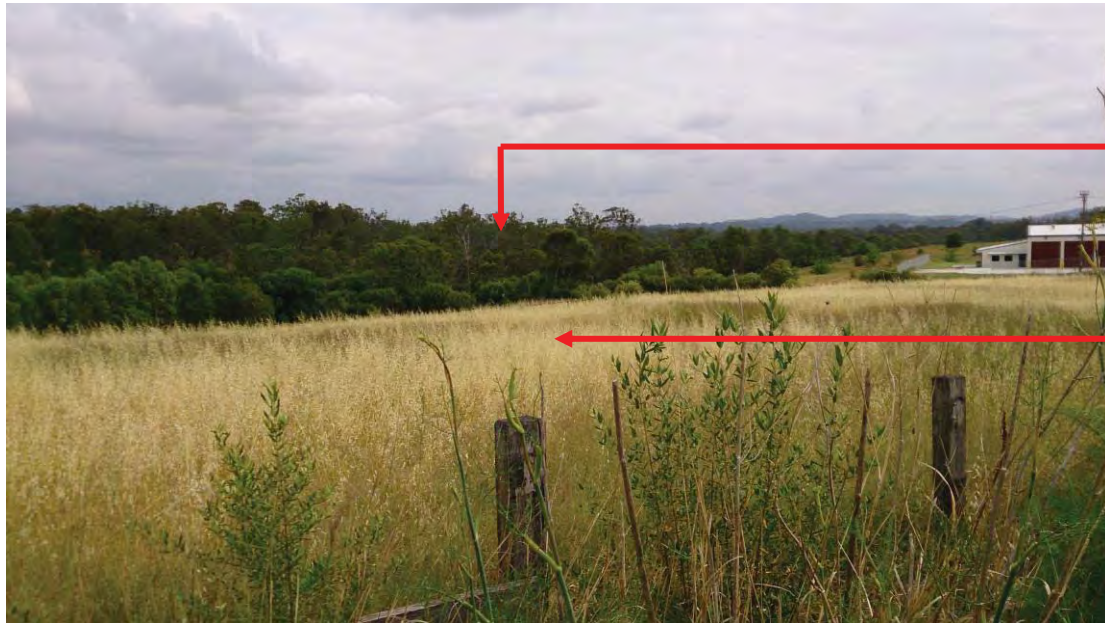
Figure 2.5 - Viewpoint 5

View from highpoint along decommissioned Old Oaks Road overlooking sloping land of subject site. View towards existing rural fire station on Werombi Road.

Vegetation along existing drainage line on adjacent property

Subject site sloping towards existing vegetation line on neighbouring property

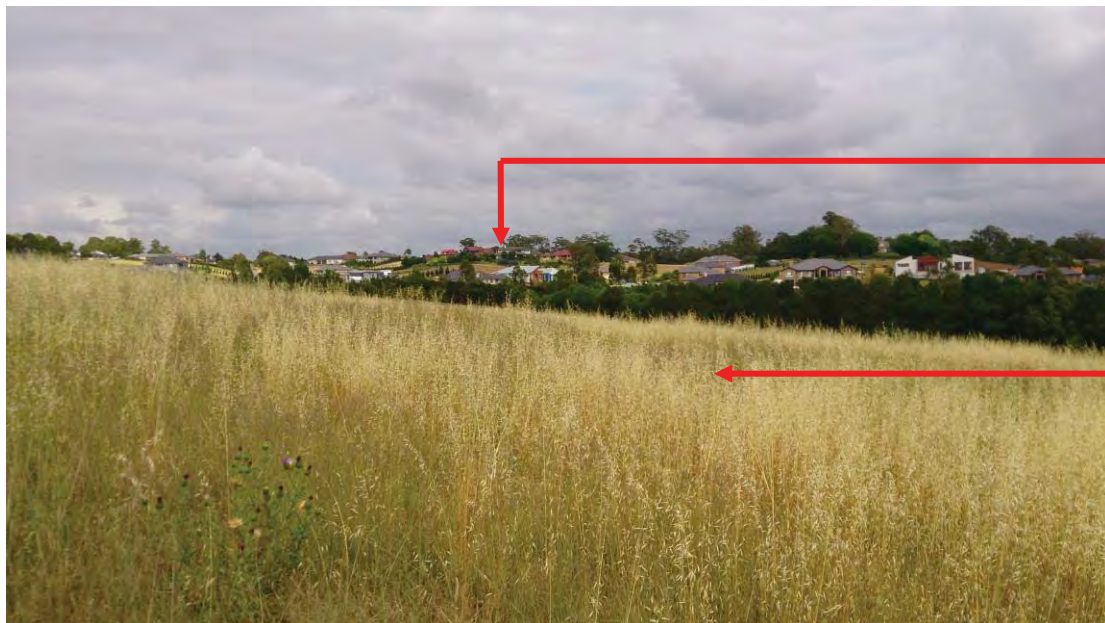
Figure 2.6 - Viewpoint 6

View from highpoint along decommissioned Old Oaks Road overlooking sloping land of subject site. View towards existing rural residential subdivision development to the south west.

Existing rural residential subdivision in background

Subject site sloping towards existing vegetation line on neighbouring property

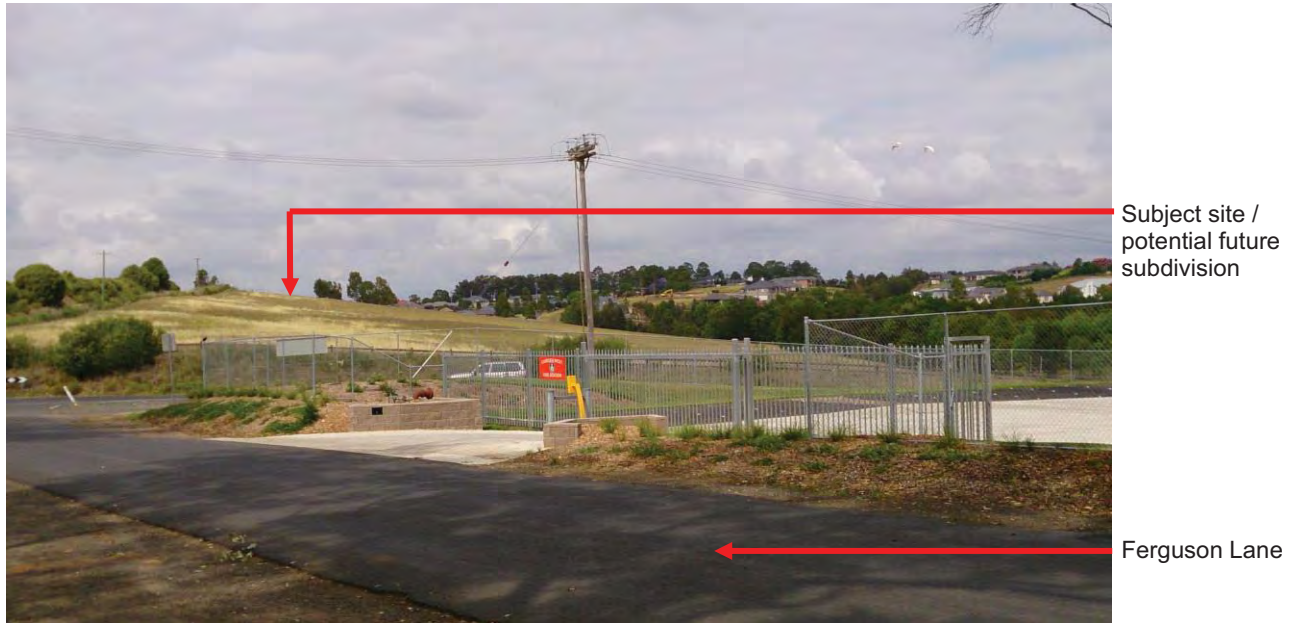
Figure 2.7 - Viewpoint 7

View from Ferguson Lane towards subject site. The potential future subdivision would be visible from this viewpoint. Ferguson Lane is a no through road; therefore not many people would see the subdivision from this viewpoint. Screen planting along Werombi Road would ameliorate the view into the site.

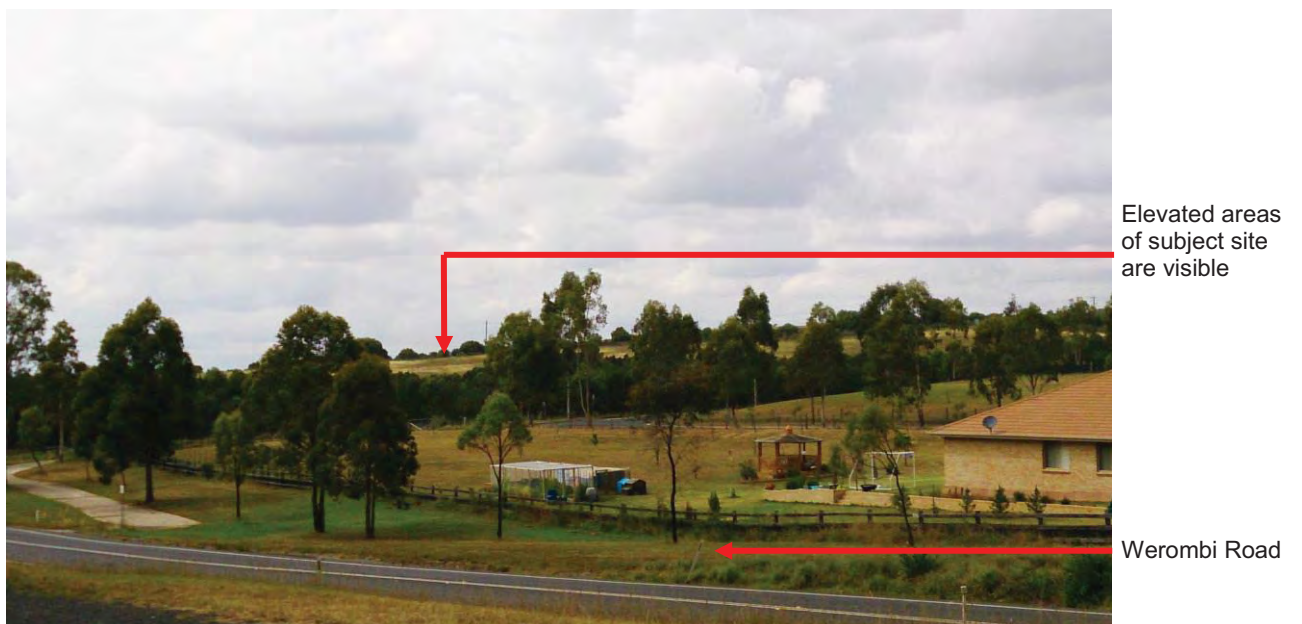
Figure 2.8 - Viewpoint 8

View from a private road off Werombi Road looking towards the subject site. Existing vegetation and landform screen the lower part of the project site. Only glimpses of the elevated parts of the subject site are visible.

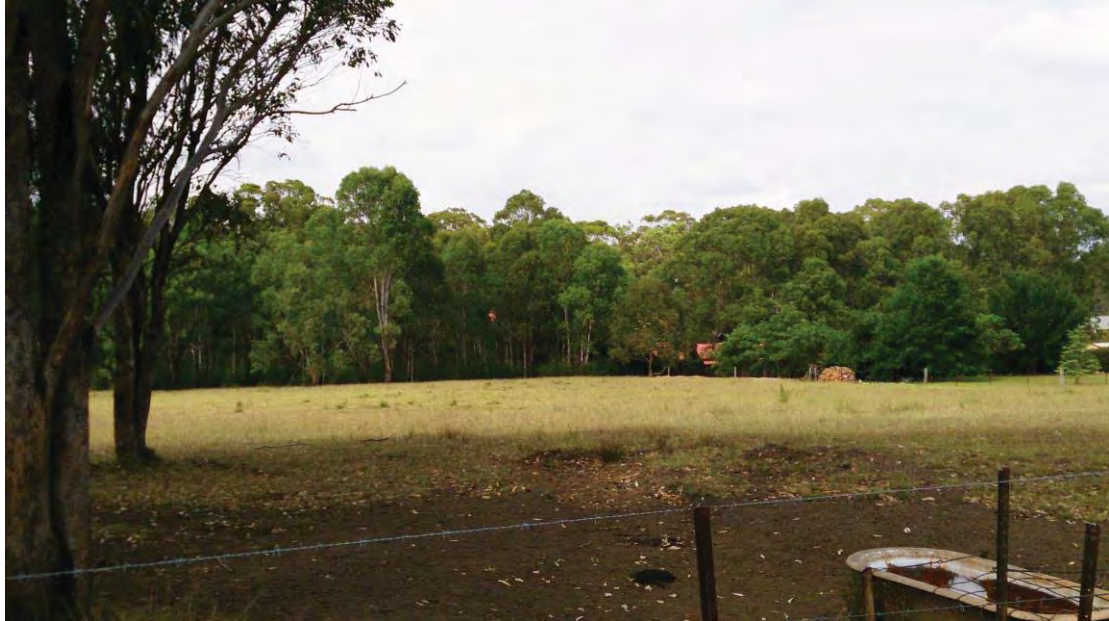
Figure 2.9 - Viewpoint 9

View from Smalls Road towards subject site. Existing vegetation and landform don't allow any views into subject site.

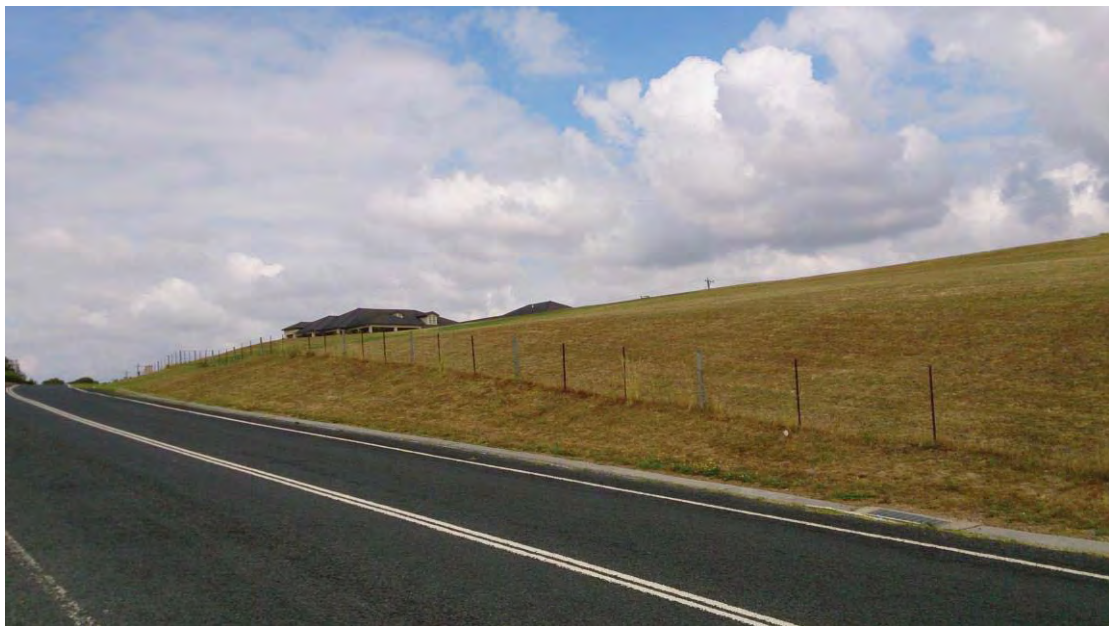
Figure 2.10 - Viewpoint 10

View from Old Oaks Road towards subject site. The potential future subdivision site is not visible from this viewpoint due to existing landform.

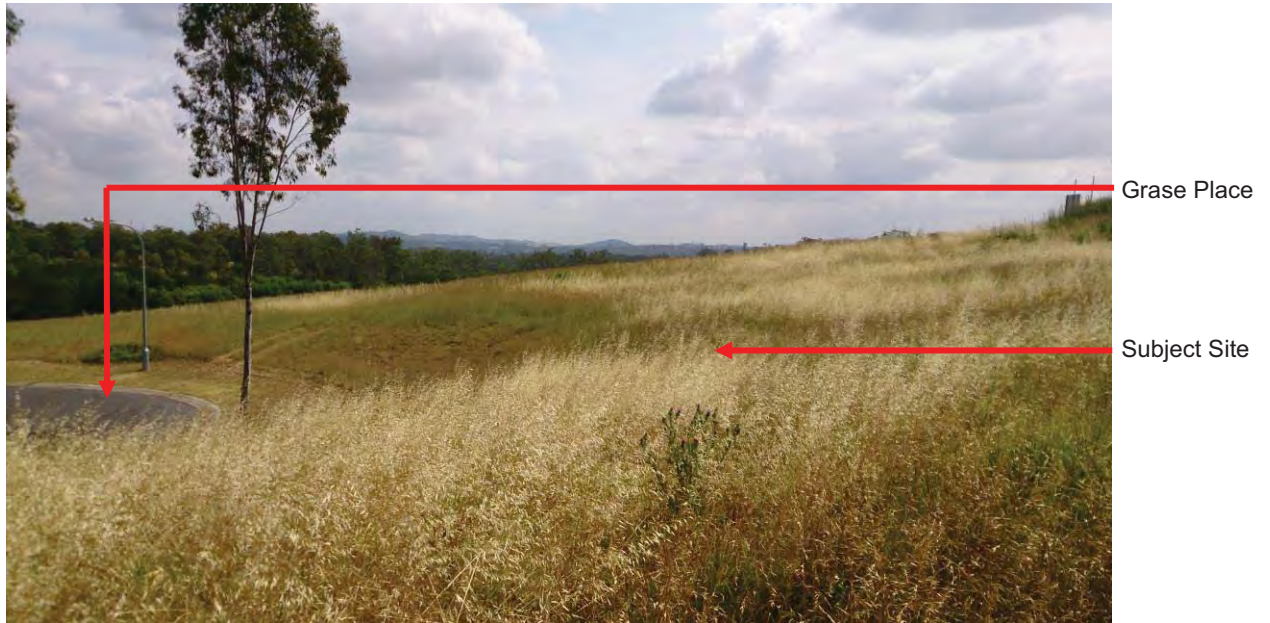
Figure 2.11 – View overlooking subject site from an elevated position within the site (along site boundary, access from Crase Place). The site is partially visible due to existing landform.

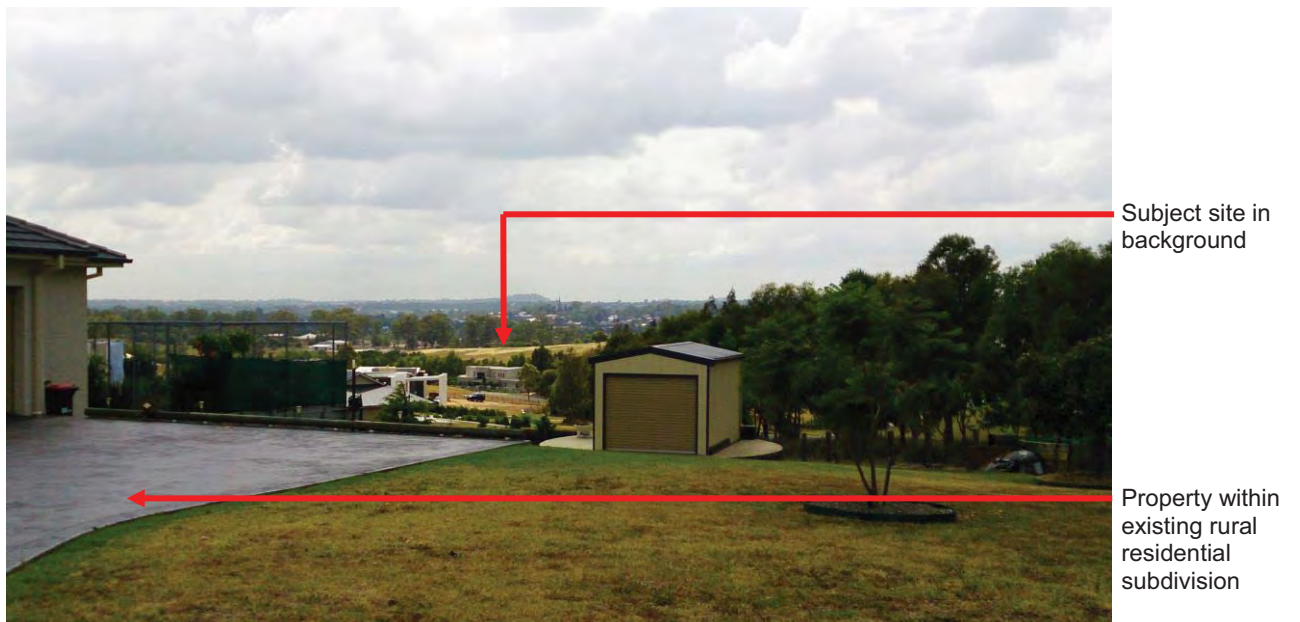
Figure 2.12 - View from highpoint within existing rural residential subdivision (Harben Vale Circuit). Elevated area of the subject site is visible. Lower lying parts of the potential future subdivision would be screened by existing dwellings and vegetation.

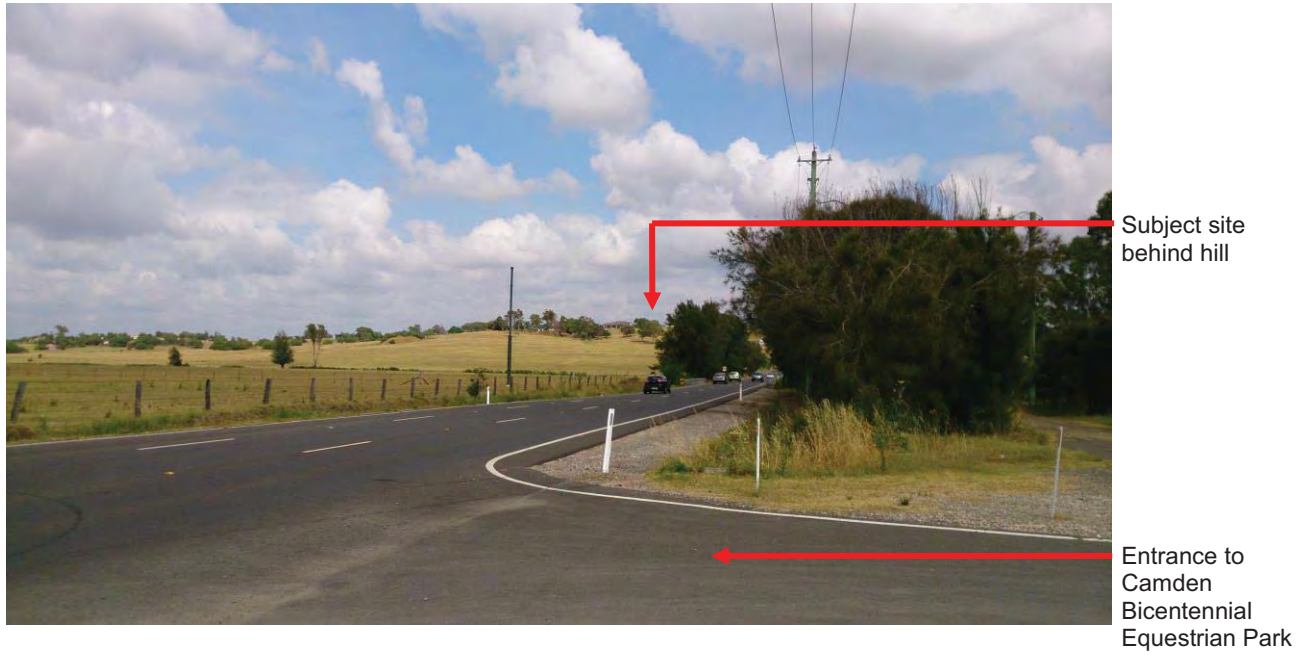
Figure 2.13 - View from entrance to Camden Bicentennial Equestrian Park towards subject site. Subject site is not visible from this viewpoint due to existing landform.

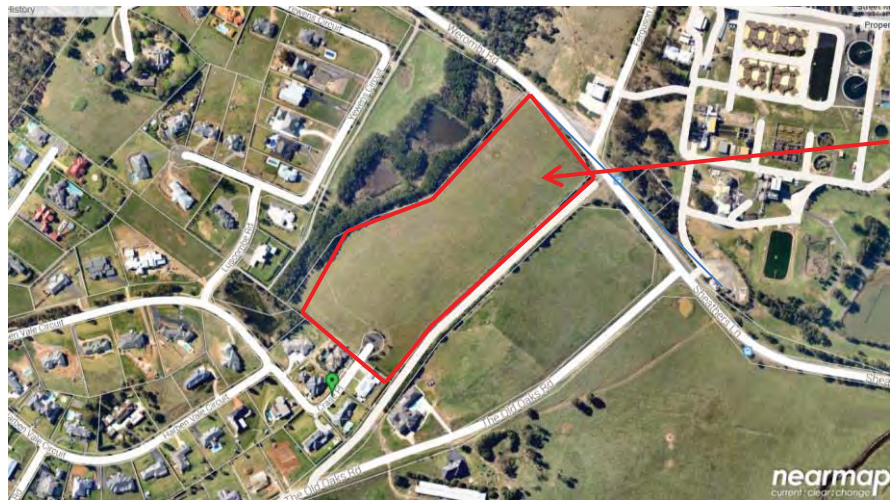
Figure 2.3 Aerial Photograph of the Site

Figure 2.3 is an aerial photo of the subject site.

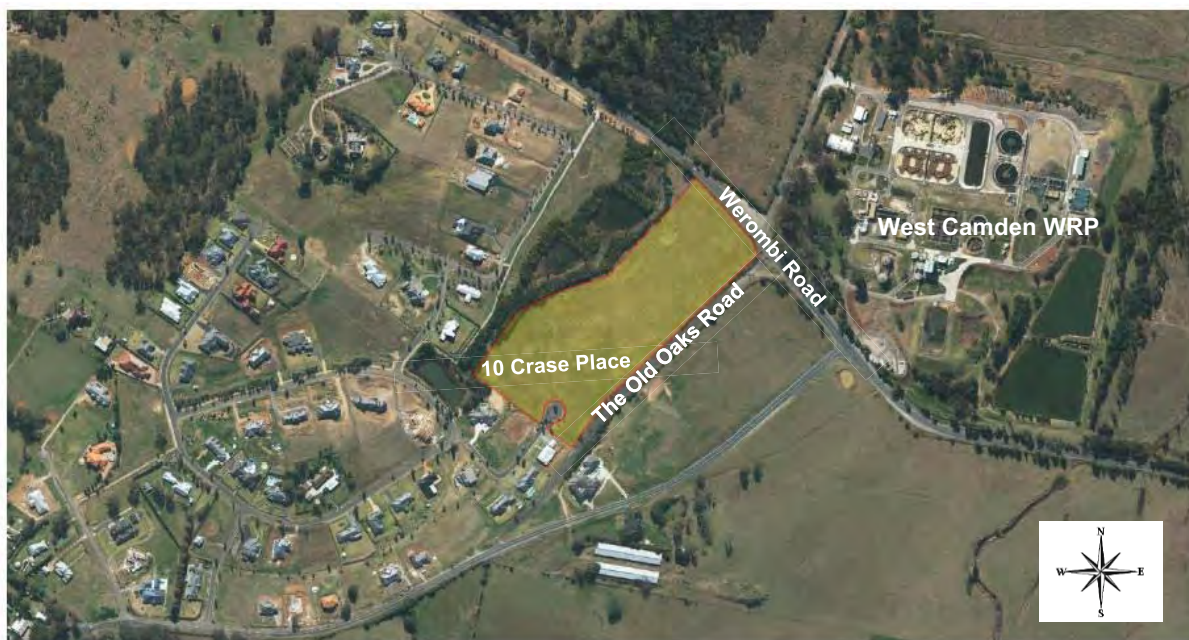
Figure 1 – Location of proposed residential premises [Source: Google Earth, March 2015]

A subdivision and rezoning is proposed at Part Lot 24 DP 1086823, 10 Crase Place, Grasmere, NSW (“the site”) having an area of approximately 5.6ha as shown outlined in the middle of Figure 1. The site is located at the end of Crase Place, Grasmere in the Camden Local Government Area (LGA). The property is bound by Werombi Road to the north, The Old Oaks Road to the east, existing residential development to the south and an unnamed watercourse to the west. The West Camden Water Recycling Plant (WRP) is located to the north-east of the site.

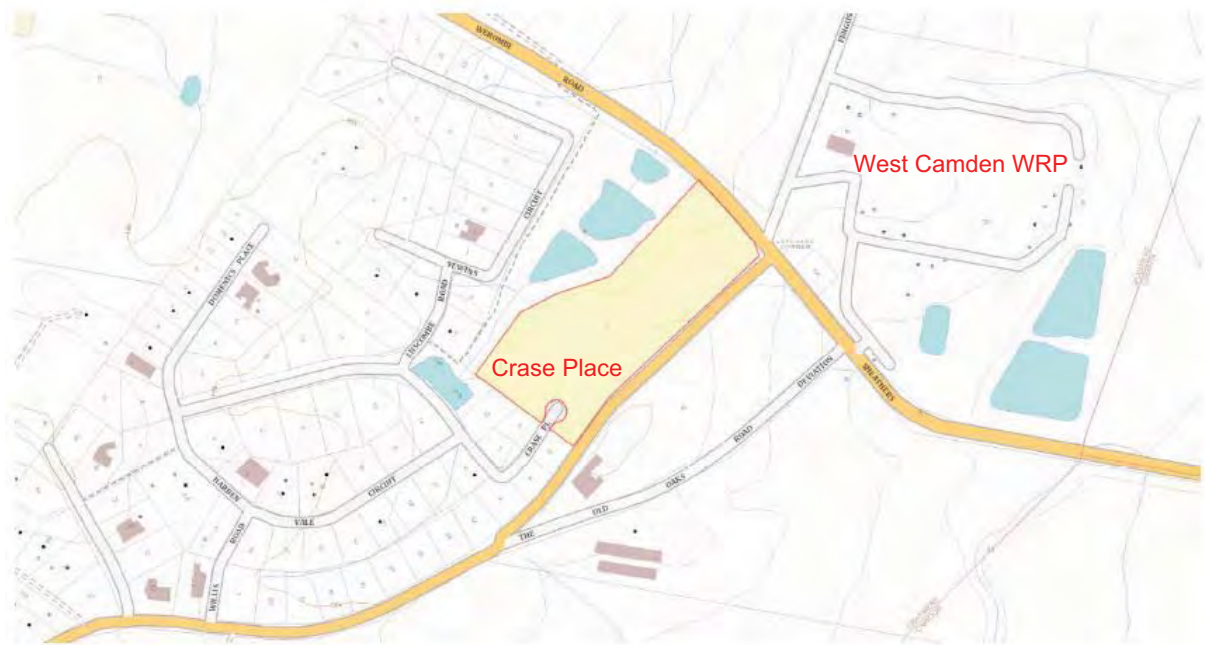
Part 2 Land Capability

The location of the proposed residential development is Lot 24 DP 1086823 at 10 Crase Place, Grasmere, NSW as shown by the red outline in Figure 4. The objective of the Planning Proposal is to rezone the south-western lots to R5 – Large Lot Residential.

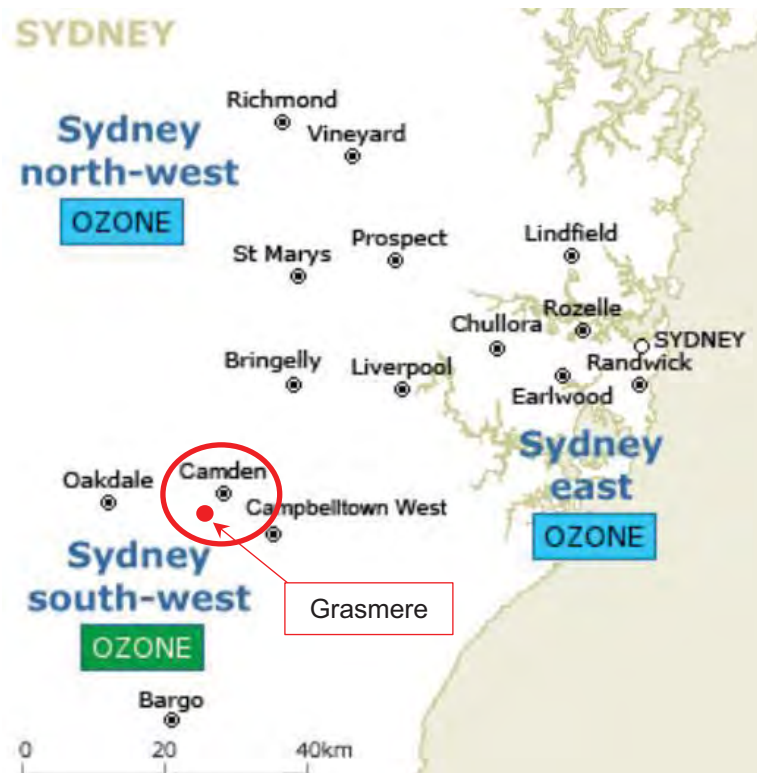
Figure 6 – Air quality monitoring station network [Office of Heritage and Environment website, 2015a]

The New South Wales Environment Protection Authority (NSW EPA) operates a number of air quality monitoring stations around the greater metropolitan Sydney area. There is no monitoring station in Grasmere itself. The nearest monitoring station is located in Camden, approximately 2.7 km north-east from the site. The location of Camden monitoring station is shown in the map below (see Figure 6).

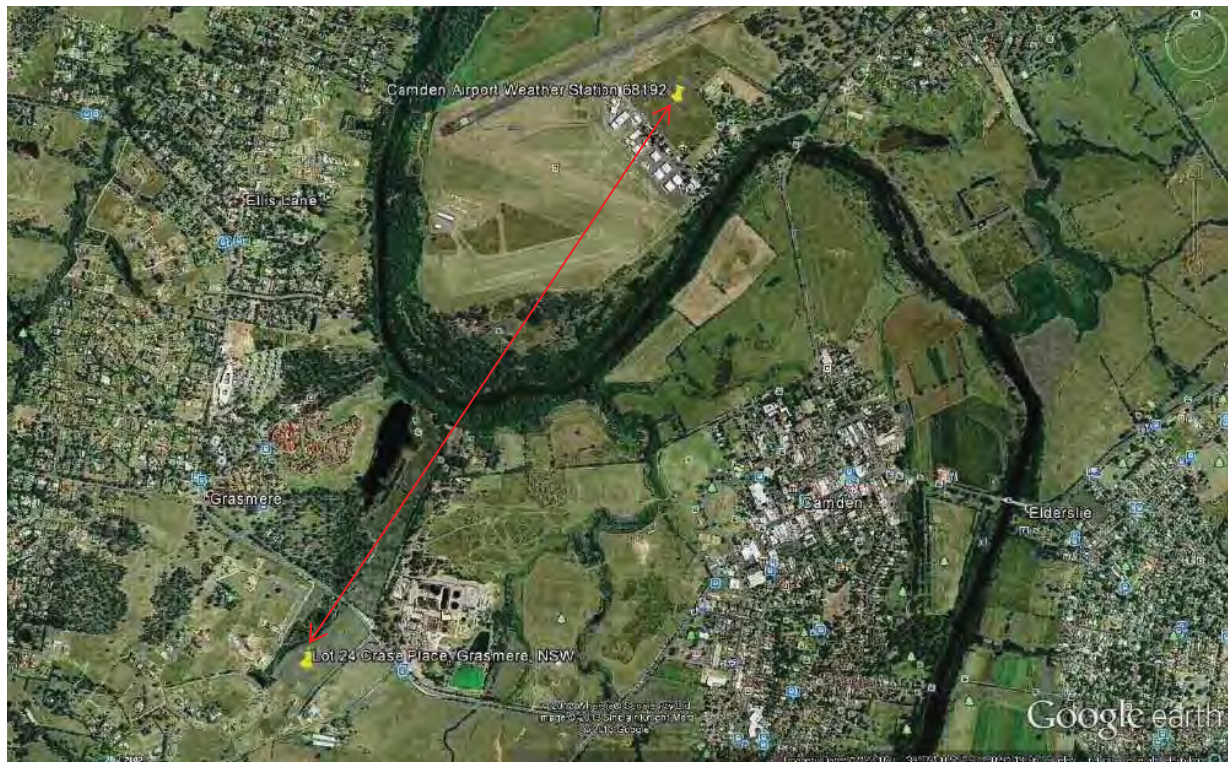
Figure 7 – Camden Airport Weather Station AWS Relative to the Site [Source: Google Earth, March 2015]

The Bureau of Meteorology (BoM) operate a weather monitoring station at Camden Airport AWS (Station No. 68192), which is located approximately 2.7 km north-east of the site (see Figure 7). The average climate and rainfall statistics since 1943 are presented in Table 3. No information was available on evaporation.

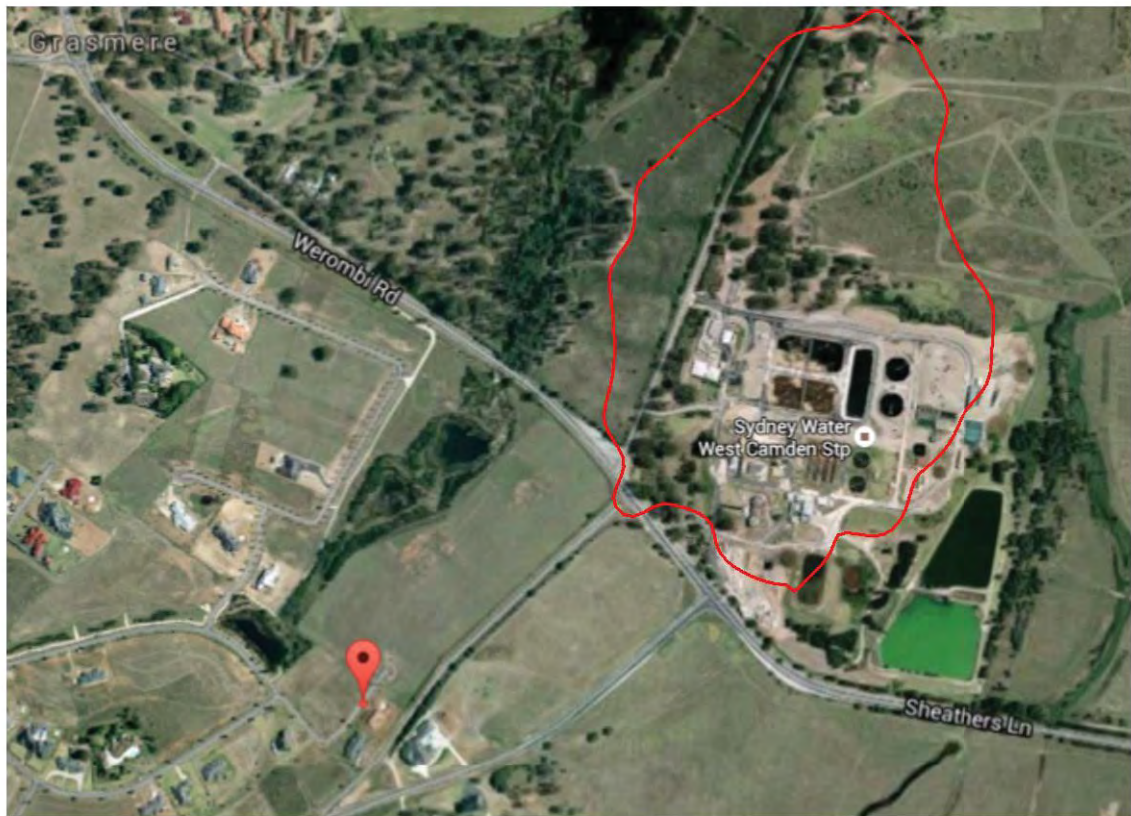
**Figure 9 – Sydney Water’s West Camden WRP odour impact on the site as modelled using Ausplume 6.0
– in relation to the proposed development site**

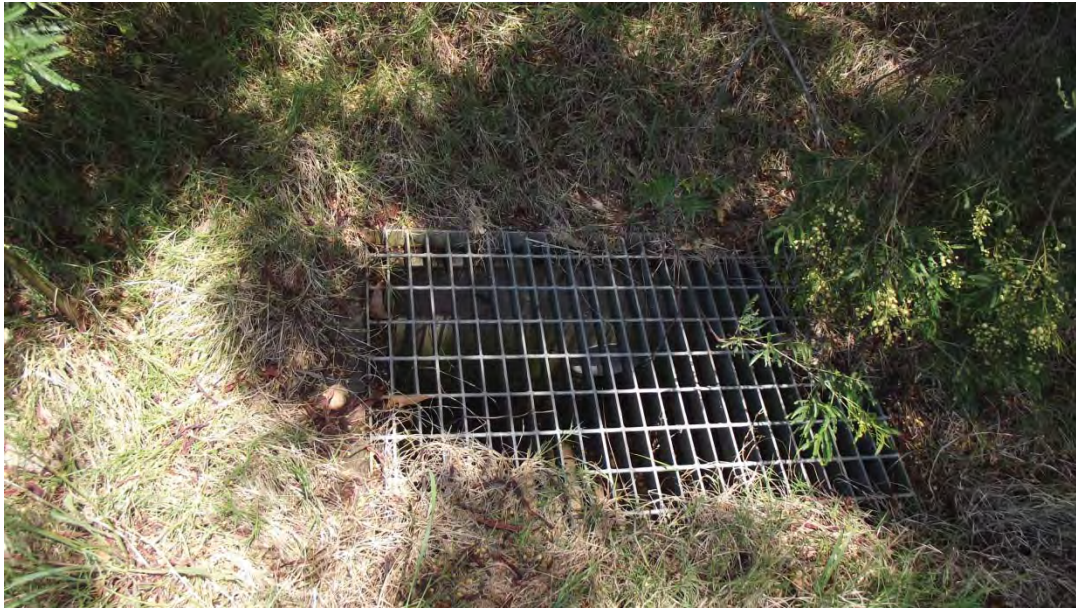
GRADED PIT AT THE END

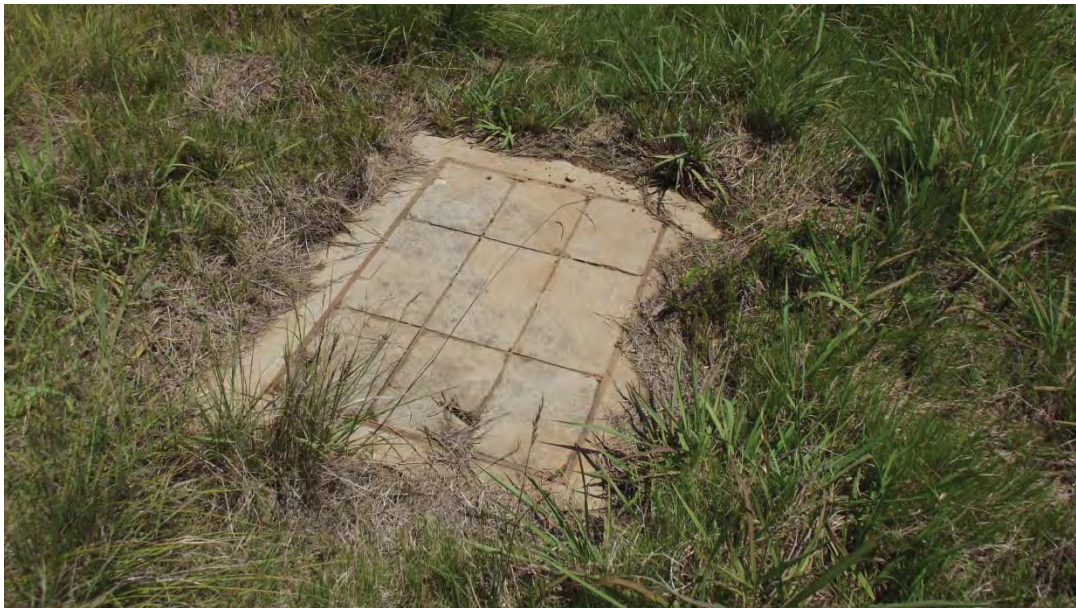
SEALED PIT 2 OFF

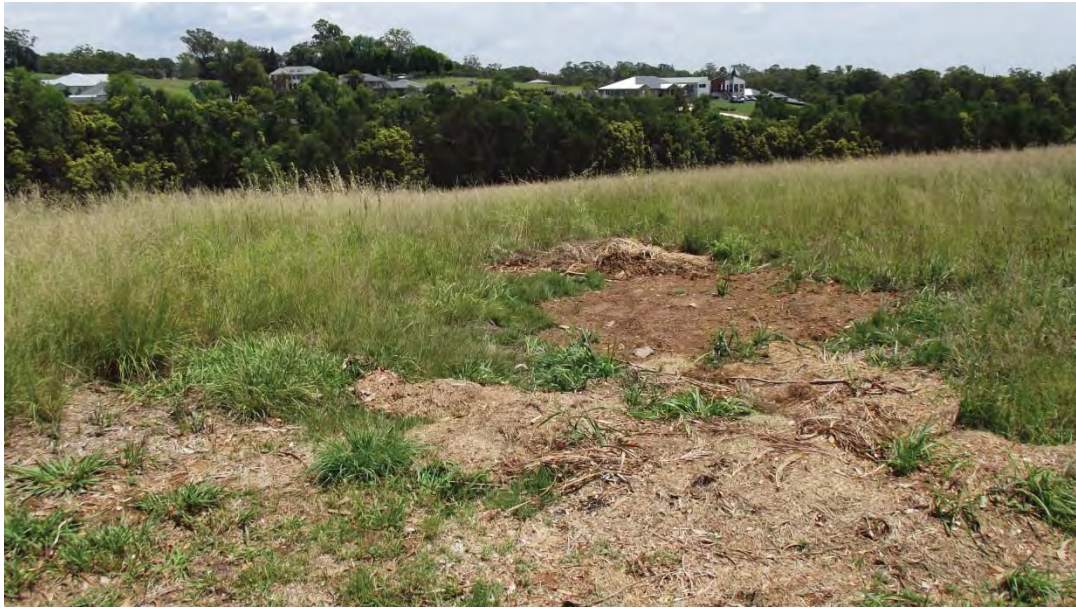
FLOW PATH ALONG

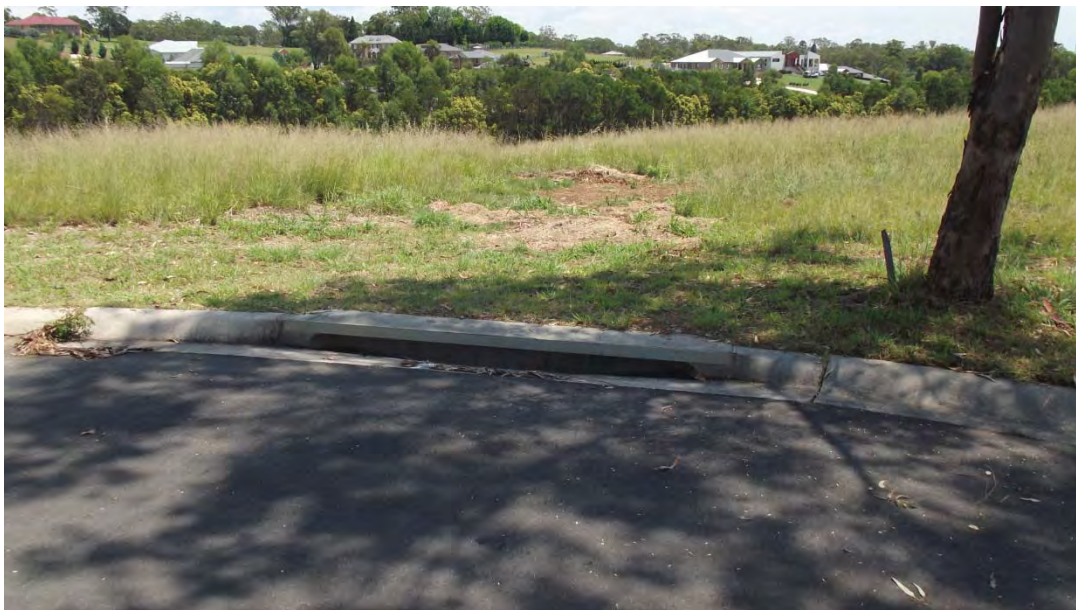
KIP AT THE UPSTREAM

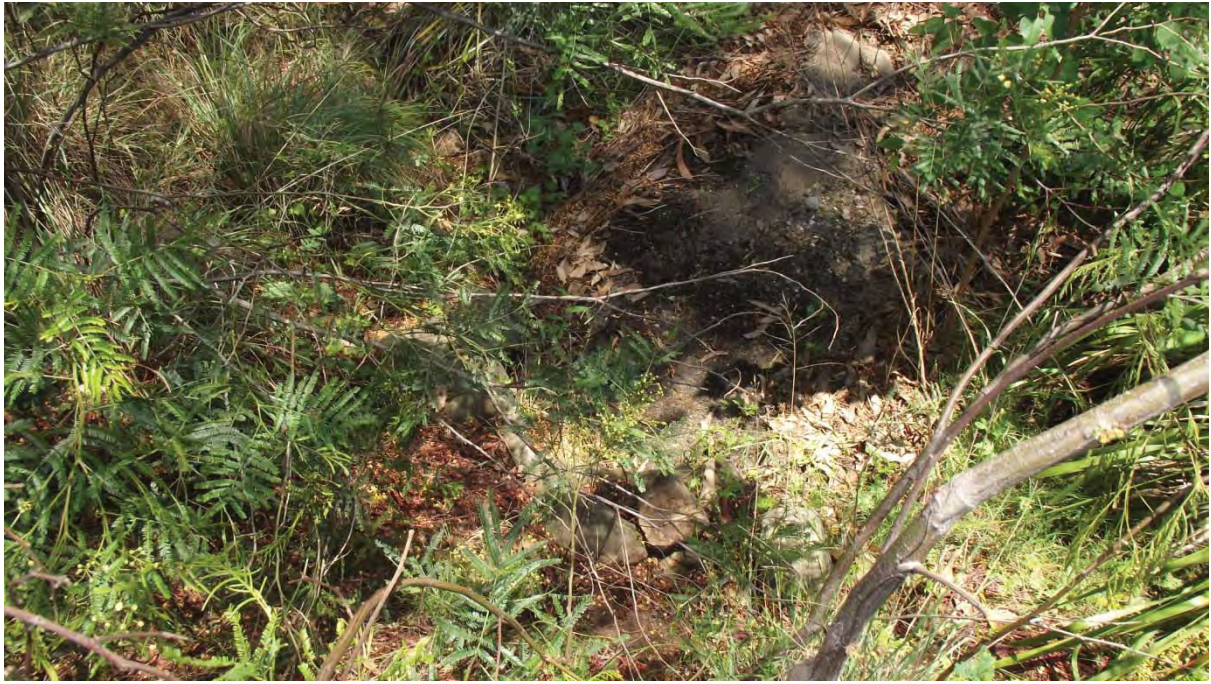
HEAD WALL AT DOWNSTREAM
