# Revised Consolidated Phase 1 Contamination Assessment

Rezoning of Glenlee Employment and Related Lands

Client: Sada Services Pty Ltd

13-May-2016

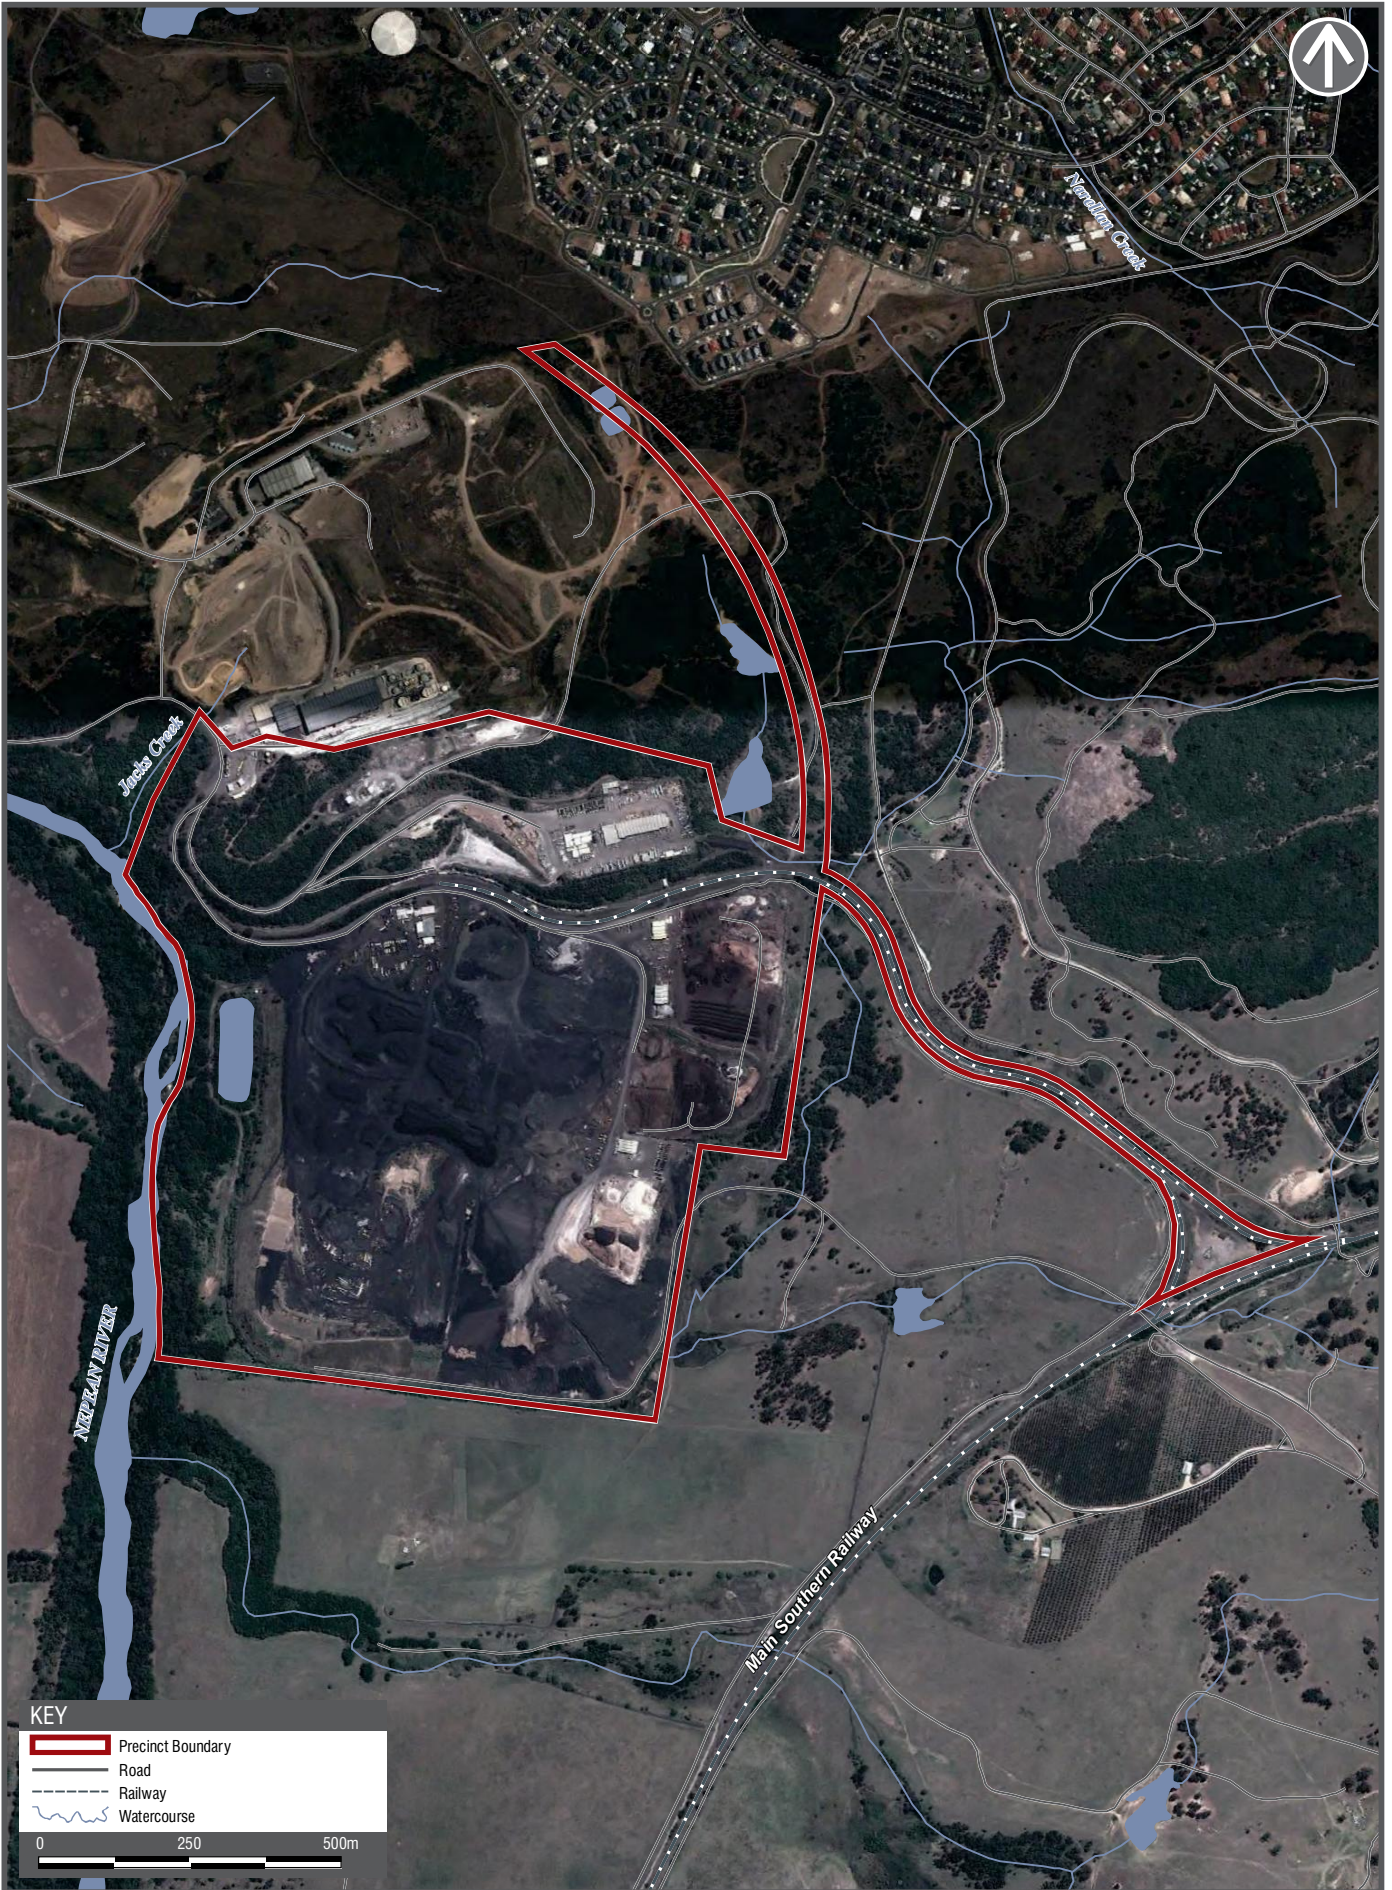
**SITE LAYOUT AND SURROUNDING AREA**  
Revised Consolidated Phase 1 Contamination Assessment  
Glenlee Road, Narellan, New South Wales

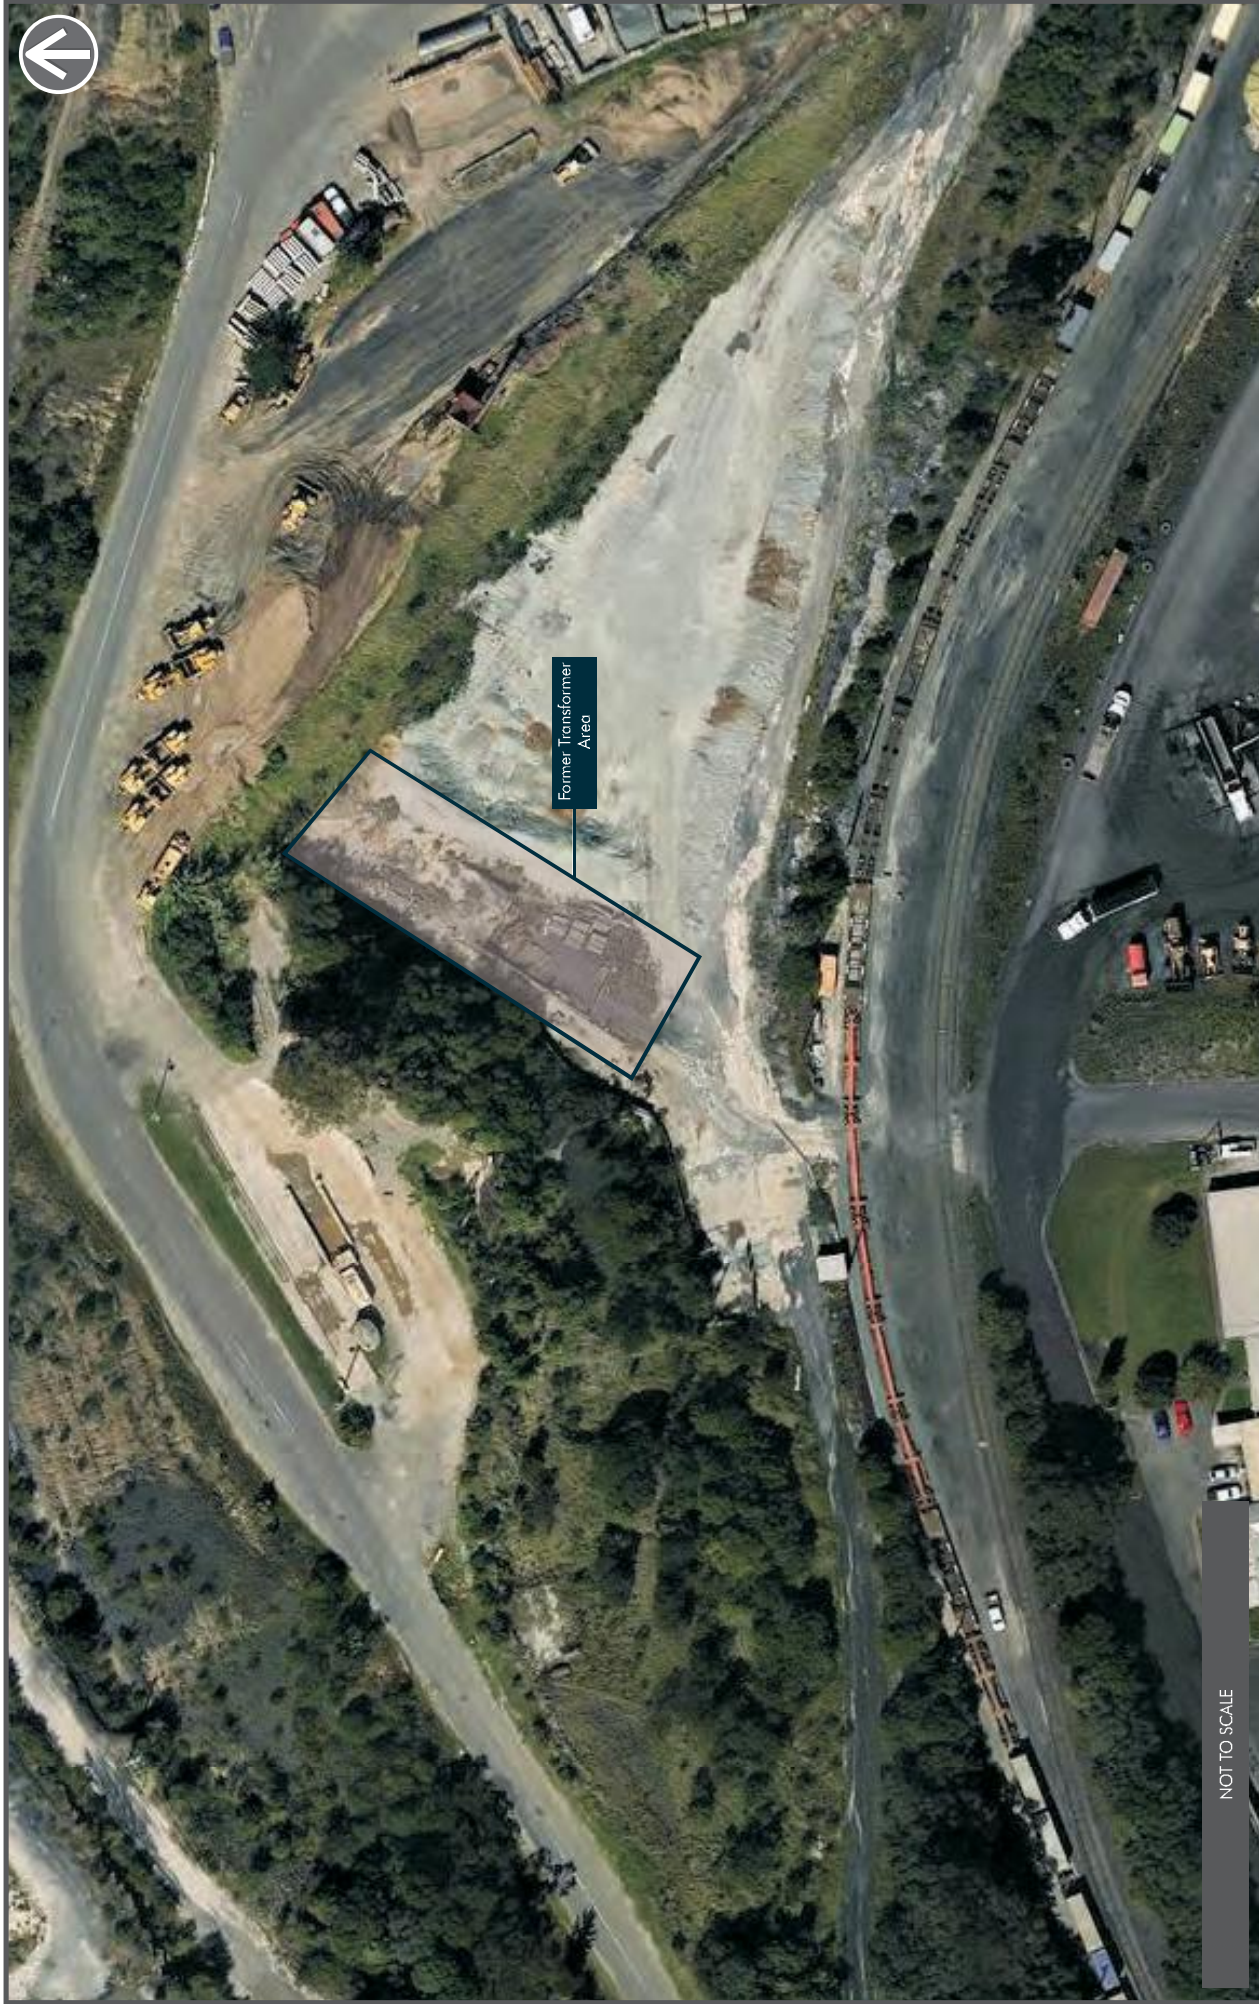
**FIGURE 7**

**PCA E - FORMER TRANSFORMER AREA**  
Revised Consolidated Phase 1 Contamination Assessment  
Glenlee Road, Narrellan, New South Wales

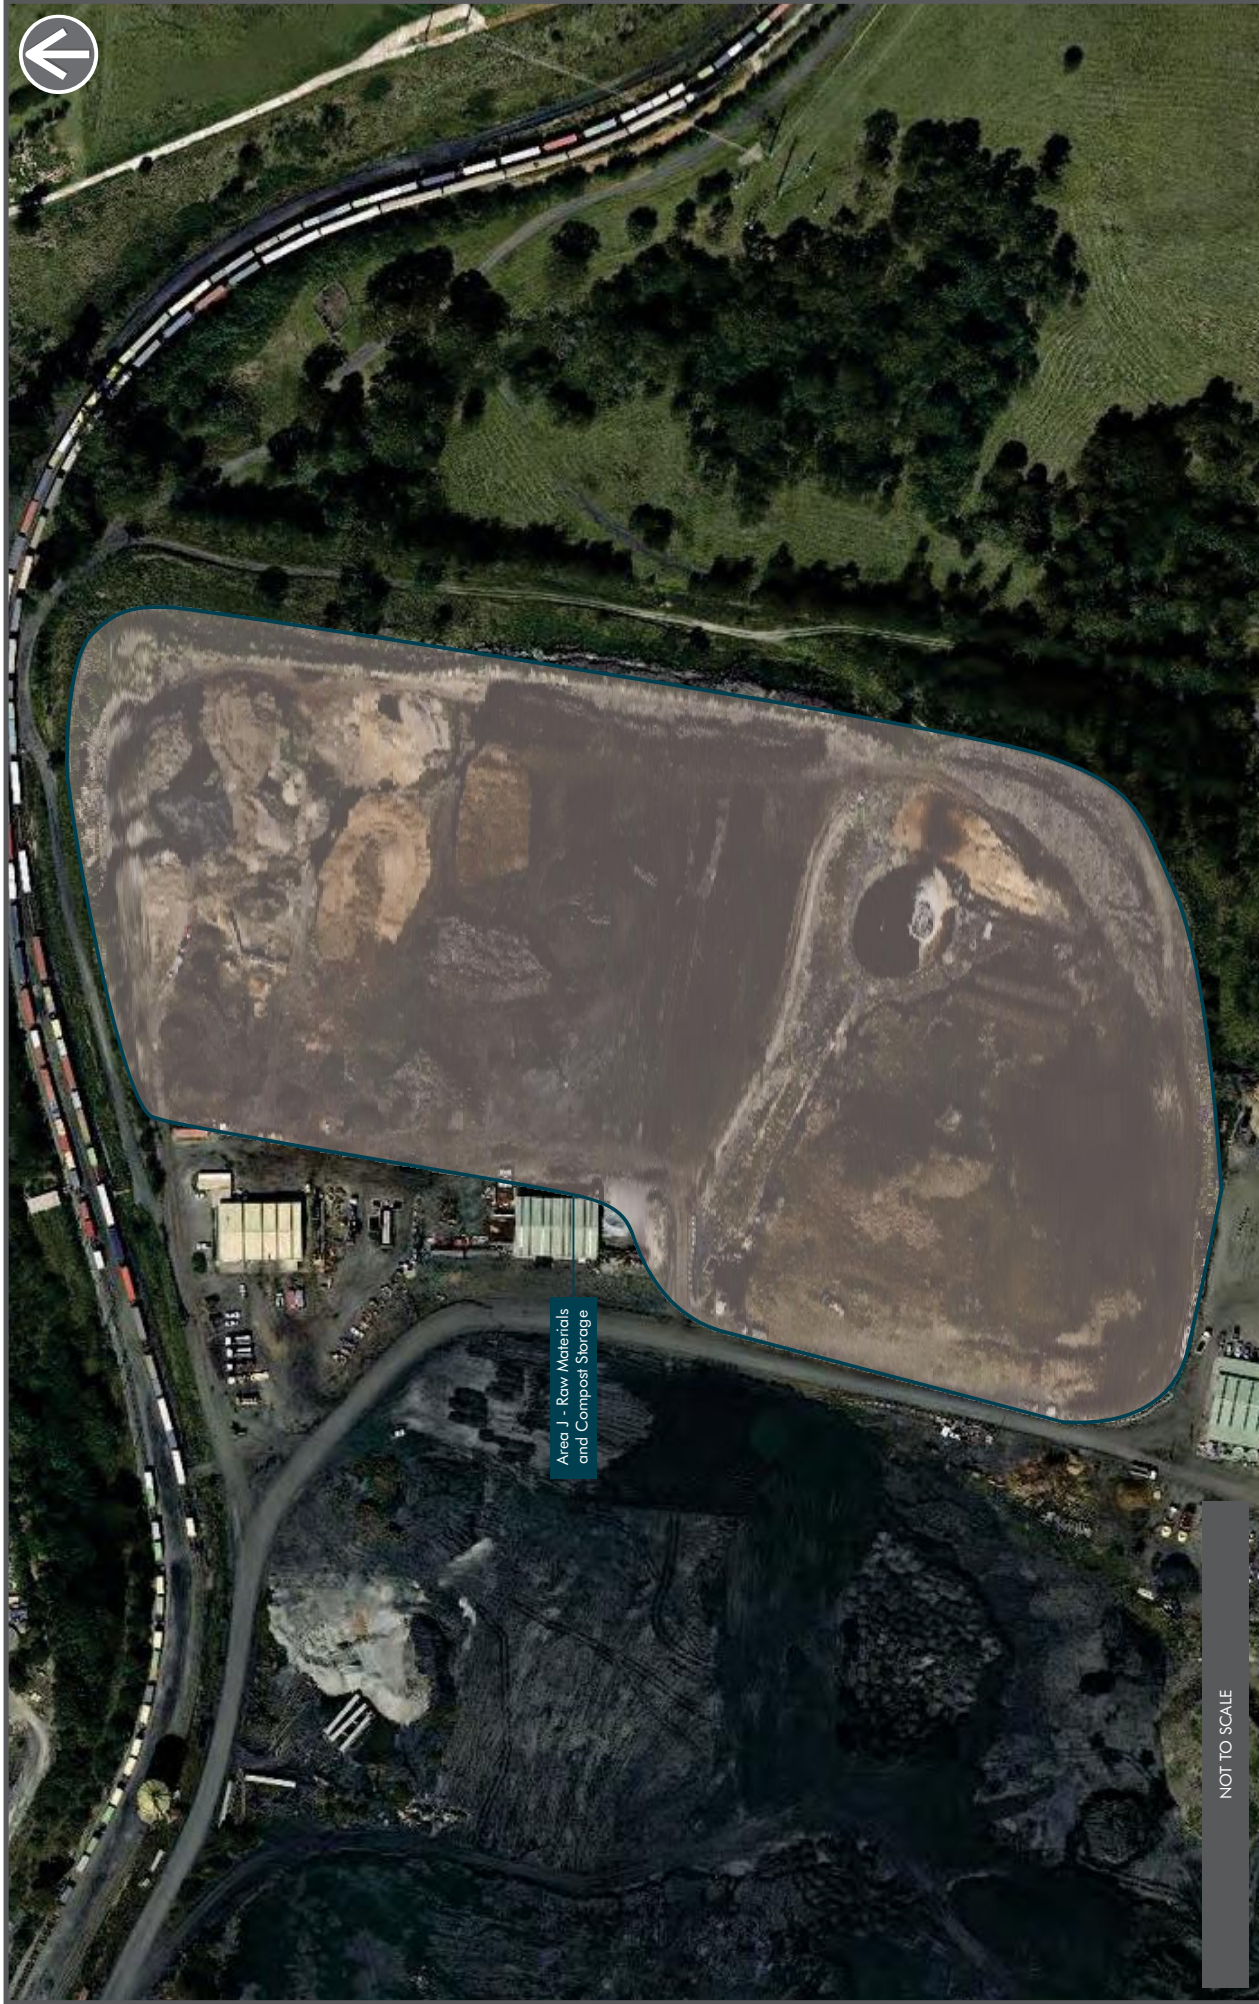
**FIGURE 11**

**PCA J - RAW MATERIALS AND COMPOST STORAGE**  
Revised Consolidated Phase 1 Contamination Assessment  
Glenlee Road, Narellan, New South Wales

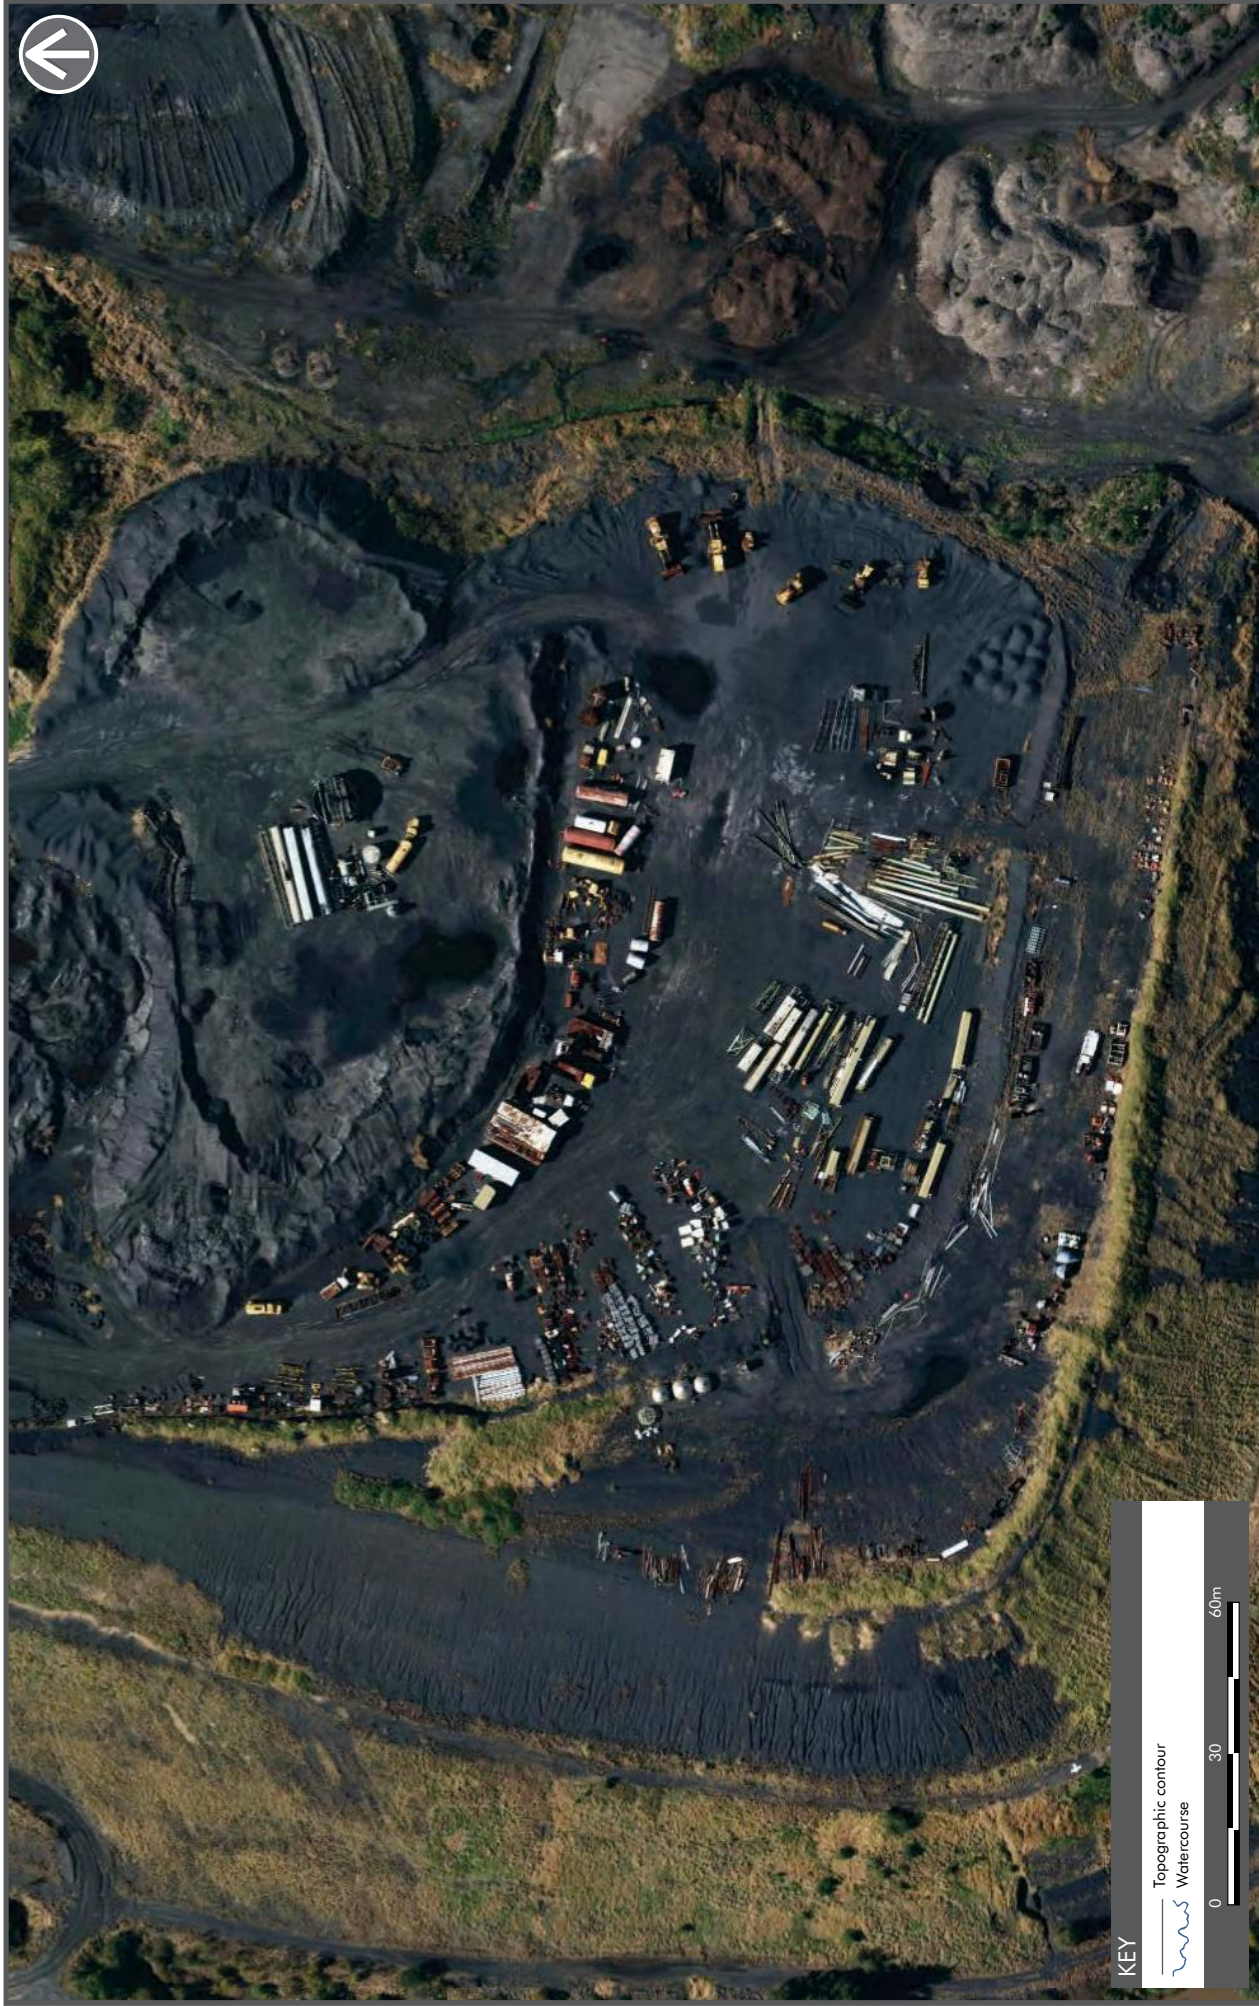
**FIGURE 12**

**PCA S - PLANT MACHINERY MATERIAL AND AST GRAVEYARD**  
 Revised Consolidated Phase 1 Contamination Assessment  
 Glenlee Road, Narellan, New South Wales

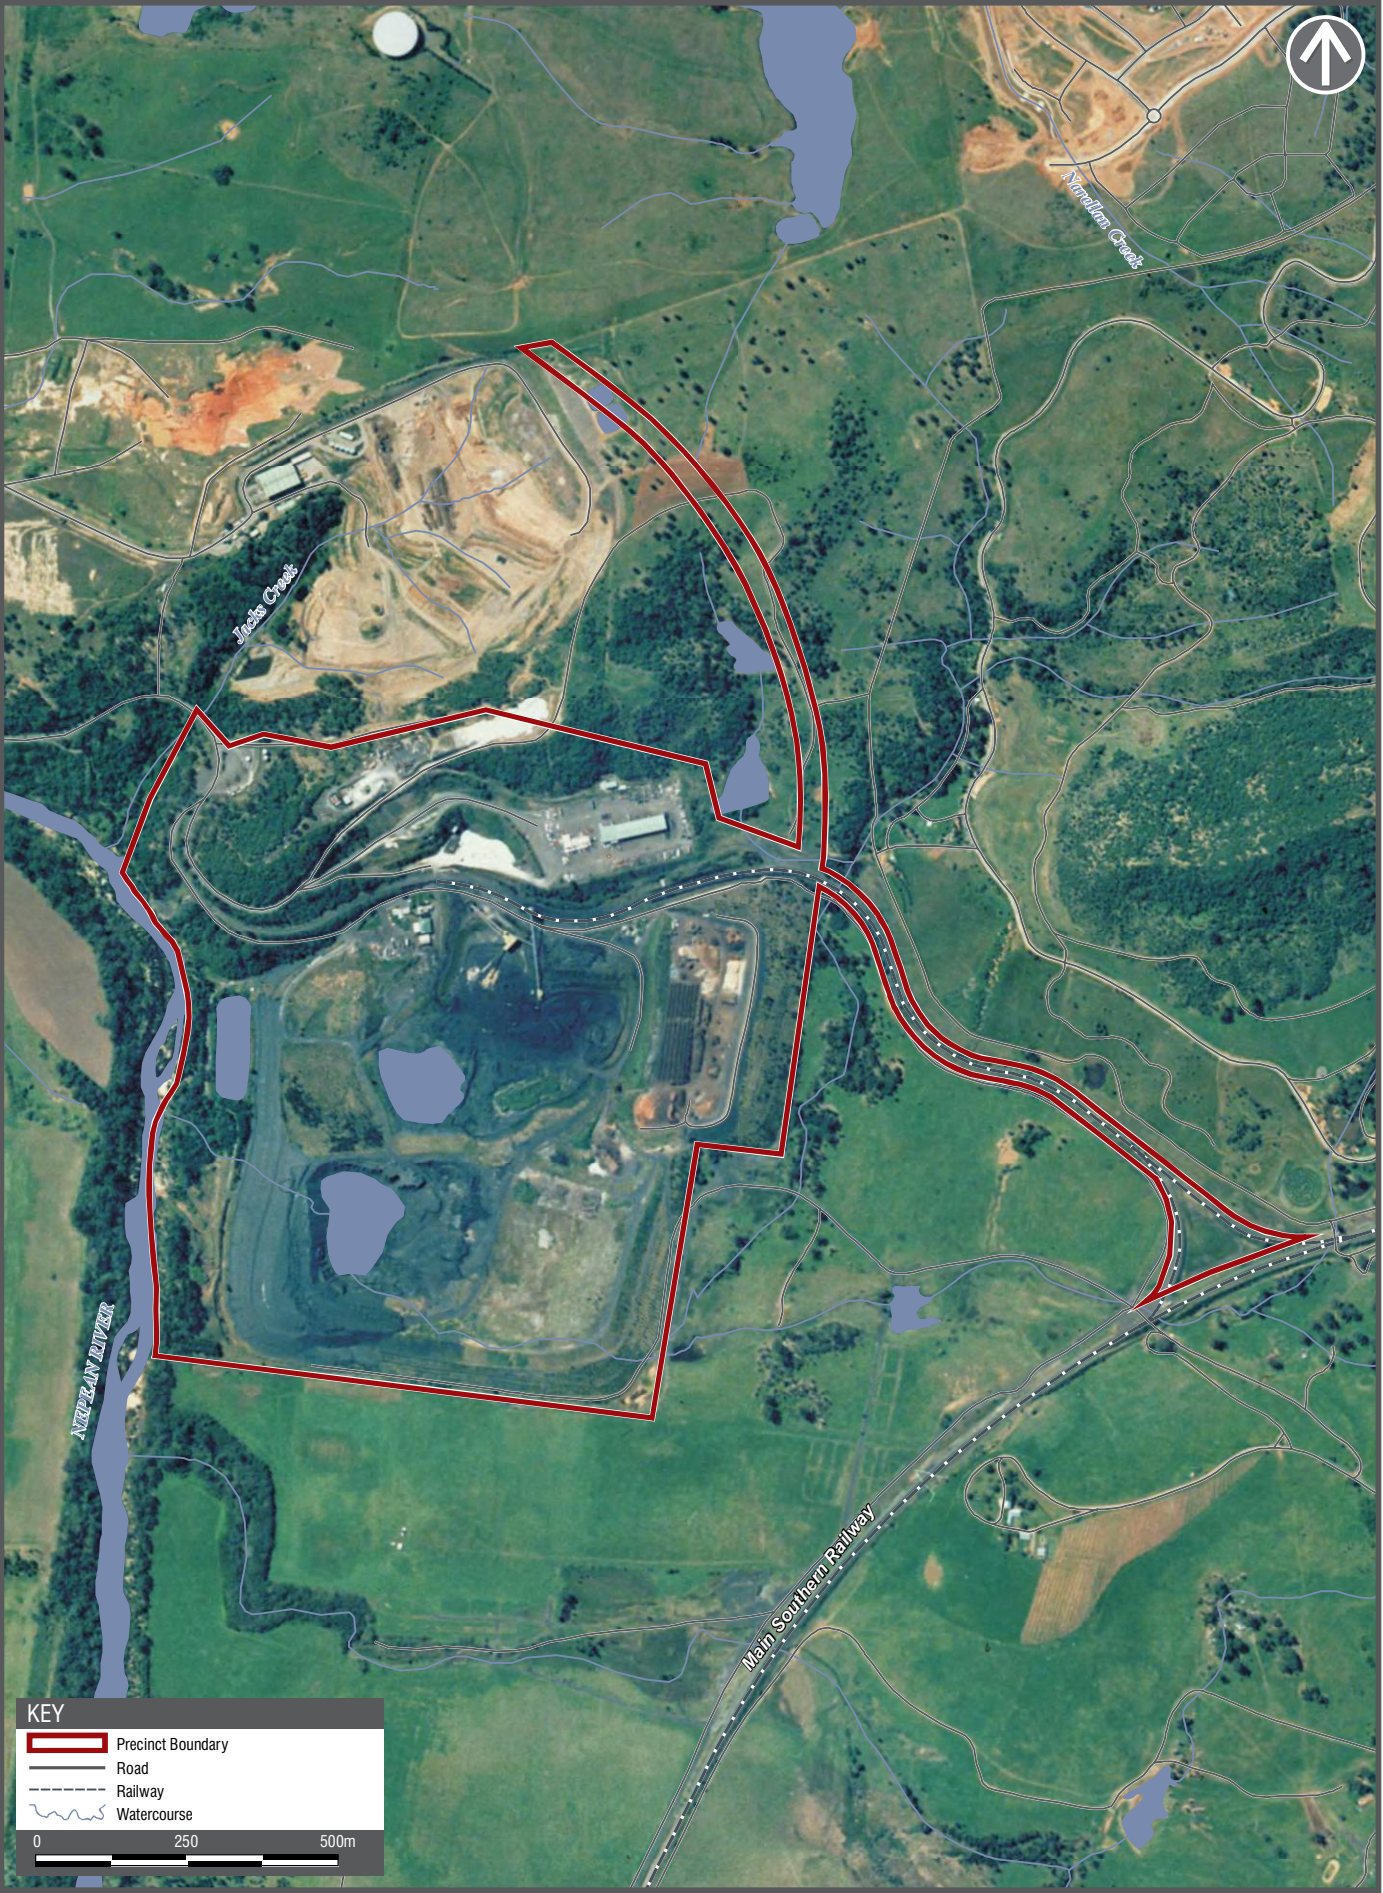
FIGURE 14

**AERIAL PHOTOGRAPH - 2003**  
Revised Consolidated Phase 1 Contamination Assessment  
Glenlee Road, Narellan, New South Wales

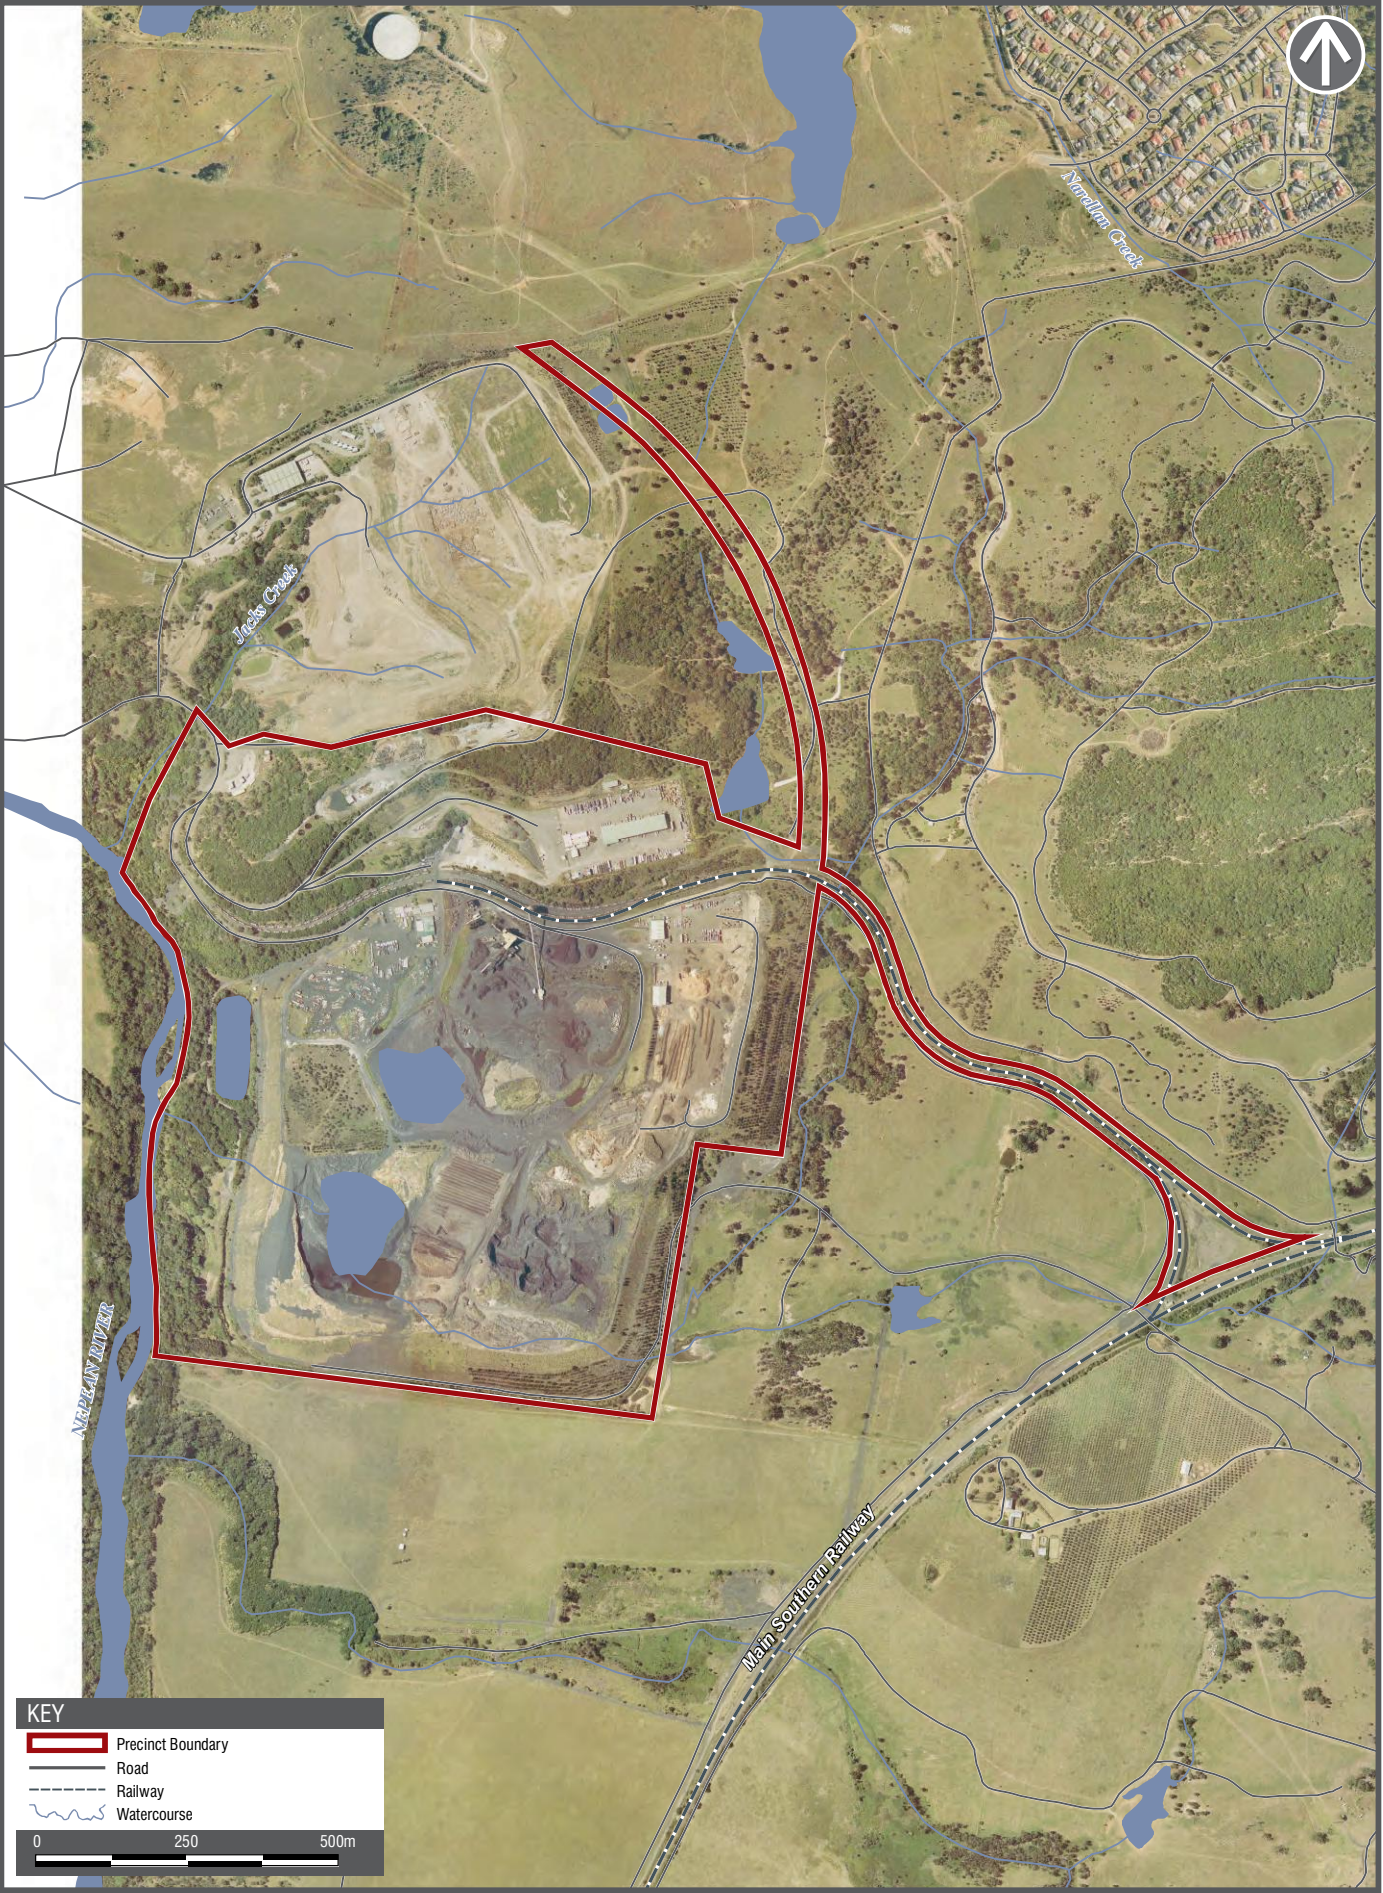
FIGURE 15

**AERIAL PHOTOGRAPH - 2004**  
Revised Consolidated Phase 1 Contamination Assessment  
Glenlee Road, Narellan, New South Wales

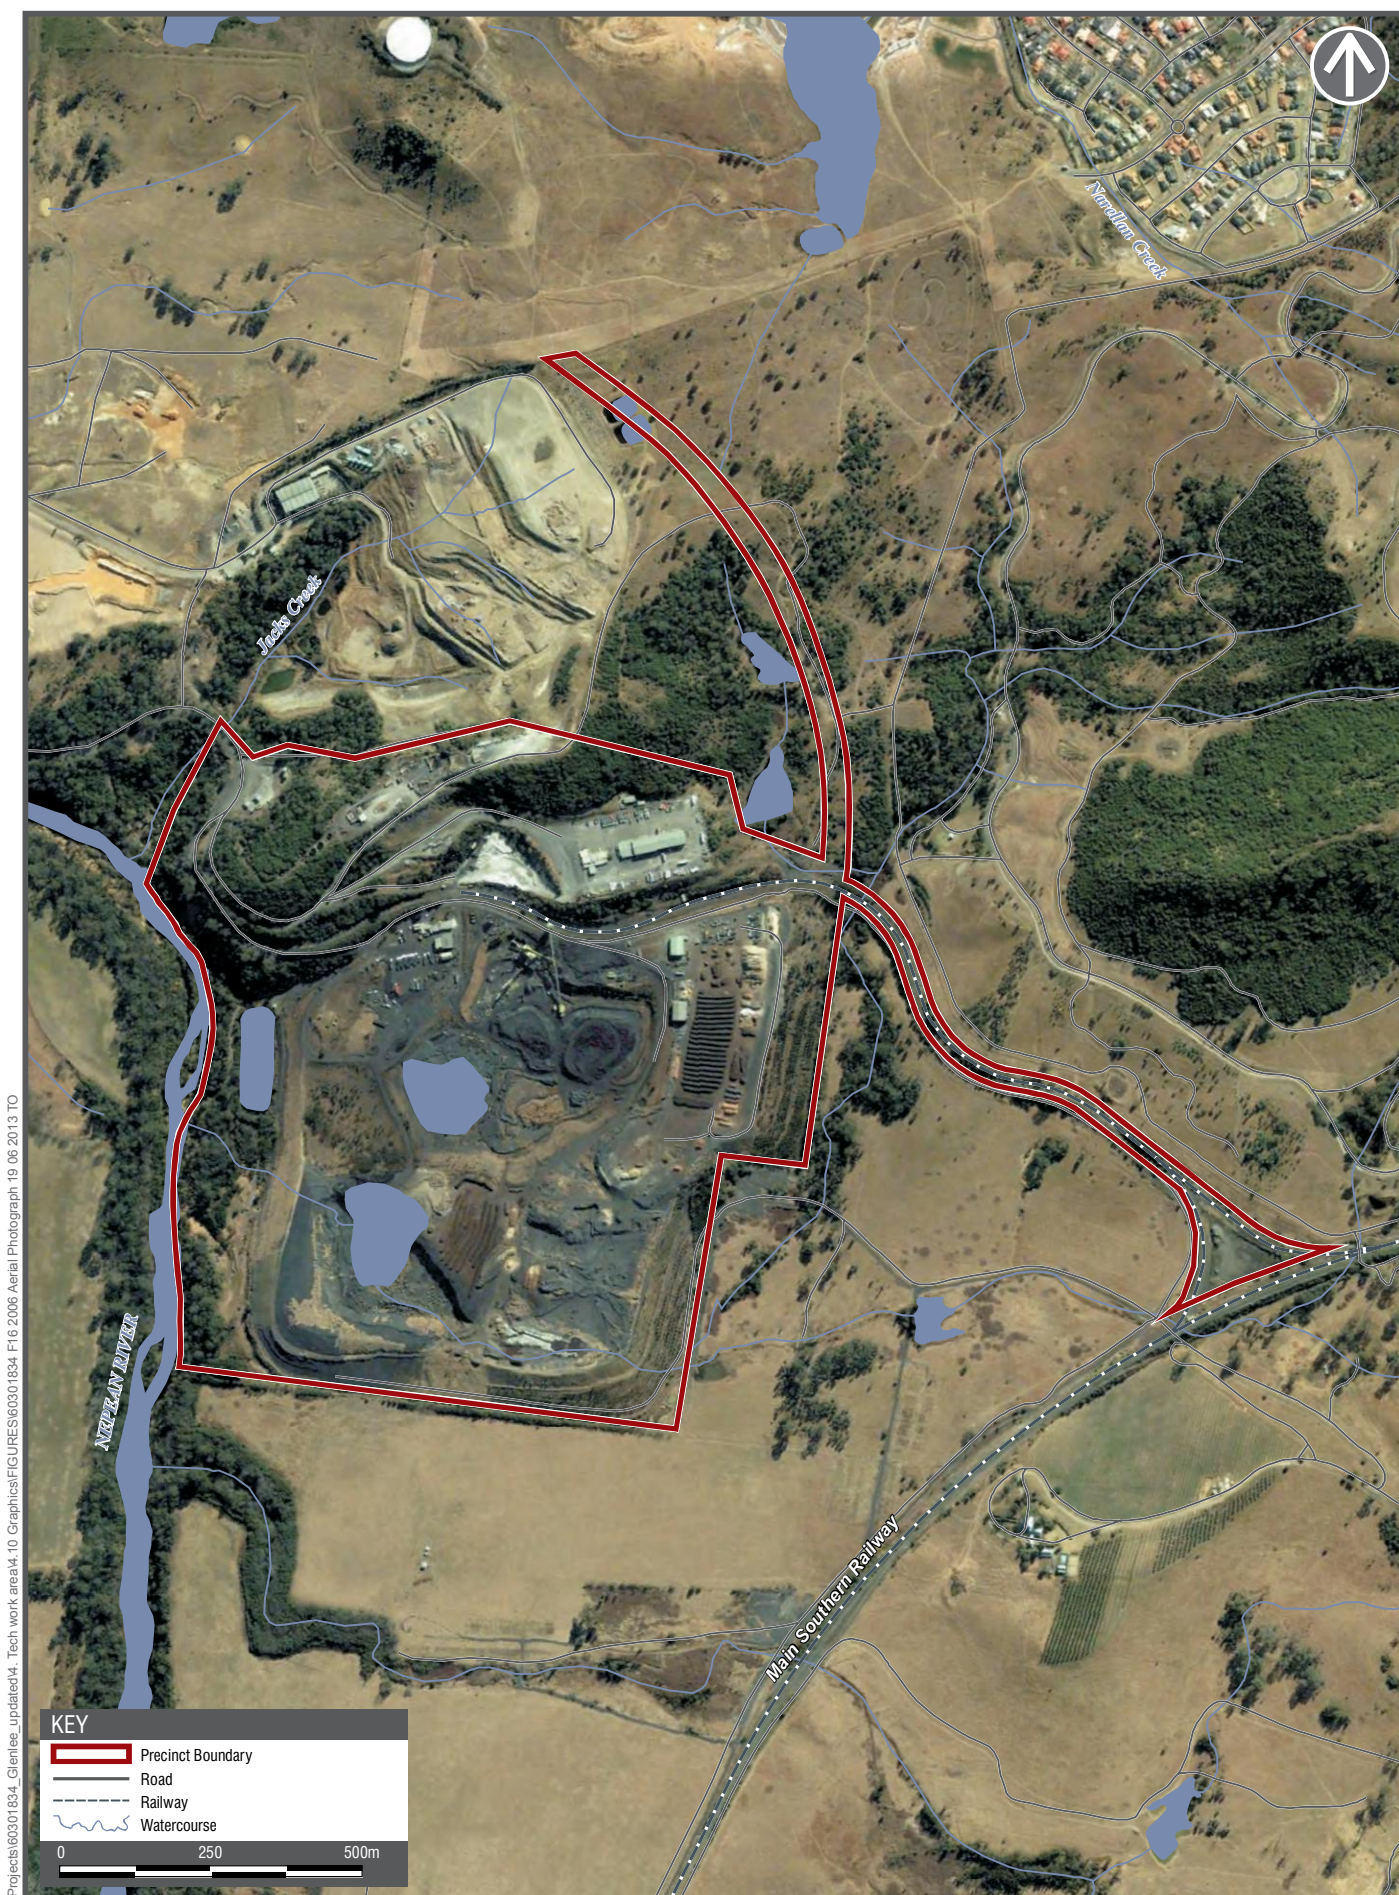
FIGURE 16

**AERIAL PHOTOGRAPH - 2006**  
 Revised Consolidated Phase 1 Contamination Assessment  
 Glenlee Road, Narellan, New South Wales

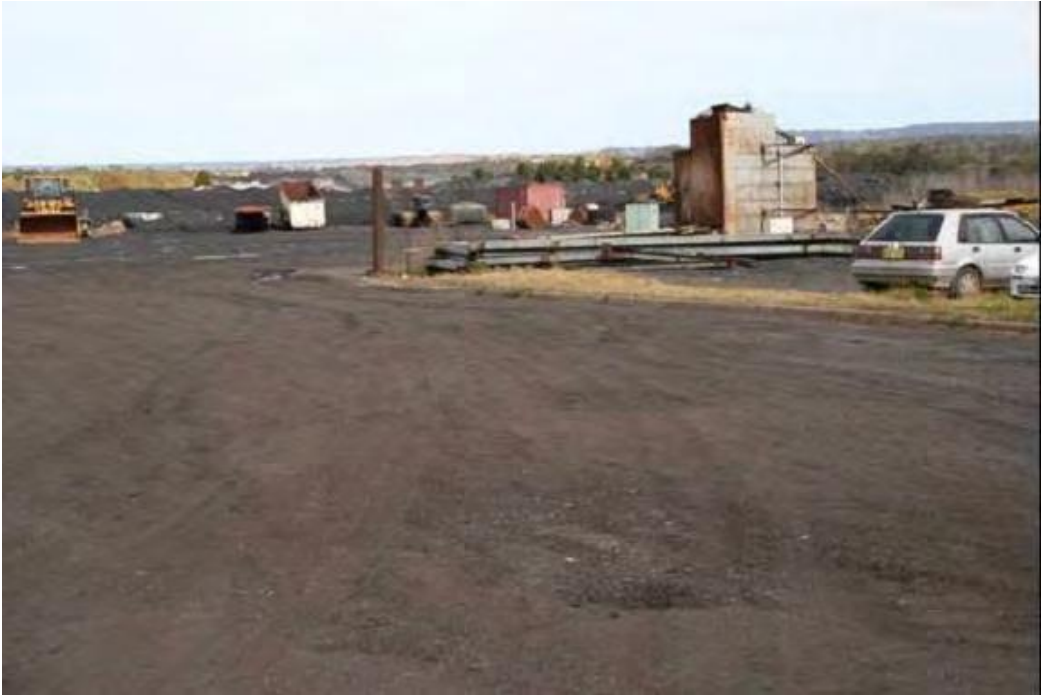
<b>Site Name:</b> Glenlee Precinct		<b>Site Location:</b> Glenlee Road, Narellan NSW	<b>Project No:</b> 60301834
<b>Plate No.</b> <b>3</b>	<b>Date:</b> 2007

<b>Direction Photo Taken:</b> South-west			
<b>Description:</b>  Diesel tank not present (refer below) - Wide view of SADA area constructed over emplacement

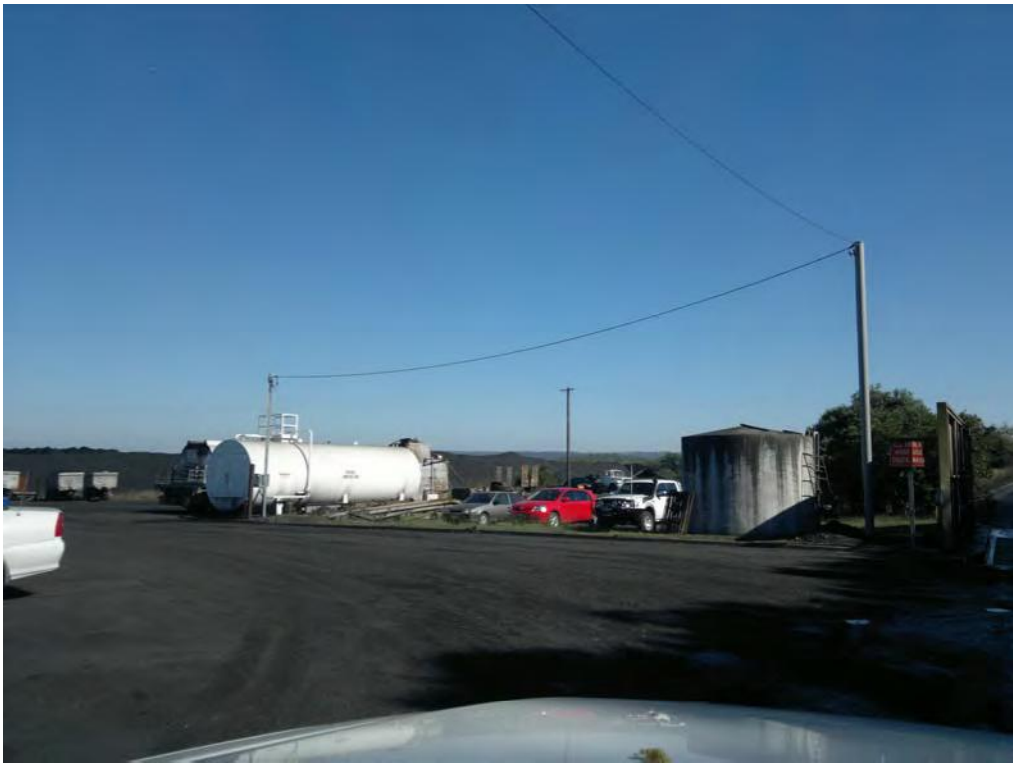
<b>Plate No.</b> <b>4</b>	<b>Date:</b> 10/05/2013

<b>Direction Photo Taken:</b> South-west		
<b>Description:</b>  Include as part of PCA A - Diesel tank at end of carpark noted. Not in photo from 2007. Clarification required regarding use status

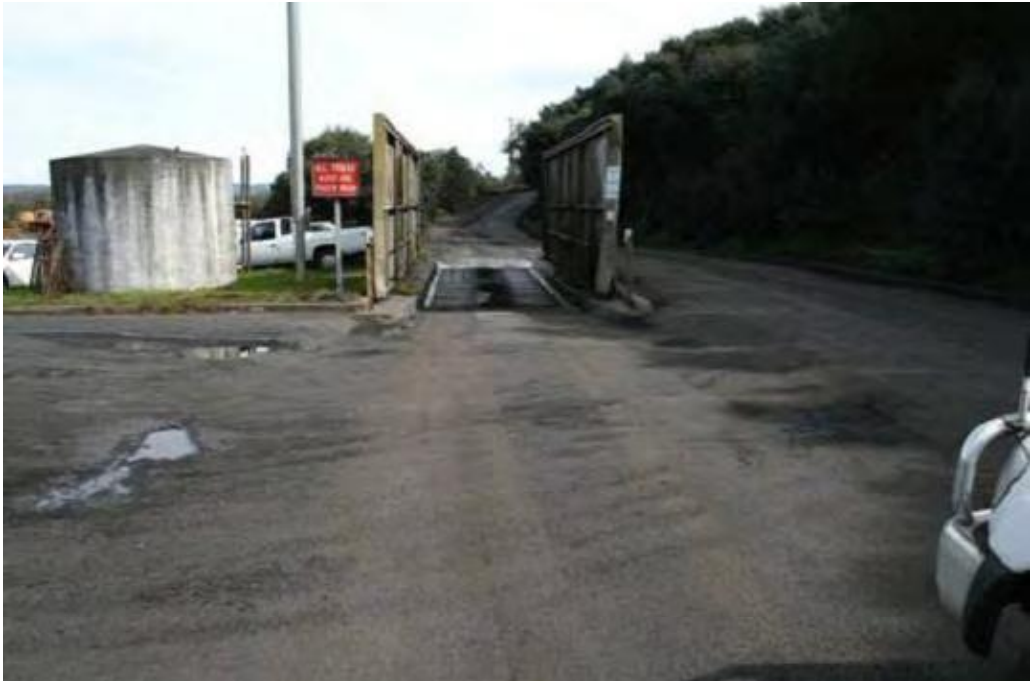
<b>Site Name:</b> Glenlee Precinct		<b>Site Location:</b> Glenlee Road, Narellan NSW	<b>Project No:</b> 60301834
<b>Plate No.</b> <b>7</b>	<b>Date:</b> 2007

<b>Direction Photo Taken:</b> West			
<b>Description:</b> PCA C - Secondary truck wash site – not considered in assessment as primarily for truck body dirt. Water is recycled

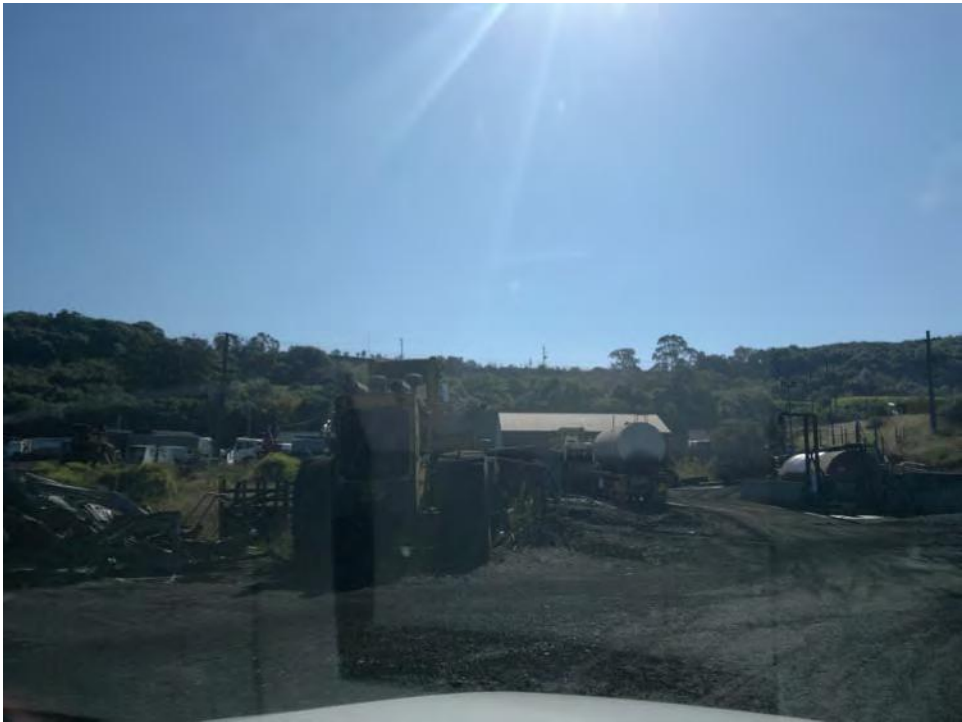
<b>Site Name:</b> Glenlee Precinct		<b>Site Location:</b> Glenlee Road, Narellan NSW	<b>Project No:</b> 60301834
<b>Plate No.</b> <b>9</b>	<b>Date:</b> 10/05/2013

<b>Direction Photo Taken:</b> North			
<b>Description:</b> PCA A - Plant, machinery and metal waste in yard behind SADA workshop

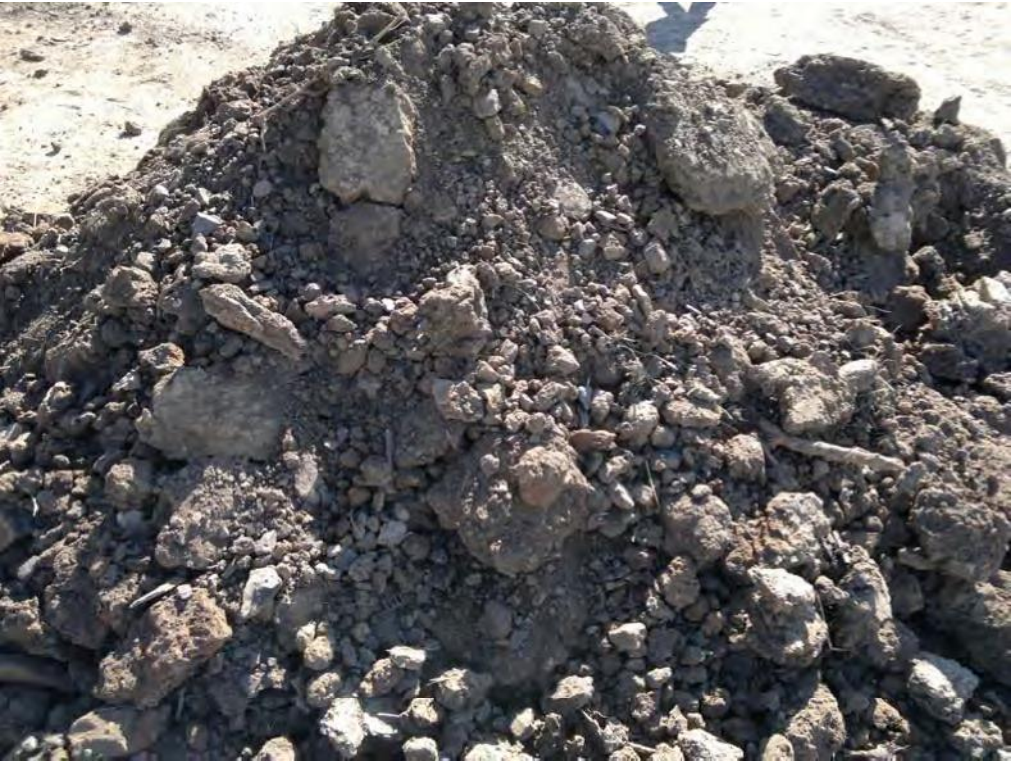
<b>PHOTOGRAPHIC LOG</b>		
<b>Site Name:</b> Glenlee Precinct		<b>Site Location:</b> Glenlee Road, Narellan NSW
<b>Project No:</b> 60301834		
<b>Plate No.</b> <b>15</b>	<b>Date:</b> 10/05/2013

<b>Direction Photo Taken:</b> Above		
<b>Description:</b> PCA L - Stockpiled excavated material from area adjacent SADA decommissioned tank farm

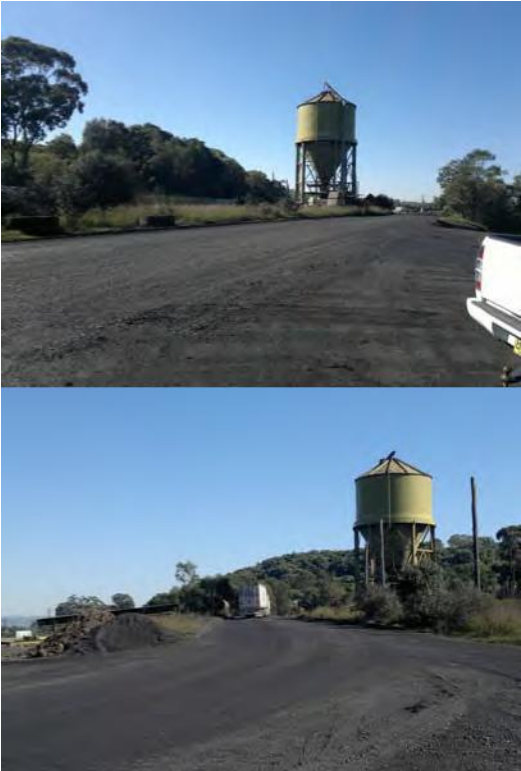
<b>Plate No.</b> <b>18</b>	<b>Date:</b> 10/05/2013

<b>Direction Photo Taken:</b> Top – East Bottom - West			
<b>Description:</b>  PCA E - Decommissioned Coal loader, some infrastructure on southern side of road has been removed since 2007 inspection
