# Revised Consolidated Phase 1 Contamination Assessment

Rezoning of Glenlee Employment and Related Lands

Client: Sada Services Pty Ltd

13-May-2016

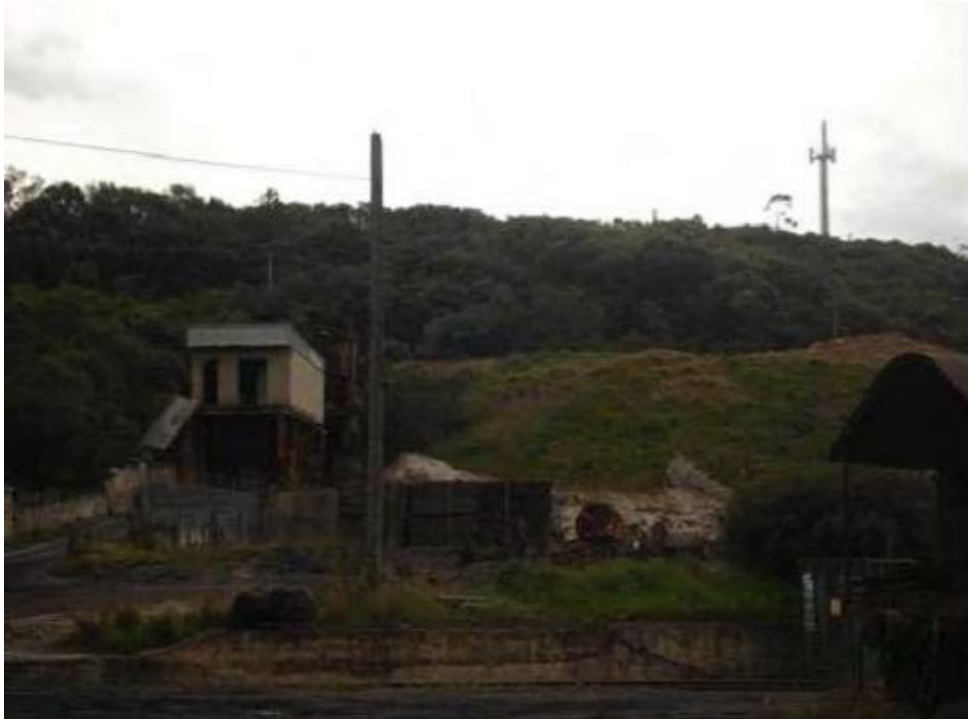
<b>Site Name:</b> Glenlee Precinct		<b>Site Location:</b> Glenlee Road, Narellan NSW	<b>Project No:</b> 60301834
<b>Plate No.</b> <b>19</b>	<b>Date:</b> XX/XX/2007

<b>Direction Photo Taken:</b> North			
<b>Description:</b>  PCA E - Former coal washery building at left of photo. Reported transformer storage area at extreme left

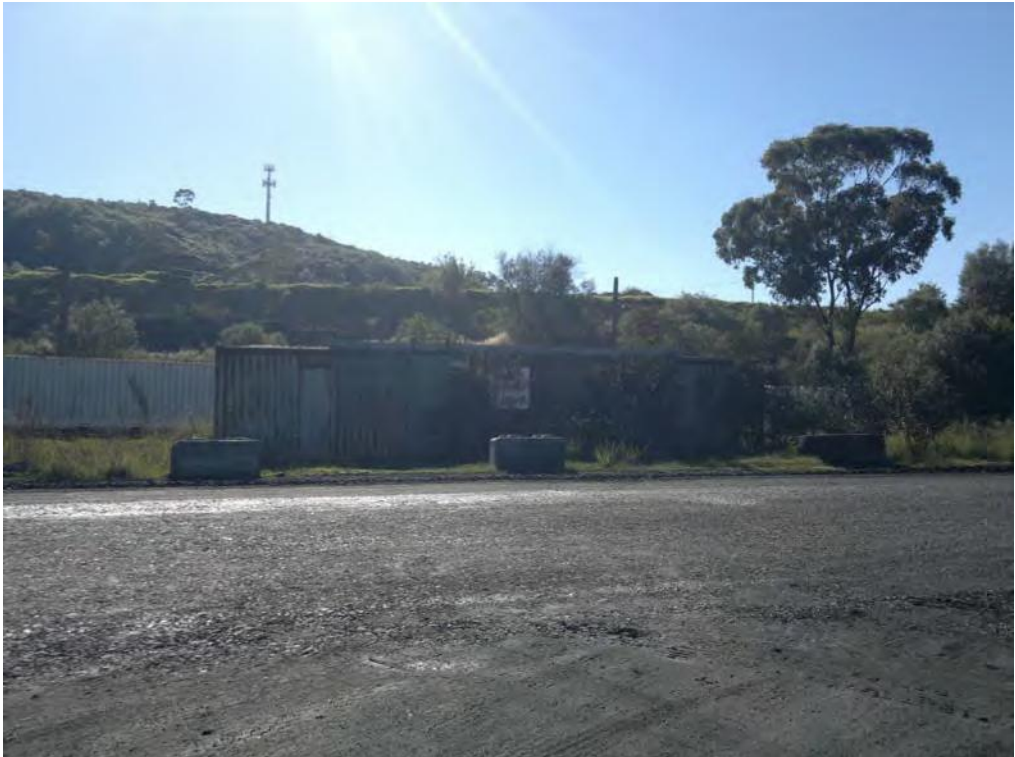
<b>Plate No.</b> <b>20</b>	<b>Date:</b> 10/05/2013

<b>Direction Photo Taken:</b> North			
<b>Description:</b>  PCA E - Area not accessible at time of inspection due to presence of train.

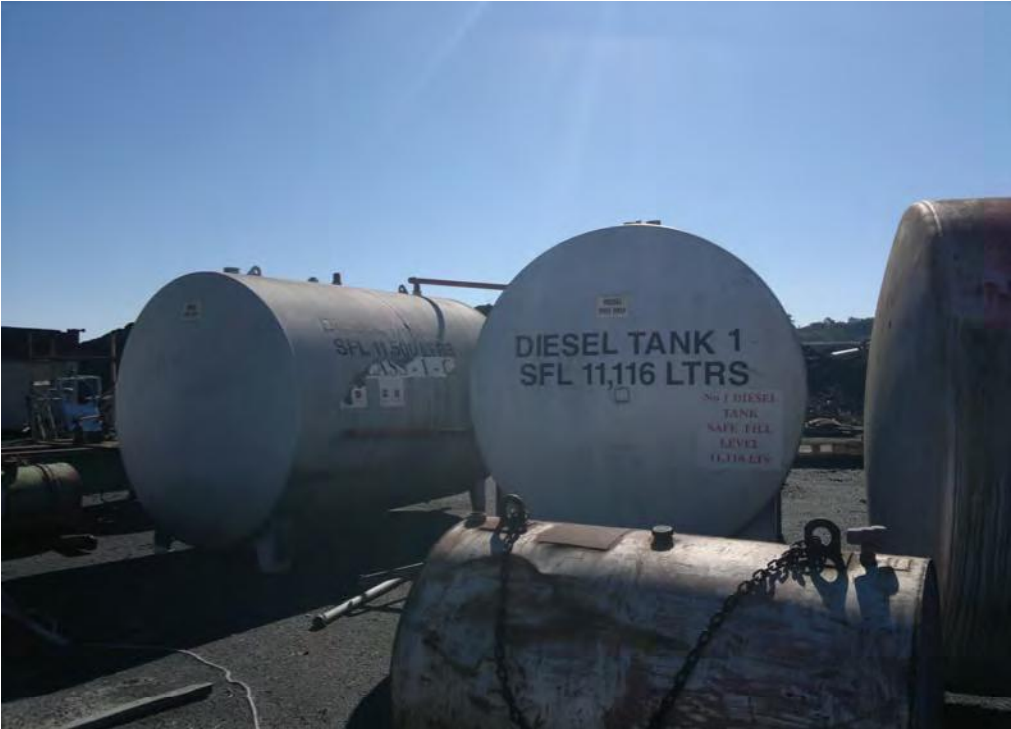
<b>Site Name:</b> Glenlee Precinct		<b>Site Location:</b> Glenlee Road, Narellan NSW	<b>Project No:</b> 60301834
<b>Plate No.</b> <b>23</b>	<b>Date:</b> 10/05/2013

<b>Direction Photo Taken:</b> East			
<b>Description:</b> Previously unidentified PCA. New PCA S. Machinery, plant, materials and ASTs "Graveyard"

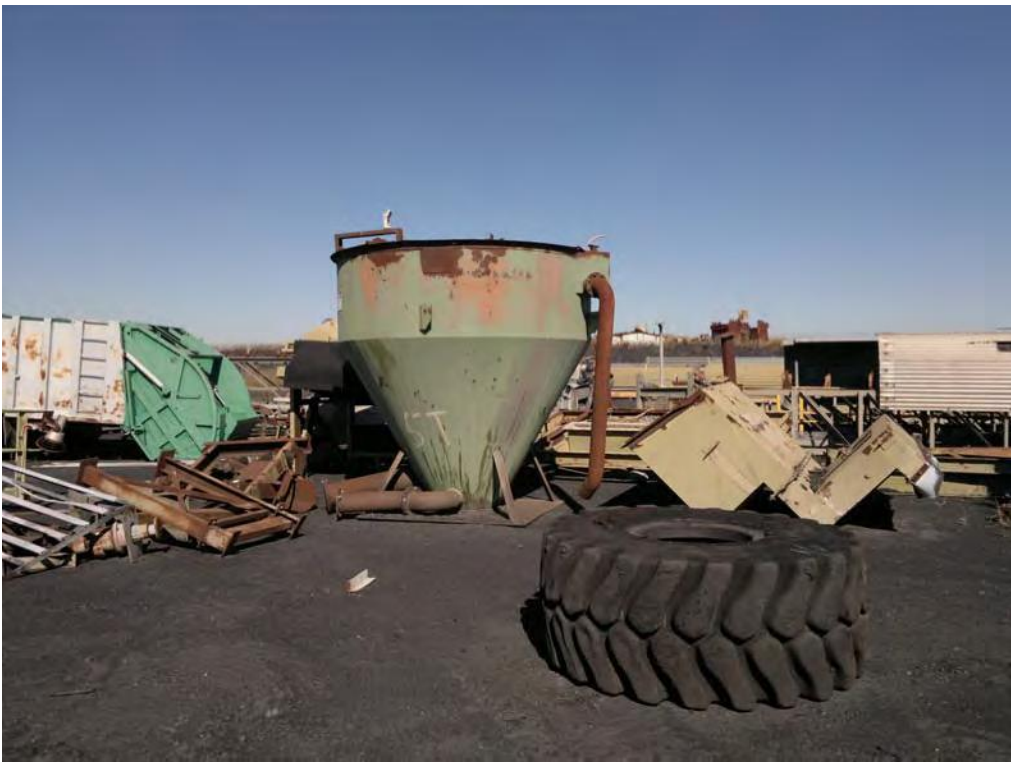
<b>Plate No.</b> <b>24</b>	<b>Date:</b> 10/05/2013

<b>Direction Photo Taken:</b> South-west		
<b>Description:</b> Previously unidentified PCA. New PCA S. Machinery, plant, materials and ASTs "Graveyard"

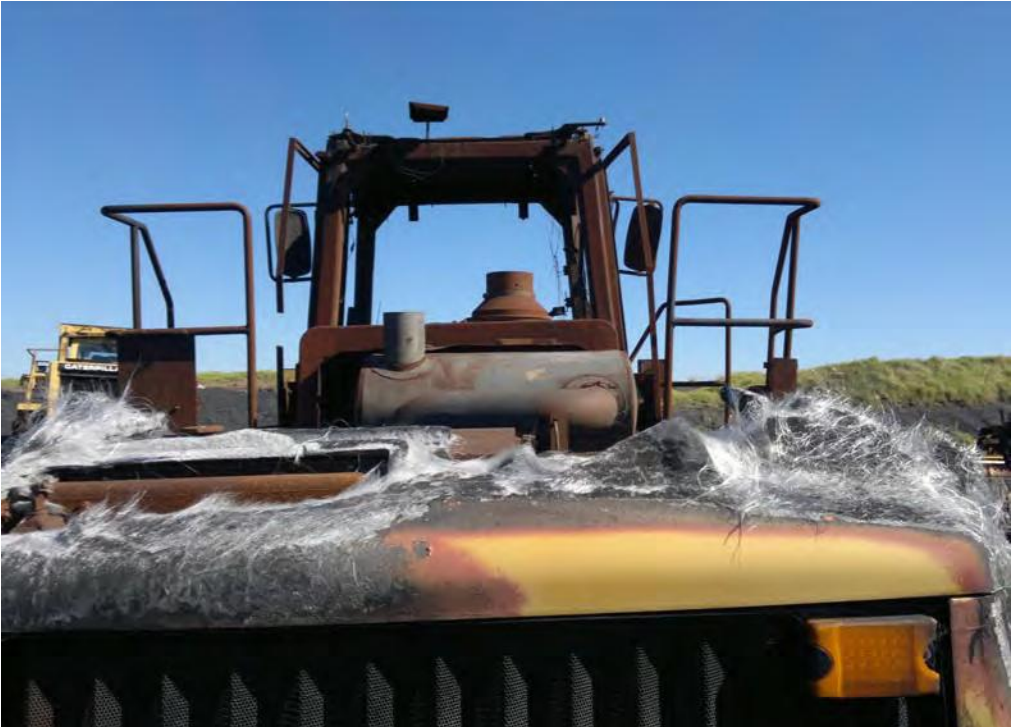
<b>PHOTOGRAPHIC LOG</b>			
<b>Site Name:</b> Glenlee Precinct		<b>Site Location:</b> Glenlee Road, Narellan NSW	<b>Project No:</b> 60301834
<b>Plate No.</b> <b>25</b>	<b>Date:</b> 10/05/2013

<b>Direction Photo Taken:</b> West			
<b>Description:</b> Previously unidentified PCA. New PCA S. Machinery, plant, materials and ASTs "Graveyard"

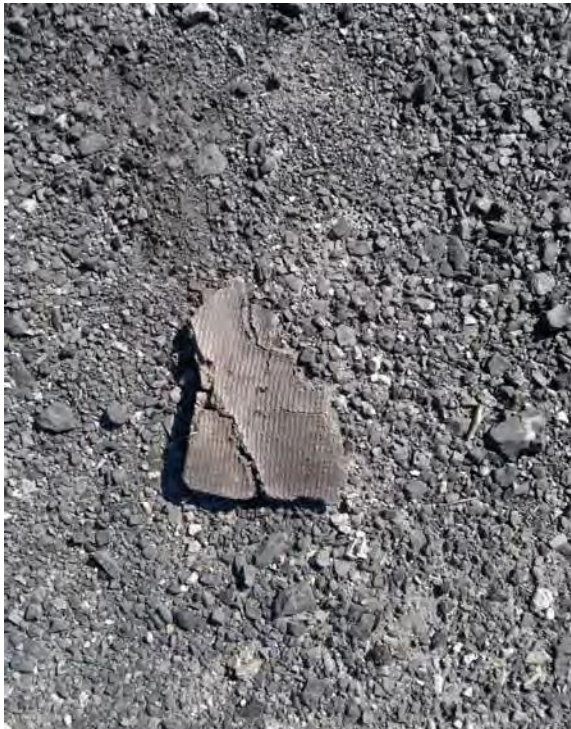
<b>PHOTOGRAPHIC LOG</b>			
<b>Site Name:</b> Glenlee Precinct		<b>Site Location:</b> Glenlee Road, Narellan NSW	<b>Project No:</b> 60301834
<b>Plate No.</b> <b>27</b>	<b>Date:</b> 10/05/2013

<b>Direction Photo Taken:</b> East			
<b>Description:</b> PCA X - Fragment of possible fibre cement containing material in south-eastern portion of emplacement area

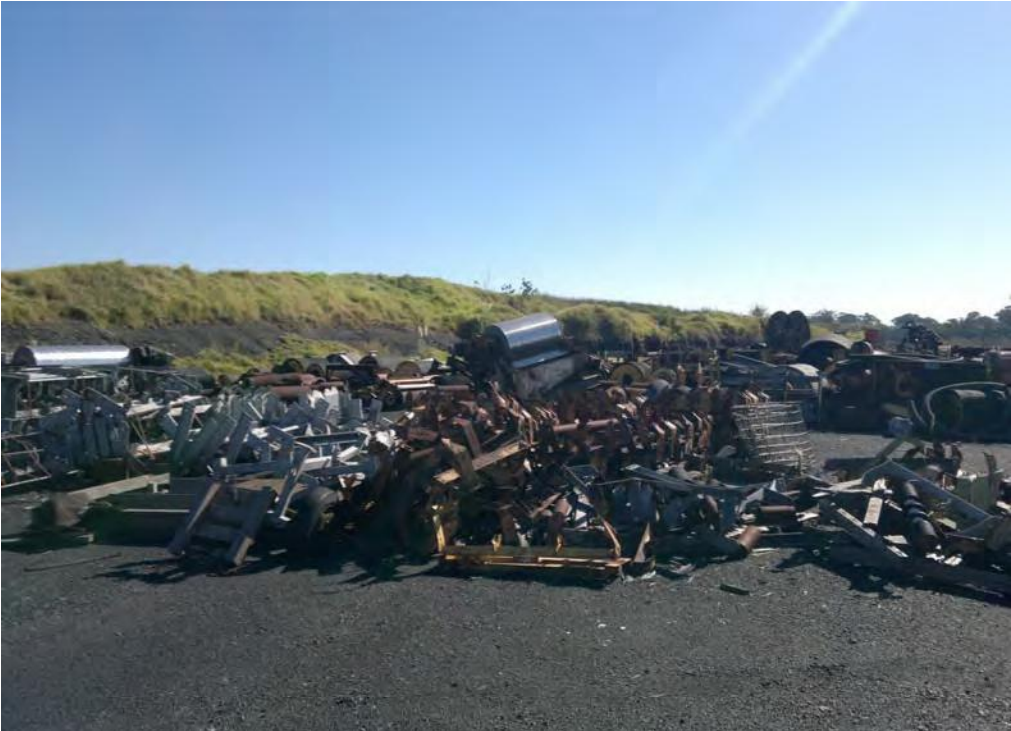
<b>PHOTOGRAPHIC LOG</b>			
<b>Site Name:</b> Glenlee Precinct		<b>Site Location:</b> Glenlee Road, Narellan NSW	<b>Project No:</b> 60301834
<b>Plate No.</b> <b>29</b>	<b>Date:</b> 10/05/2013

<b>Direction Photo Taken:</b> North			
<b>Description:</b> Previously unidentified PCA. New PCA S. Machinery, plant, materials and ASTs "Graveyard"

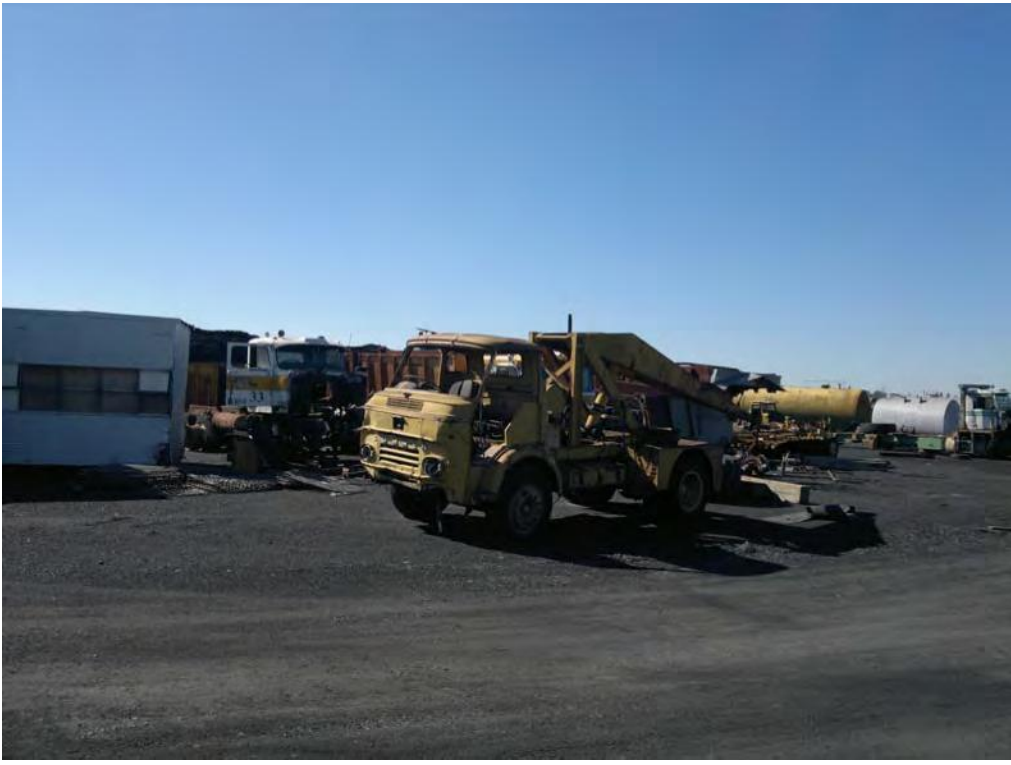
<b>Plate No.</b> <b>30</b>	<b>Date:</b> 10/05/2013

<b>Direction Photo Taken:</b> South-west		
<b>Description:</b> Previously unidentified PCA. New PCA S. Machinery, plant, materials and ASTs "Graveyard"

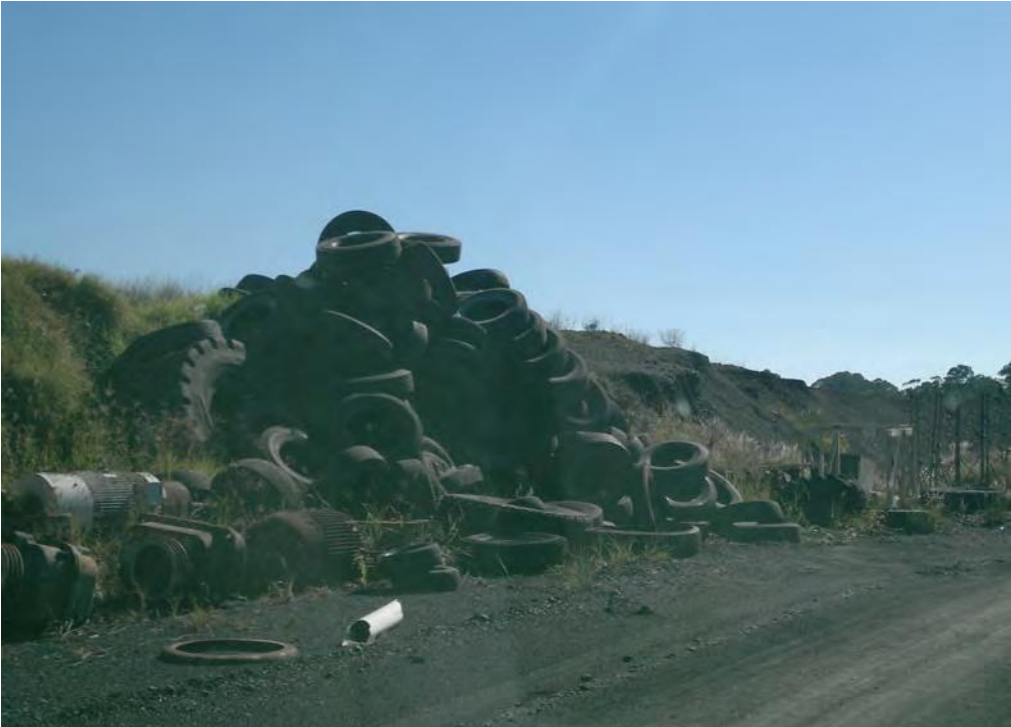
<b>PHOTOGRAPHIC LOG</b>			
<b>Site Name:</b> Glenlee Precinct		<b>Site Location:</b> Glenlee Road, Narellan NSW	<b>Project No:</b> 60301834
<b>Plate No.</b> <b>31</b>	<b>Date:</b> 10/05/2013

<b>Direction Photo Taken:</b> North-east			
<b>Description:</b> PCA X - Stockpiles of tyres on eastern portion of SADA site

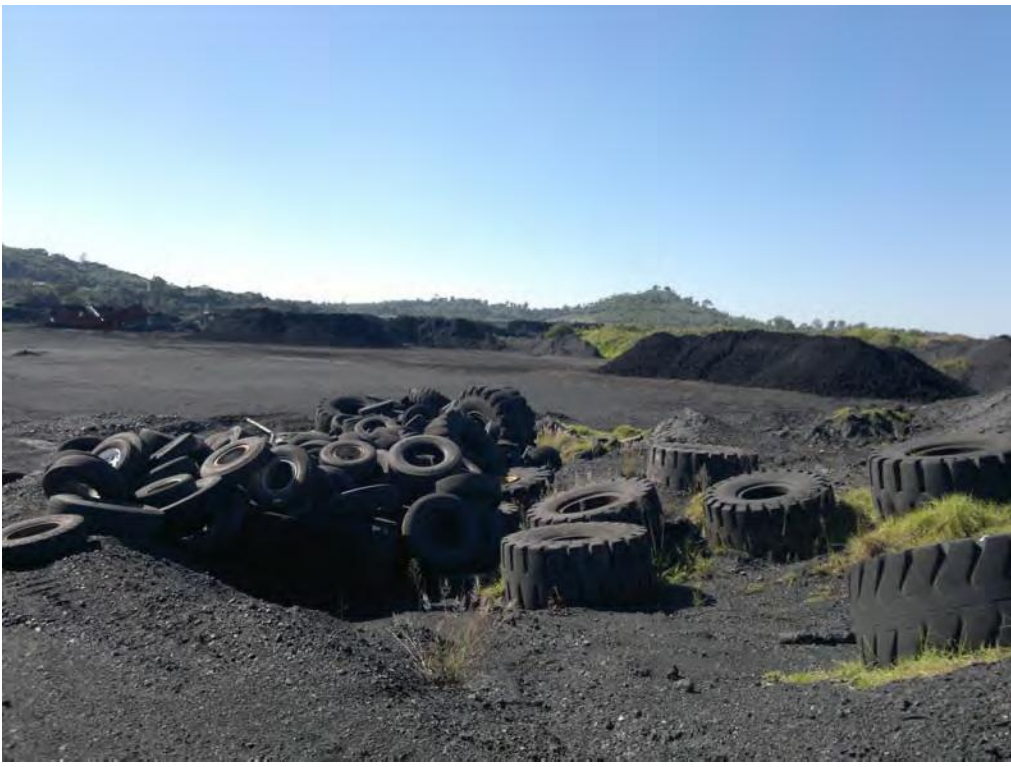
<b>Plate No.</b> <b>32</b>	<b>Date:</b> 10/05/2013

<b>Direction Photo Taken:</b> North-west		
<b>Description:</b> PCA X - Stockpiles of tyres on eastern portion of SADA site

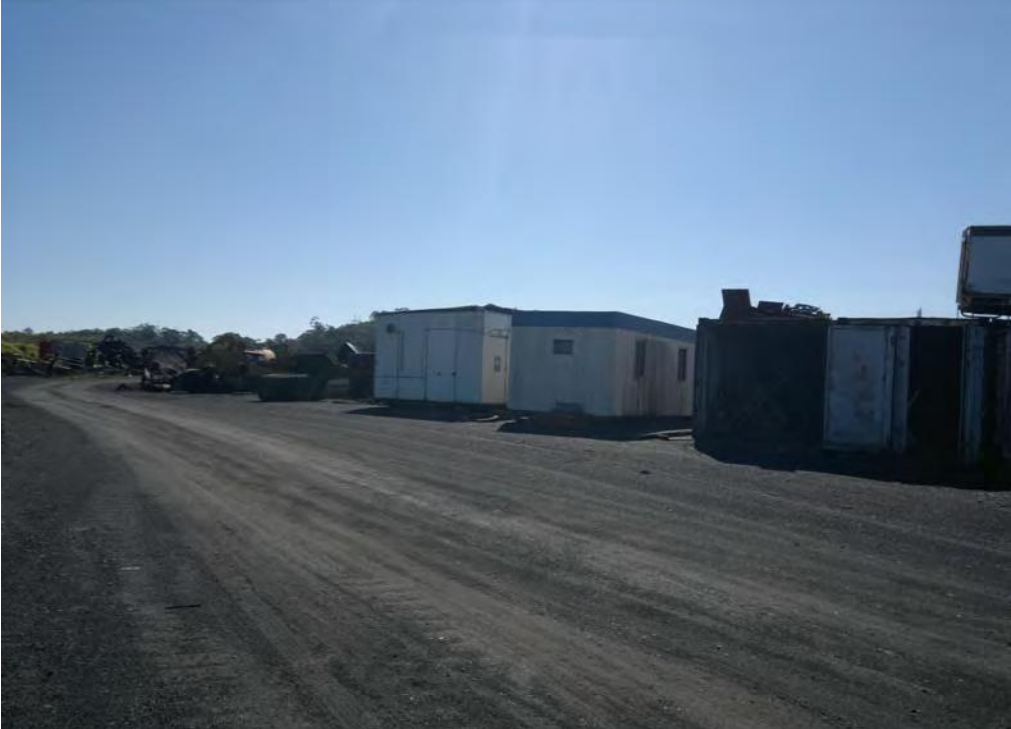
<b>PHOTOGRAPHIC LOG</b>			
<b>Site Name:</b> Glenlee Precinct		<b>Site Location:</b> Glenlee Road, Narellan NSW	<b>Project No:</b> 60301834
<b>Plate No.</b> <b>33</b>	<b>Date:</b> 10/05/2013

<b>Direction Photo Taken:</b> North			
<b>Description:</b> New PCA S - Demountable office buildings near machinery and plant storage area

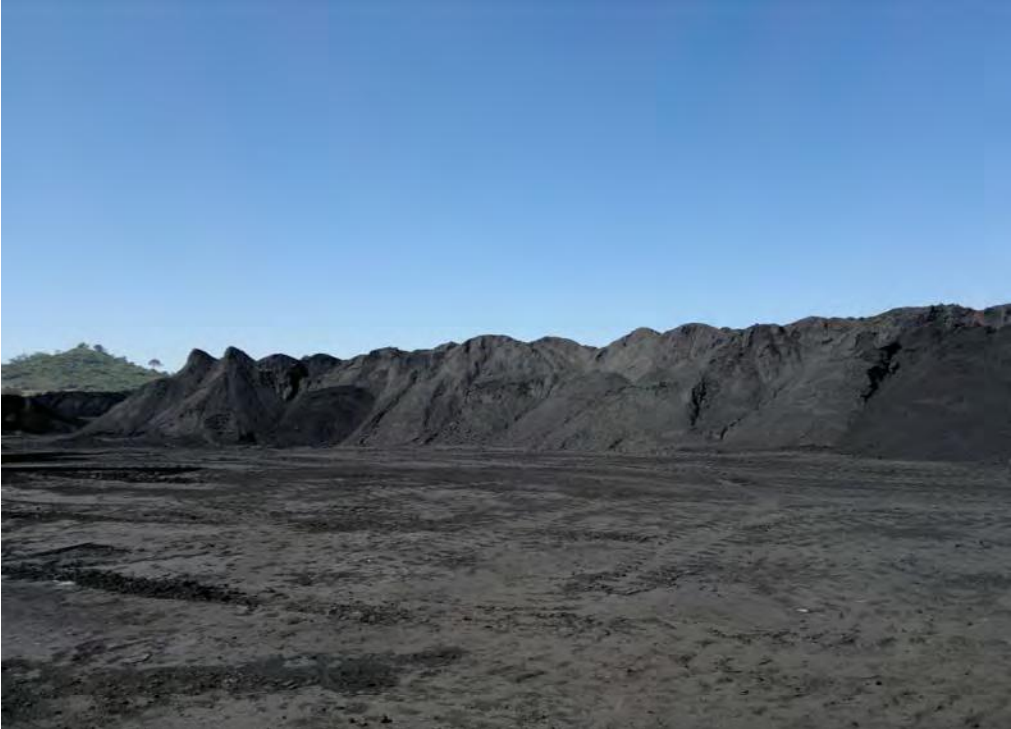
<b>PHOTOGRAPHIC LOG</b>			
<b>Site Name:</b> Glenlee Precinct		<b>Site Location:</b> Glenlee Road, Narellan NSW	<b>Project No:</b> 60301834
<b>Plate No.</b> <b>35</b>	<b>Date:</b> 10/05/2013

<b>Direction Photo Taken:</b> North-east			
<b>Description:</b> PCA X – Emplacement. Coal reject stockpiles on eastern portion of Site

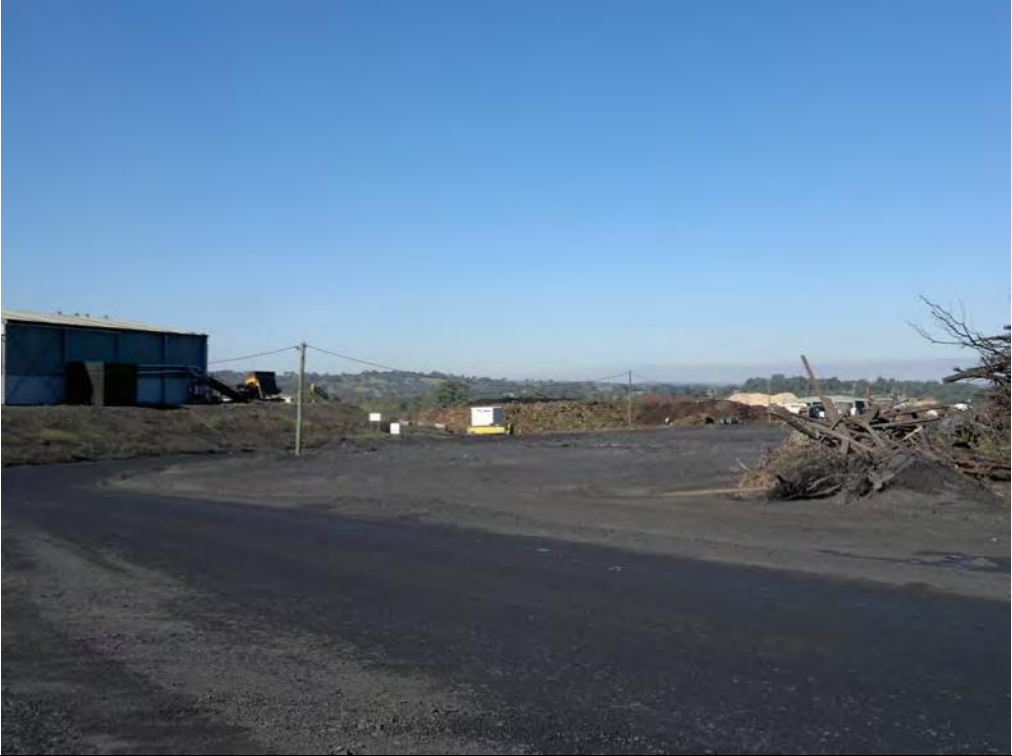
<b>PHOTOGRAPHIC LOG</b>			
<b>Site Name:</b> Glenlee Precinct		<b>Site Location:</b> Glenlee Road, Narellan NSW	<b>Project No:</b> 60301834
<b>Plate No.</b> <b>41</b>	<b>Date:</b> 2007

<b>Direction Photo Taken:</b> South-east			
<b>Description:</b> PCA J - CSM building on left hand side of photo and green waste sorting area centre of photo and green waste stockpiled beside road to CSM site.

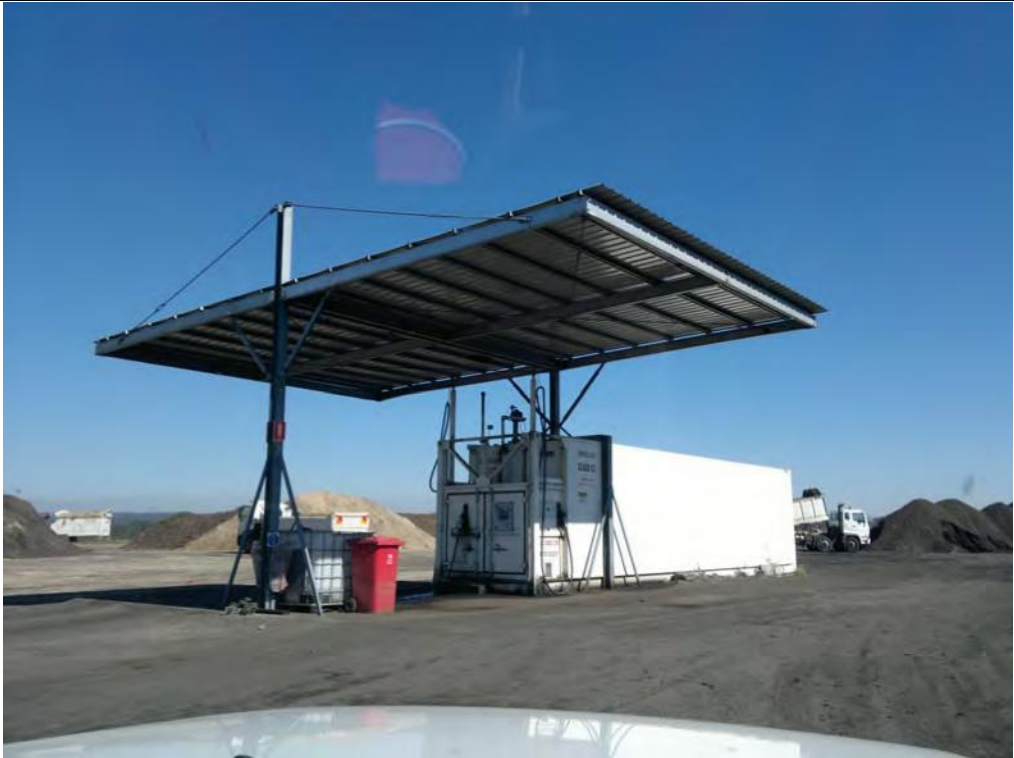
<b>Site Name:</b> Glenlee Precinct		<b>Site Location:</b> Glenlee Road, Narellan NSW	<b>Project No:</b> 60301834
<b>Plate No.</b> <b>49</b>	<b>Date:</b> 2007

<b>Direction Photo Taken:</b> South-east			
<b>Description:</b> New Tripodi Diesel refueling facility – PCA P

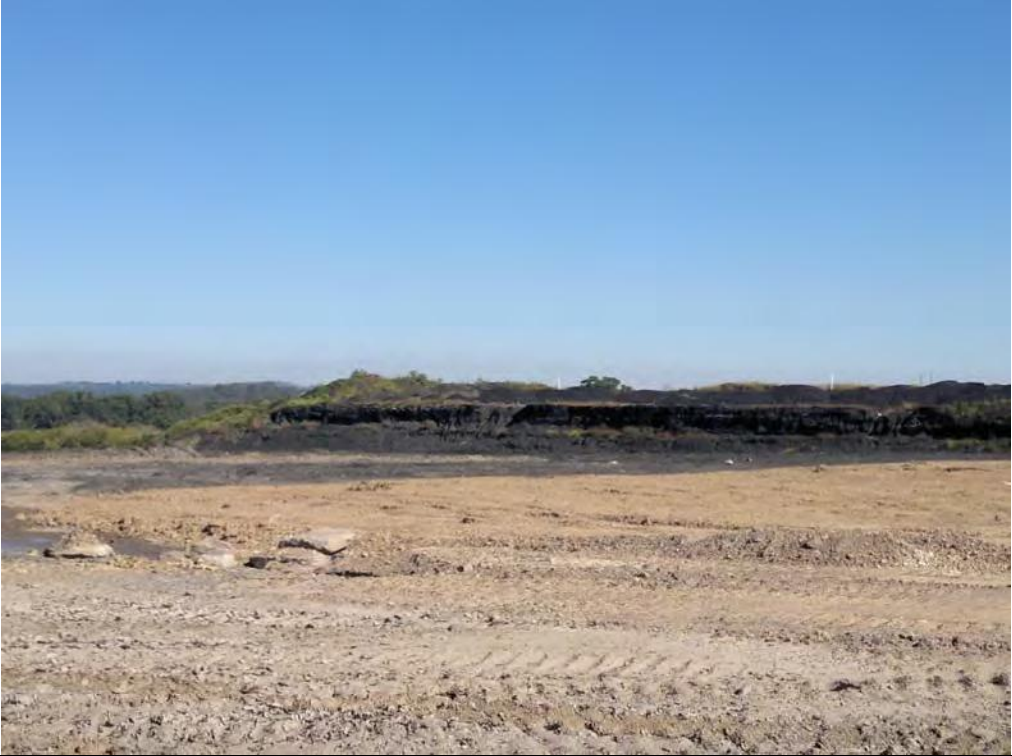
<b>PHOTOGRAPHIC LOG</b>			
<b>Site Name:</b> Glenlee Precinct		<b>Site Location:</b> Glenlee Road, Narellan NSW	<b>Project No:</b> 60301834
<b>Plate No.</b> <b>51</b>	<b>Date:</b> 2007

<b>Direction Photo Taken:</b> South-east			
<b>Description:</b> Extent of VENM infilling towards SADA portion of Site with coal reject infilling

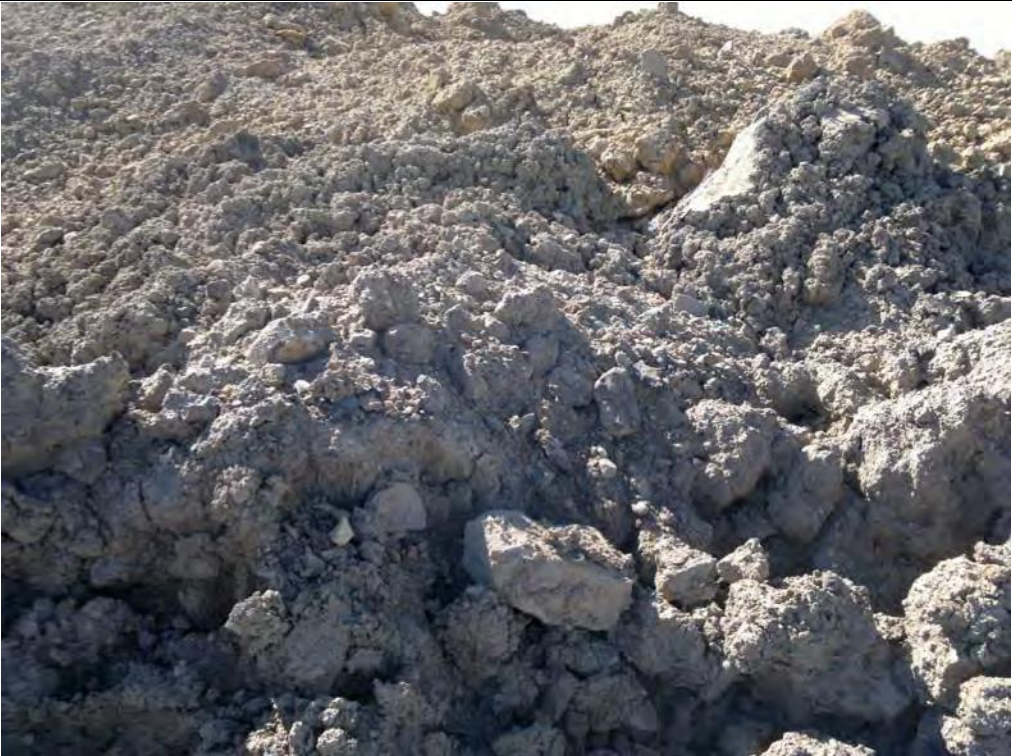
<b>PHOTOGRAPHIC LOG</b>			
<b>Site Name:</b> Glenlee Precinct		<b>Site Location:</b> Glenlee Road, Narellan NSW	<b>Project No:</b> 60301834
<b>Plate No.</b> <b>53</b>	<b>Date:</b> 2007

<b>Direction Photo Taken:</b> Above			
<b>Description:</b> Close up of material type. Stockpile of VENM imported from SITA waste management facility at Eastern Creek

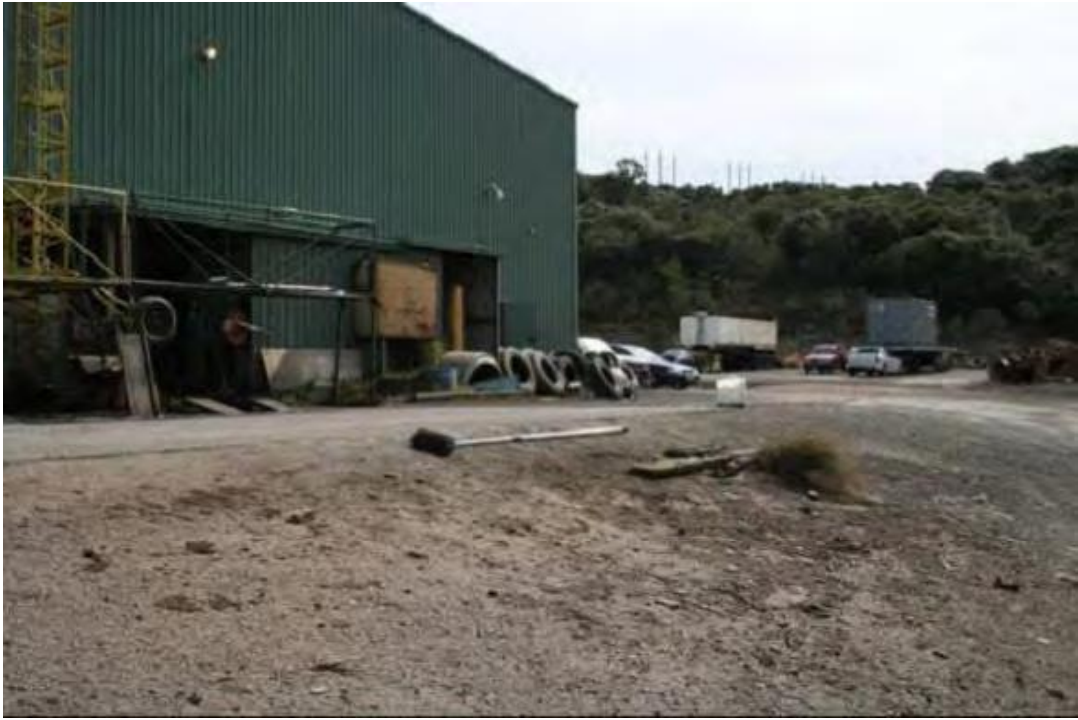
<b>Site Name:</b> Glenlee Precinct		<b>Site Location:</b> Glenlee Road, Narellan NSW	<b>Project No:</b> 60301834
<b>Plate No.</b> <b>55</b>	<b>Date:</b> 2007

<b>Direction Photo Taken:</b> North-west			
<b>Description:</b> PCA H – TRN Workshop

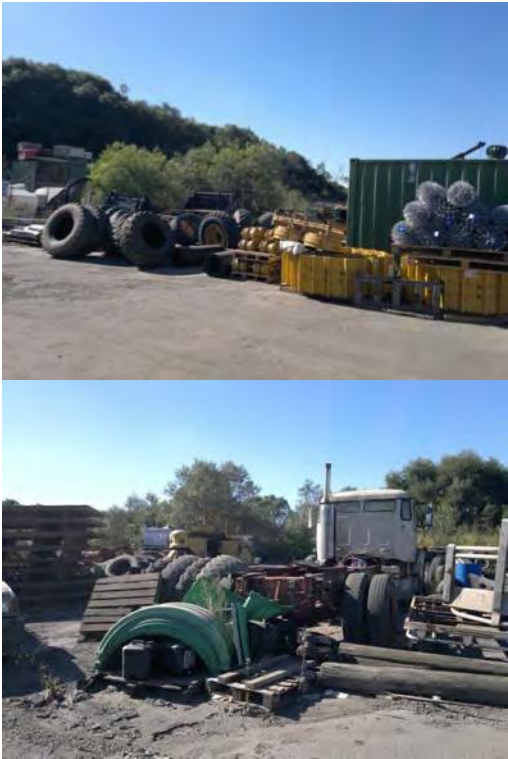
<b>Plate No.</b> <b>58</b>	<b>Date:</b> 10/05/2013

<b>Direction Photo Taken:</b> North-east			
<b>Description:</b> PCA H - Current state of stockpiled plant, machinery and spares on eastern boundary of TRN compound – multiple lease users

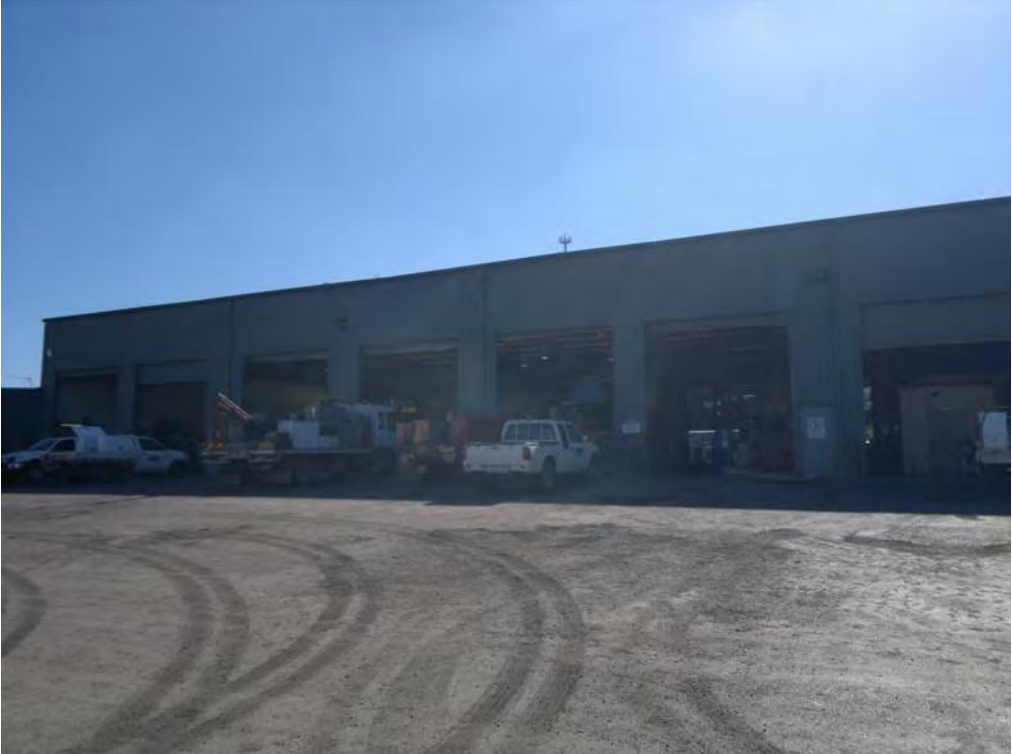
<b>Direction Photo Taken:</b> North			
<b>Description:</b> PCA H - Rear of TRN Workshop

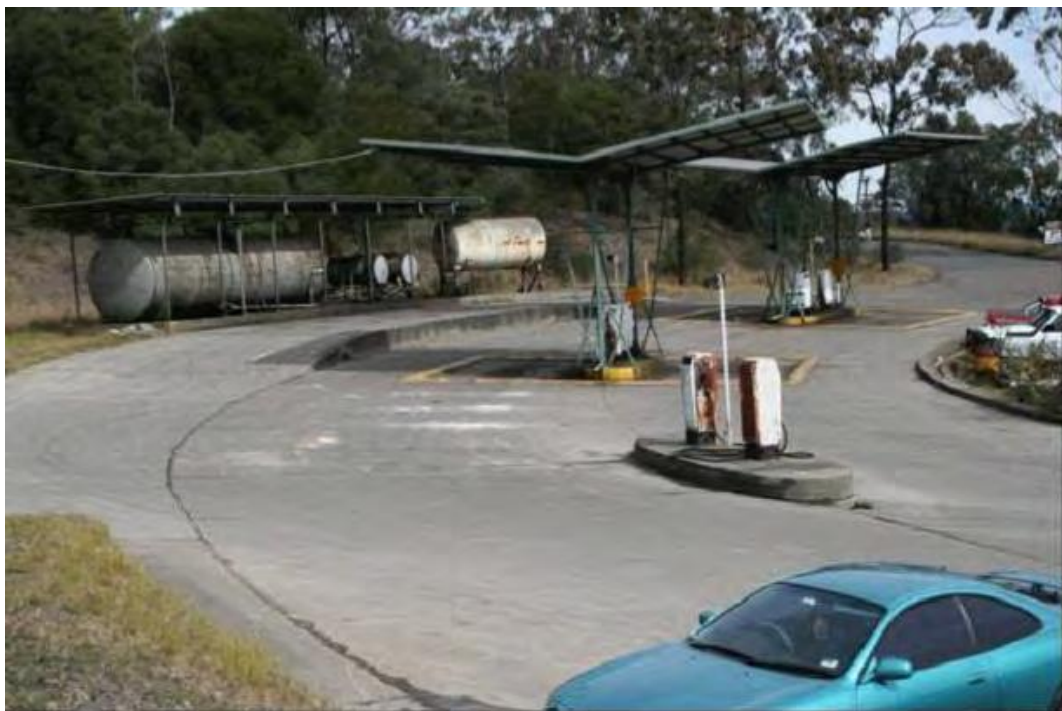
<b>Direction Photo Taken:</b> West			
<b>Description:</b>  PCA I - Above ground fuel tanks and old bowsers at TRN tank farm

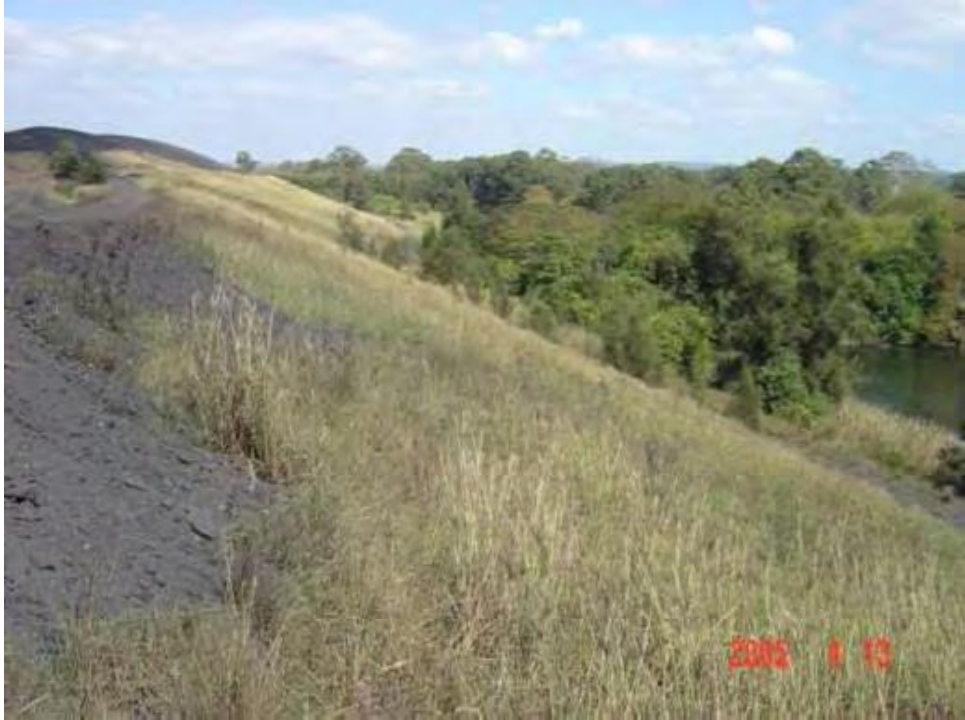
<b>Site Name:</b> Glenlee Precinct		<b>Site Location:</b> Glenlee Road, Narellan NSW	<b>Project No:</b> 60301834
<b>Plate No.</b> <b>75</b>	<b>Date:</b> 2005

<b>Direction Photo Taken:</b> South-east			
<b>Description:</b> Western embankment

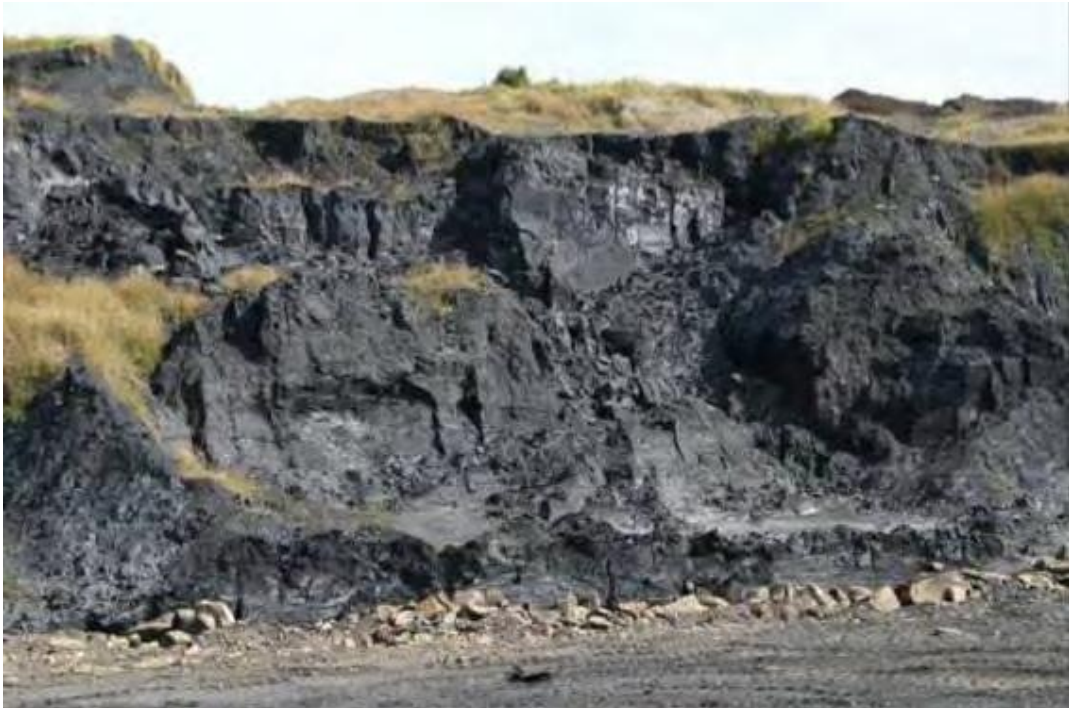
<b>Direction Photo Taken:</b> East			
<b>Description:</b>  PCA X - In emplacement showing profile of tailings

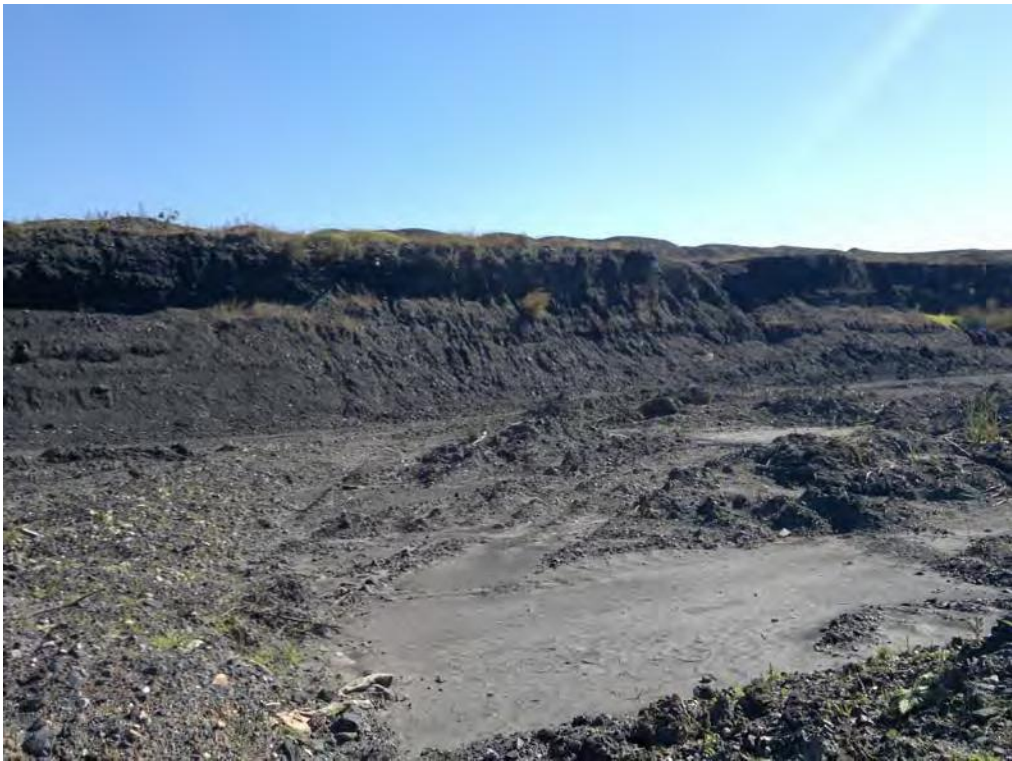
<b>Plate No.</b> <b>84</b>	<b>Date:</b> 10/05/2013

<b>Direction Photo Taken:</b> East		
<b>Description:</b>  PCA X - Current emplacement showing profile of coal reject or tailings or stockpiled coal for export
