# Glenlee Precinct Rezoning

## RIPARIAN CORRIDOR STUDY

16-May-2016

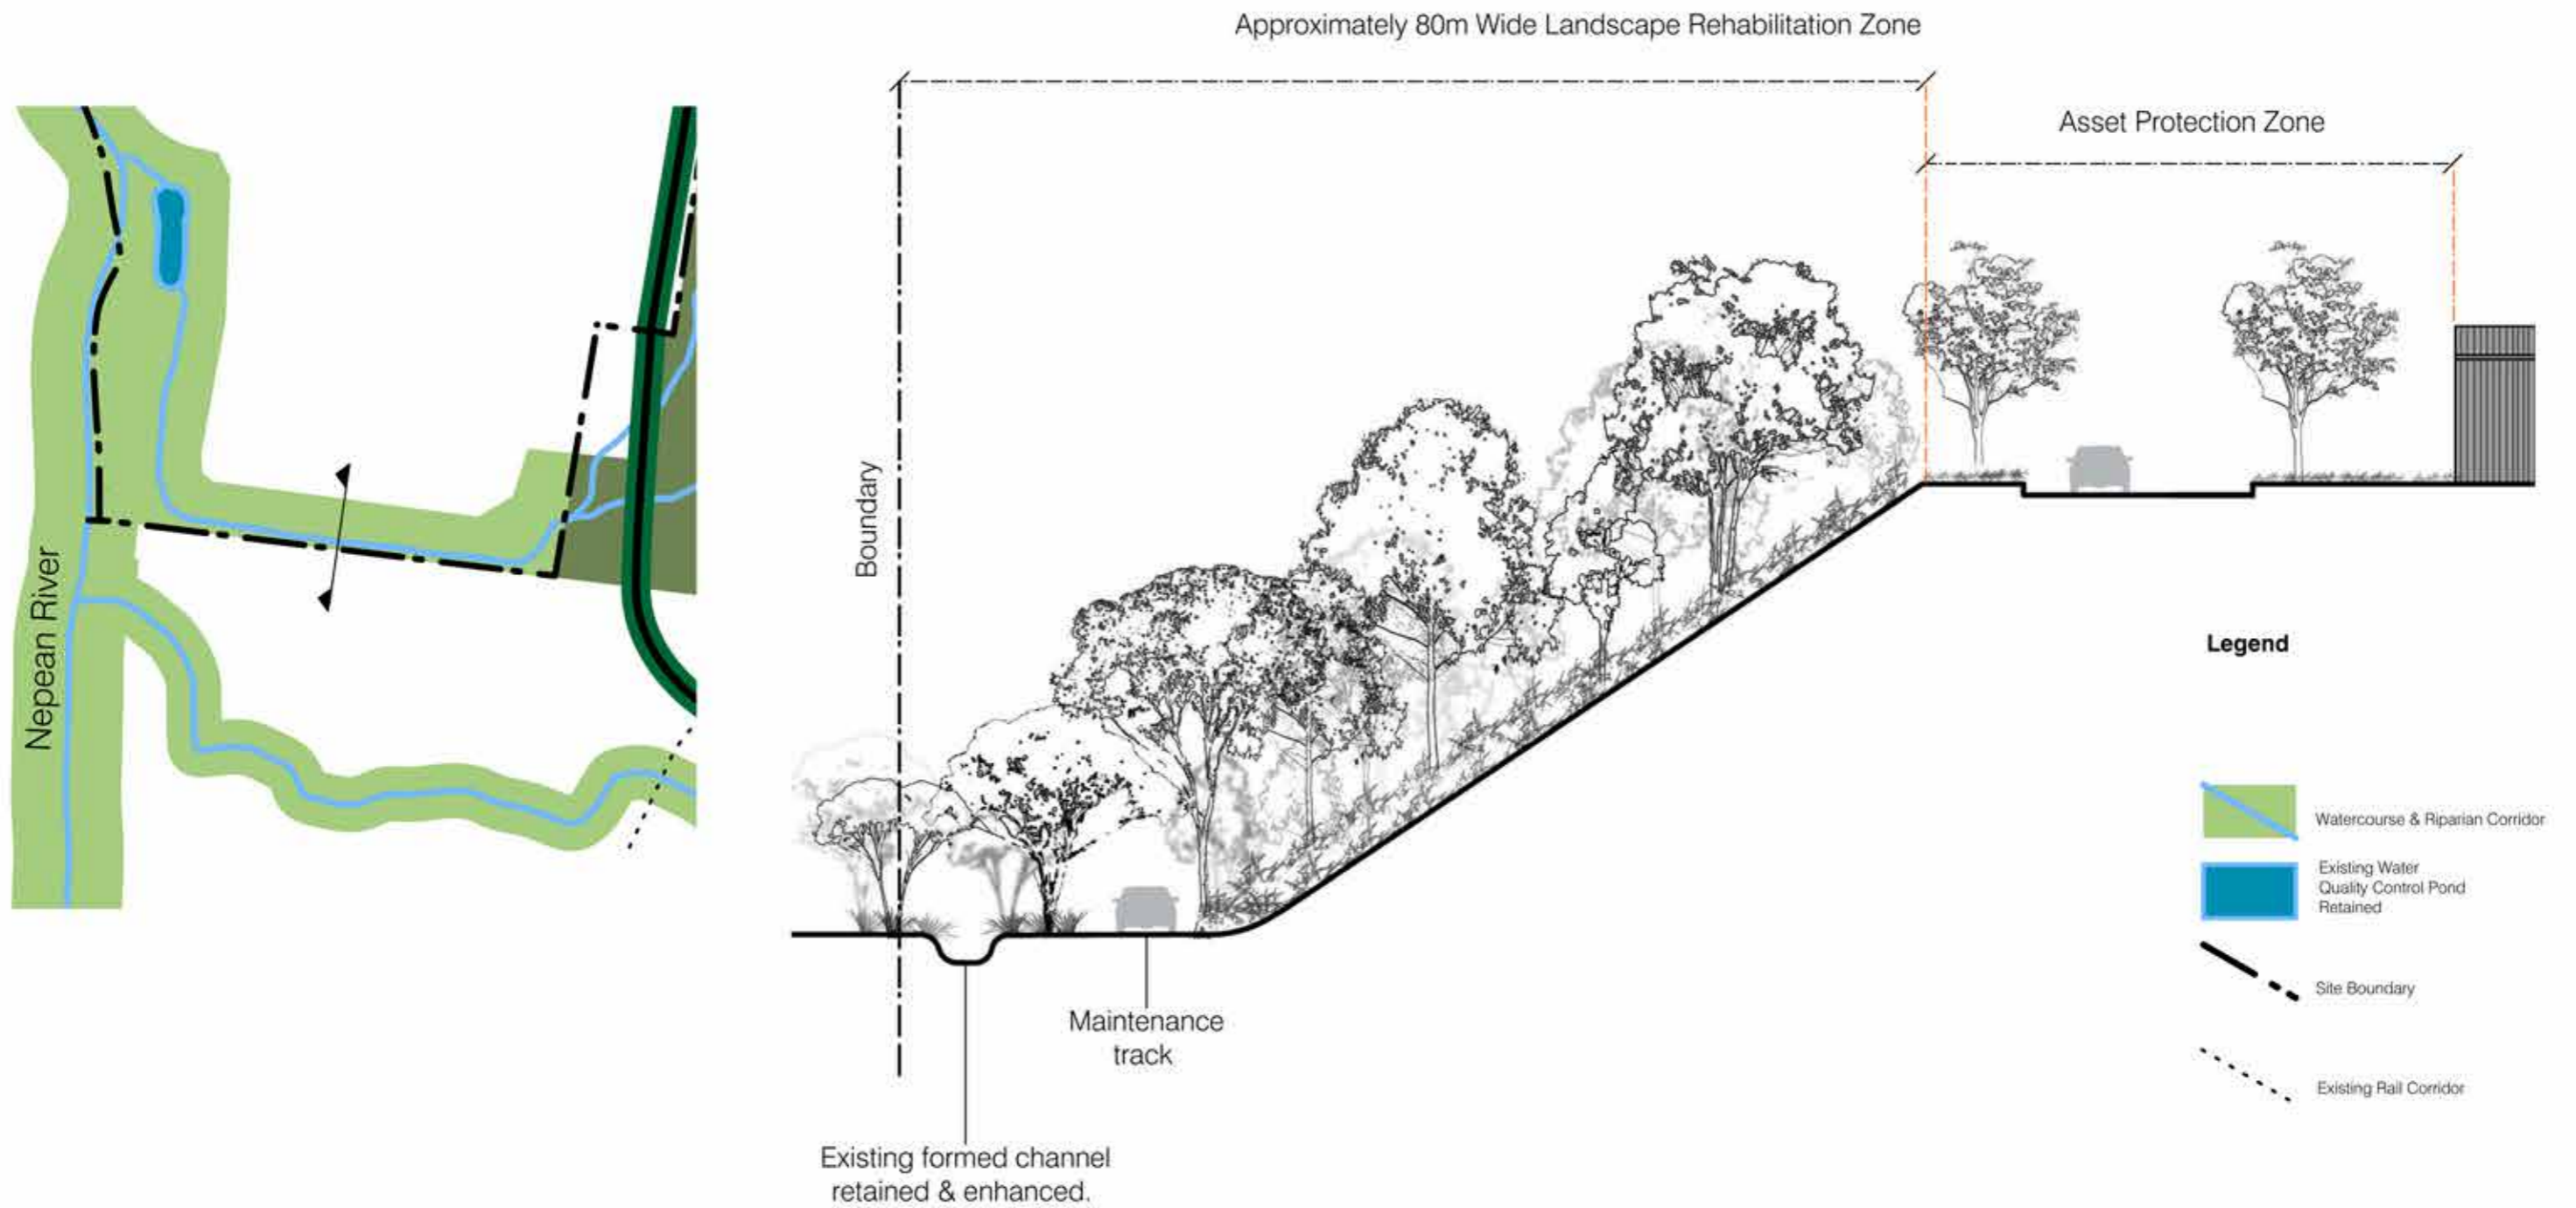
Figure 9. Detail - Southern Boundary Restoration  
 Glenlee Precinct - Proposed Rezoning

Restoration for this area (Management Zone B) would take the form of a gradual process of partial landscape restoration, commencing with the gradual planting and establishment of endemic tree species within and adjoining the management zone, followed by a gradual process of African Olive removal and replacement with native shrub and ground layer species where practical. This work would be detailed within a Vegetation Management Plan.

Restoration planting adjacent to the watercourse will comprise of a plant association characteristic of the River-flat Eucalypt Forest community, with the batter slopes being planted to a modified, site specific community comprising of those locally endemic species best able to colonise the drought-prone, relatively free-draining conditions of the soil remediated slope, e.g. Cumberland Plain Woodland species, and / or potentially components of the local Elderslie Banksia Scrub Forest community which is adapted to highly free-draining conditions. All plant material used in the restoration process will be of local provenance. The design intent of this process is to provide a broad suite of species which have the greatest potential to successfully colonise / stabilise the batter, and create a self-regenerating, native ecological community.
