Camden Council Business Paper

**ORD08 Proposed Amendments to Camden LEP
2010 (No 32) and Camden DCP 2011 -
Lot 24 DP 1086823 Crase Place
Grasmere
PLANNING PROPOSAL APPENDICES**

BUSHFIRE HAZARD ASSESSMENT FOR PROPOSED
REZONING OF 10 CRASE PLACE, GRASMERE

**Phase 1 Contamination Assessment and Salinity Assessment
Part Lot 24 DP1086823, 10 Crase Place,
Grasmere, NSW**

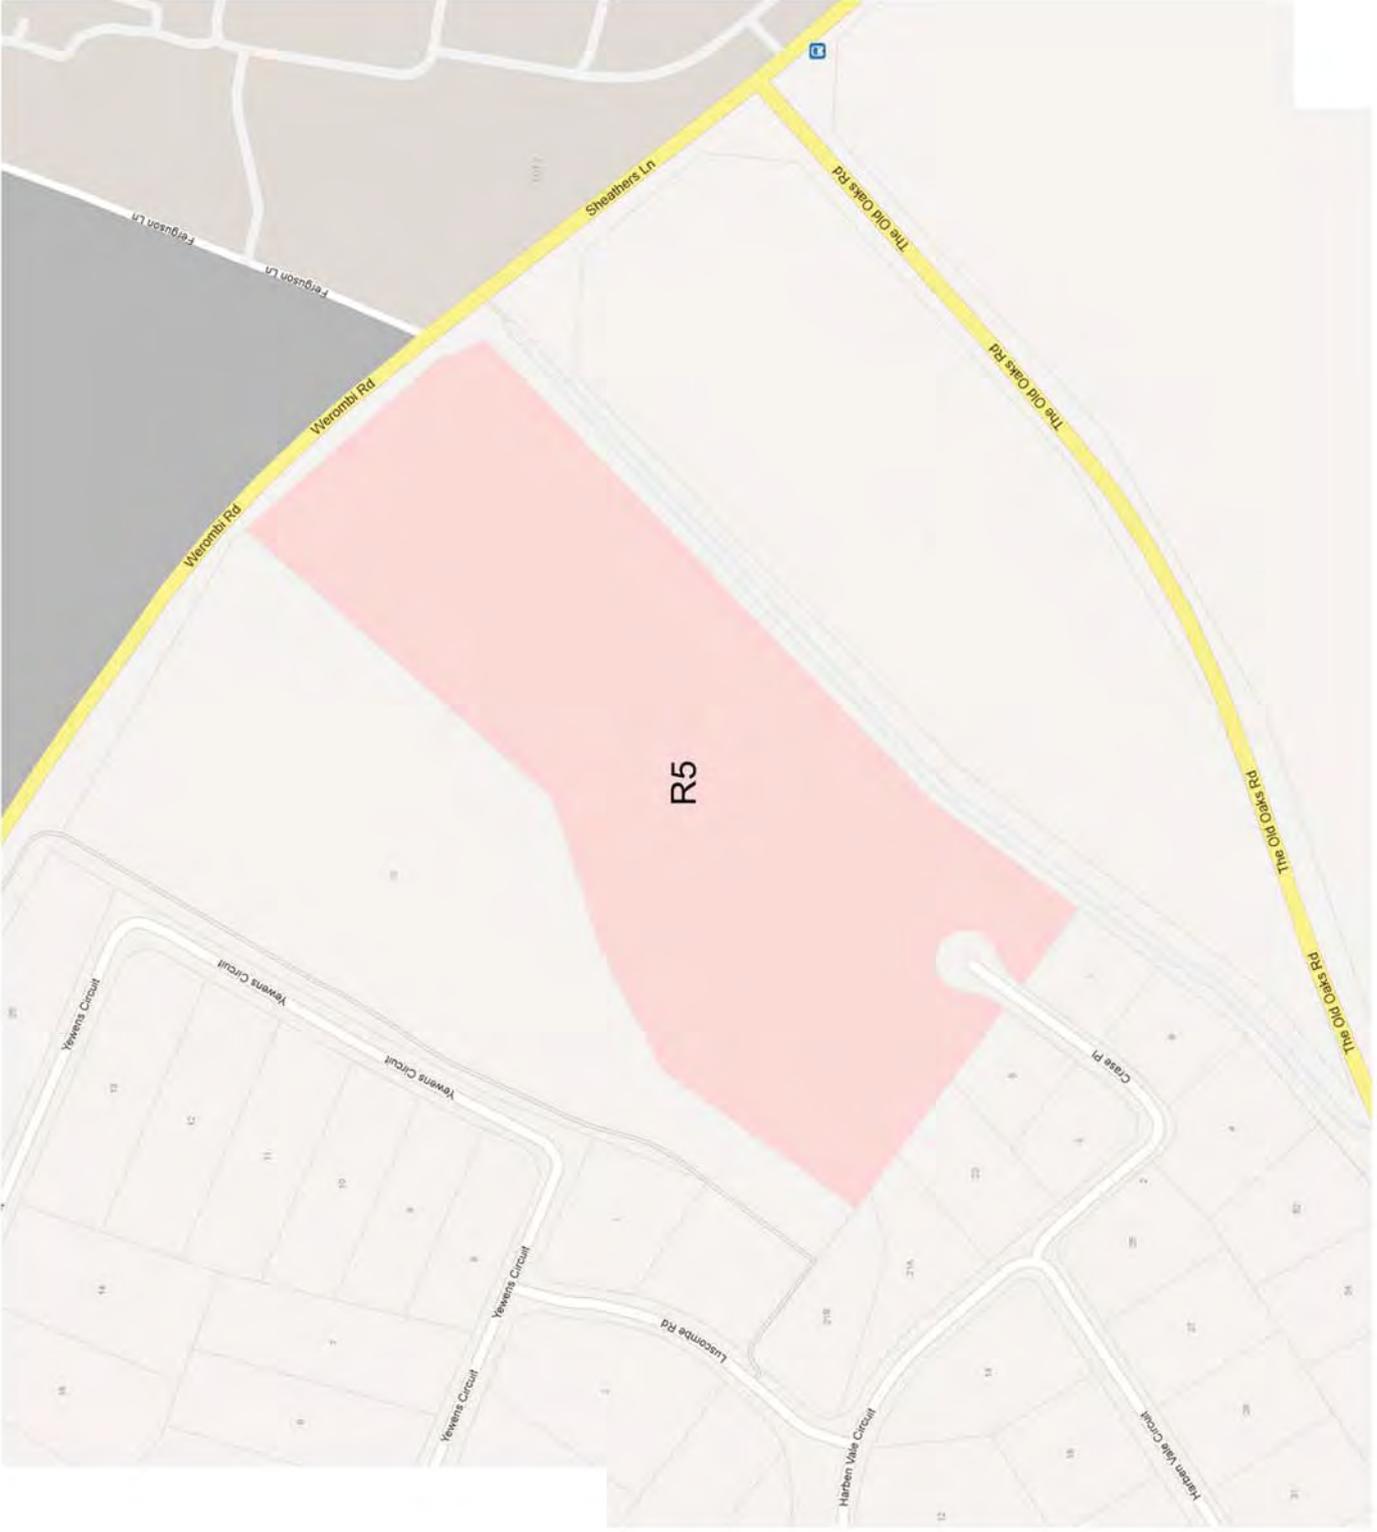
APPENDIX A

Proposed Zoning and Minimum Lot Size provisions

LEGEND
 R5
 LARGE LOT
 RESIDENTIAL

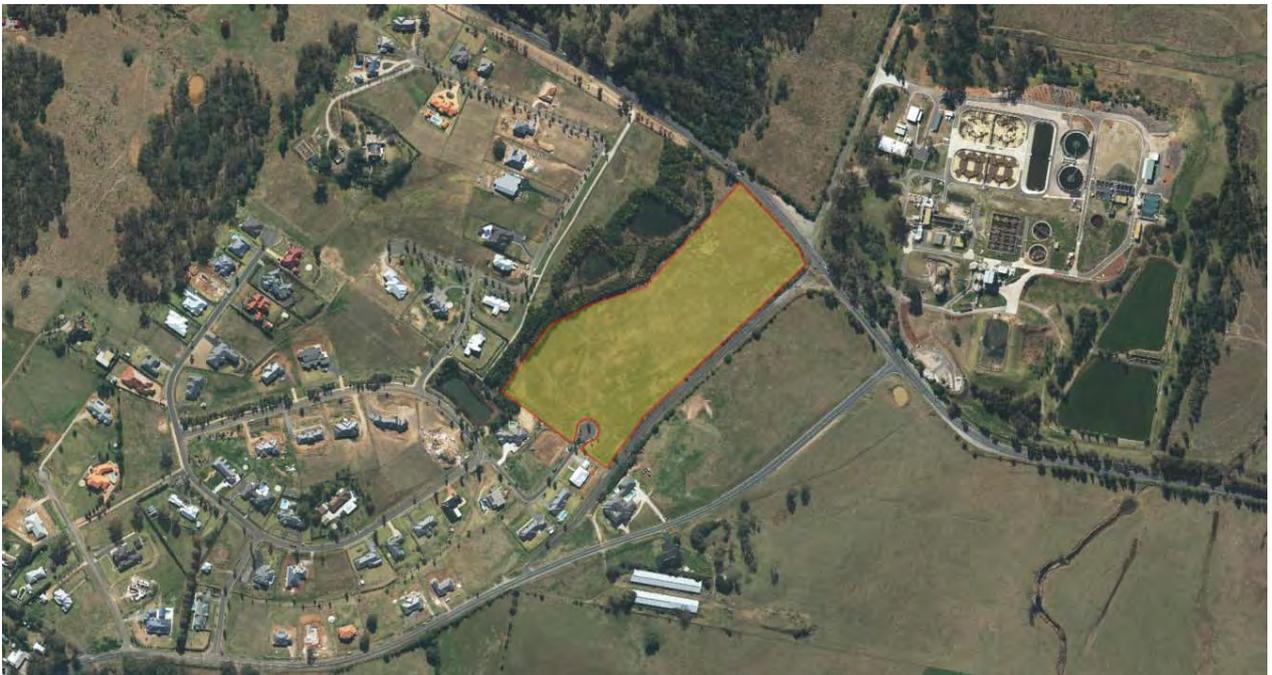
Figure 1 Location of property

The subject site (Lot 24 DP 1086823) is located approximately 2 kilometres west of Camden and is accessed off Harben Vale Circuit. The whole south eastern boundary adjoins The Old Oaks Road. The north eastern boundary adjoins Werombi Road. The Camden Sewerage Treatment Plant is located on the other side of Werombi Road directly north east of the site. The northern boundary adjoins a series of water storage dams.

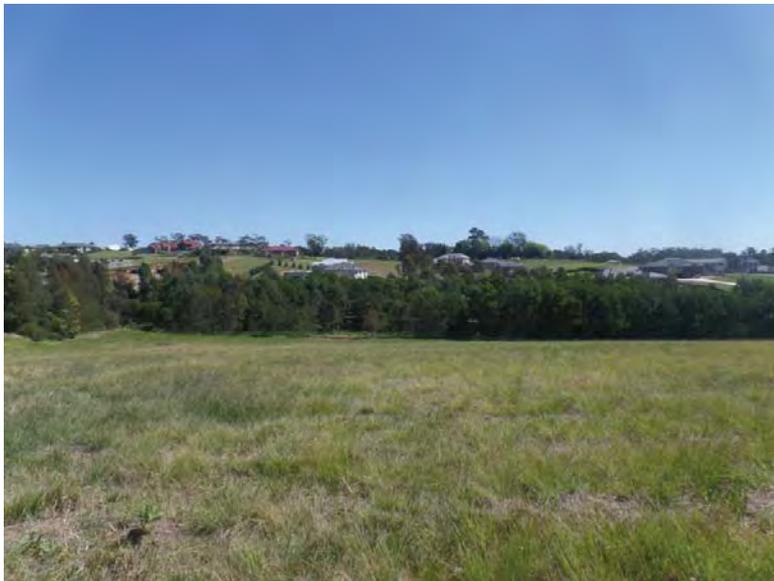
Photo 1 View of grassland and riparian corridor on north western elevation

Figure 6 shows the bushfire prone land within 100m of the area identified suitable for dwellings. The dominant vegetation formation is characterised as grassland. The only trees near to the site are located within the nature strip where the creek and water supply dams are, as shown in Photo 1. There is also a bike track within this riparian corridor. For bushfire assessment purposes, the trees in the riparian corridor are considered "Rainforest", as the total width measures approximately 40m and the PBP 2006 page 52, allows "*Riparian areas are those areas of vegetation which are no greater than 20m in width and are found on either bank of a river, creek or stream identified on a bush fire prone land map and treated the same as rainforest*". These trees are still juvenile as shown in Photo 2.

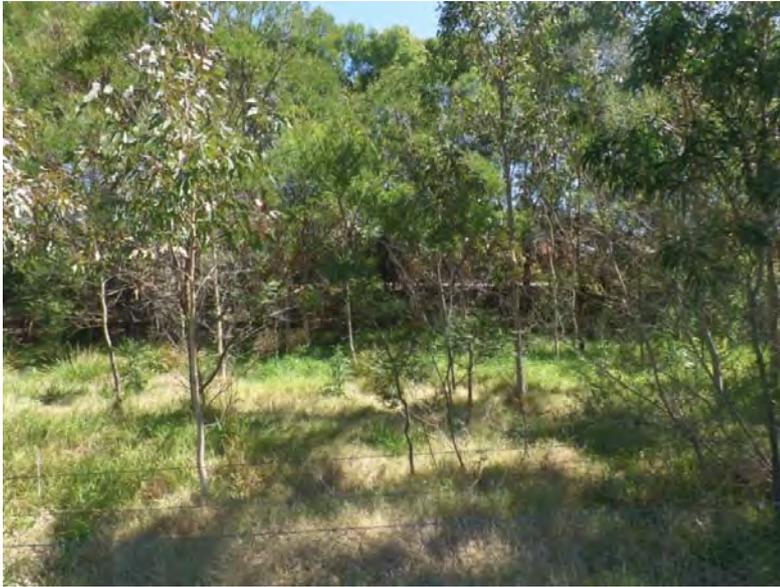
Photo 2 View of tree planting in riparian corridor and bike track

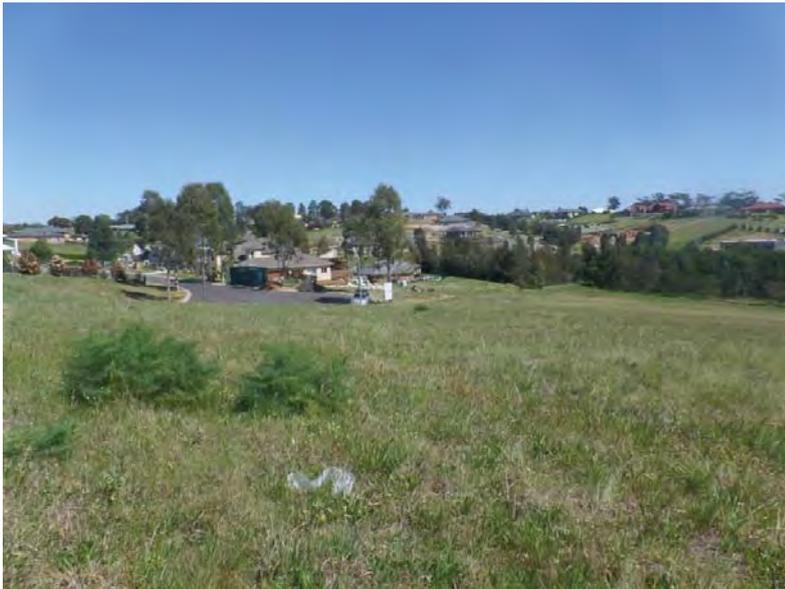
Photo 3 View looking west

The subject lot is located on an undulating side slope with a north westerly orientation. This assessment found that the slope influencing bushfire behavior on the north west falls into the PBP (2006) category of “downslope 5-10 degrees”. Photo 3 shows the downslope looking directly west from proposed indicative dwelling footprints. The east and south elevations falls into the PBP (2006) category of level/upslope. Photo 4 shows the upslope looking east from indicative dwelling footprints.

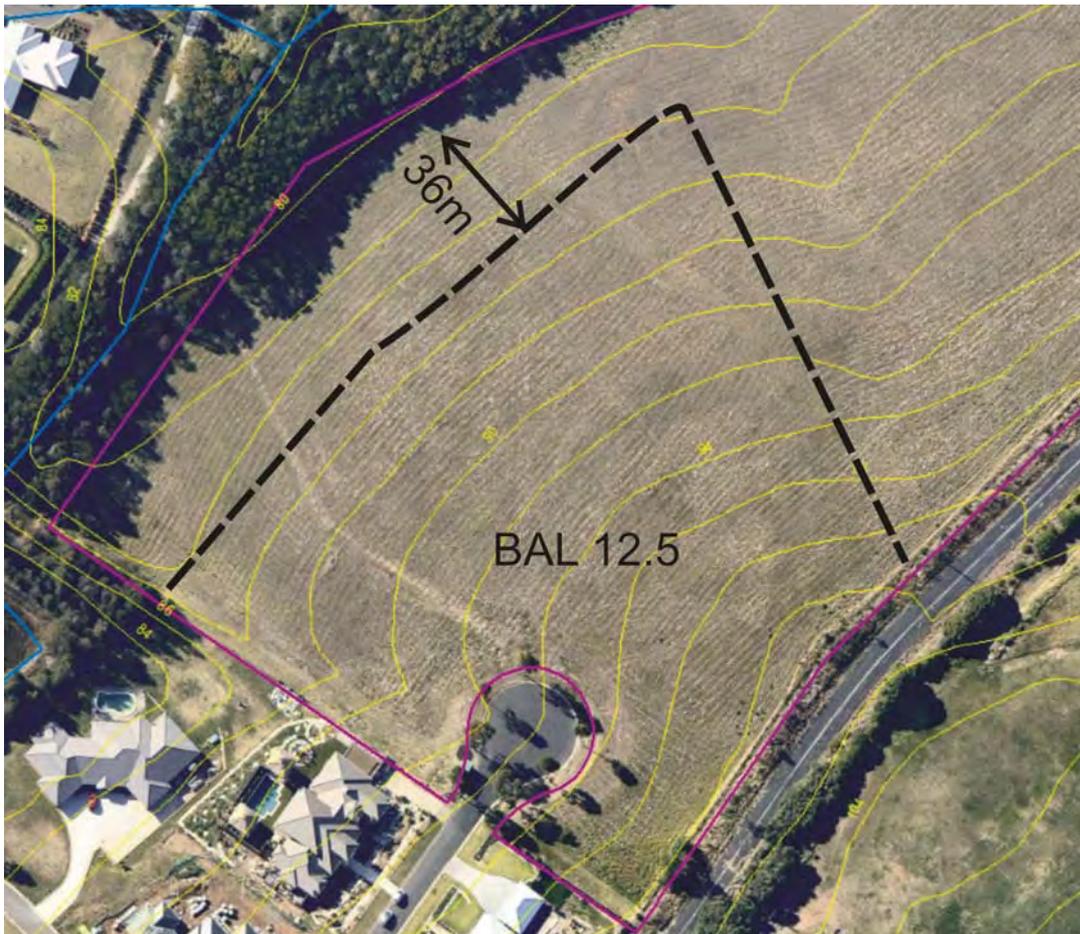
Figure 7 APZ Requirements of indicative dwelling footprints

Land where houses would meet BAL 12.5 APZ requirements

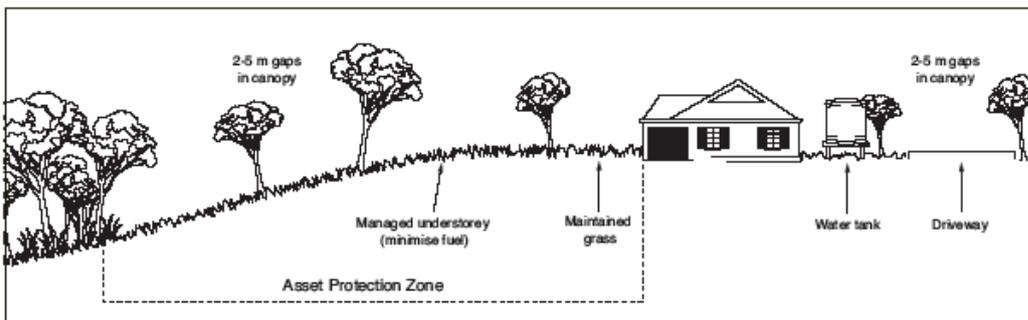
Figure A 2.1 Asset Protection Zone (setback) design

The inner component of an asset protection zone, consisting of an area maintained to minimal fuel loads and comprising a combination of perimeter road, fire trail, rear yard or reserve, so that fire path is not created between the hazard and the building. An IPA should provide a tree canopy of less than 15% and should be located greater than 2 metres from any part of the roofline of a dwelling. Garden beds of flammable shrubs are not to be located under trees and should be no closer than 10 metres from an exposed window or door. Trees should have lower limbs removed up to a height of 2 metres above the ground.

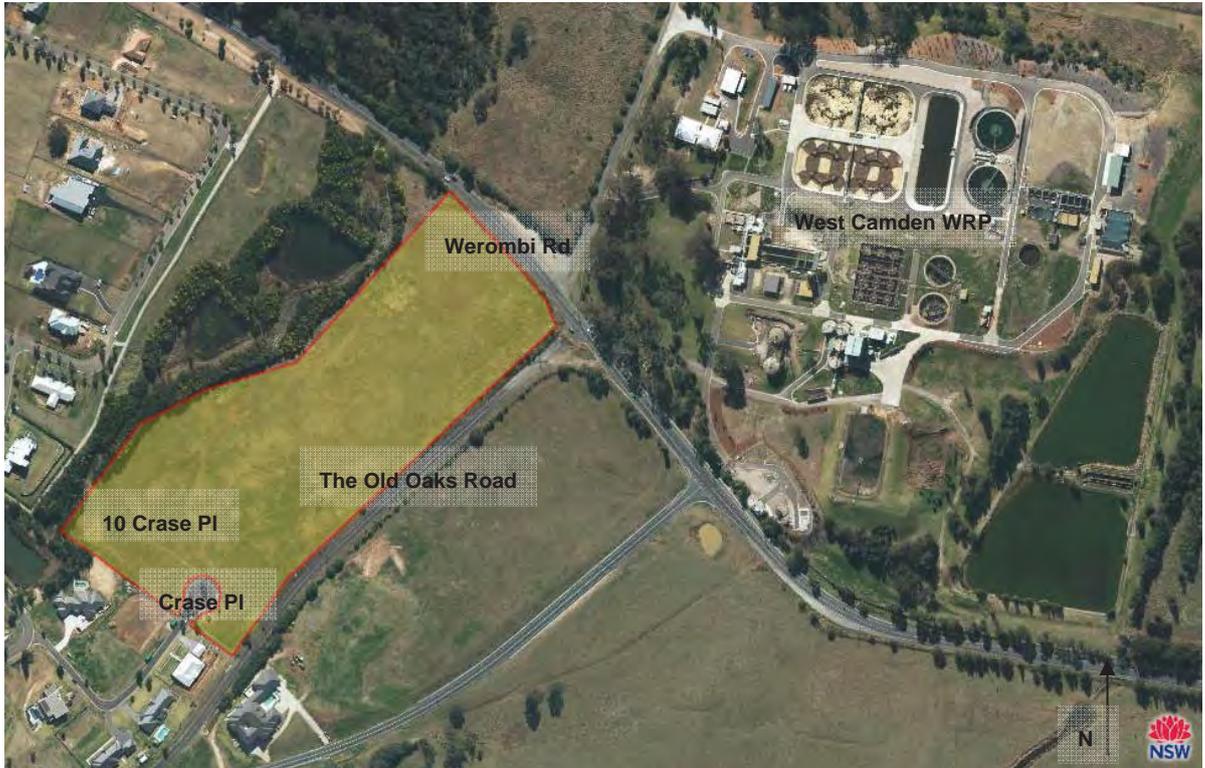
Figure 1: Extent of the property at 10 Crase Place, Grasmere

The subject property is located at the end of Crase Place, Grasmere in the Camden Local Government Area (LGA). The property is bound by Werombi Road to the north, The Old Oaks Road to the east, existing residential development to the south and an unnamed watercourse to the west. The West Camden WRP is located to the north-east of the site (refer to **Figure 1**).

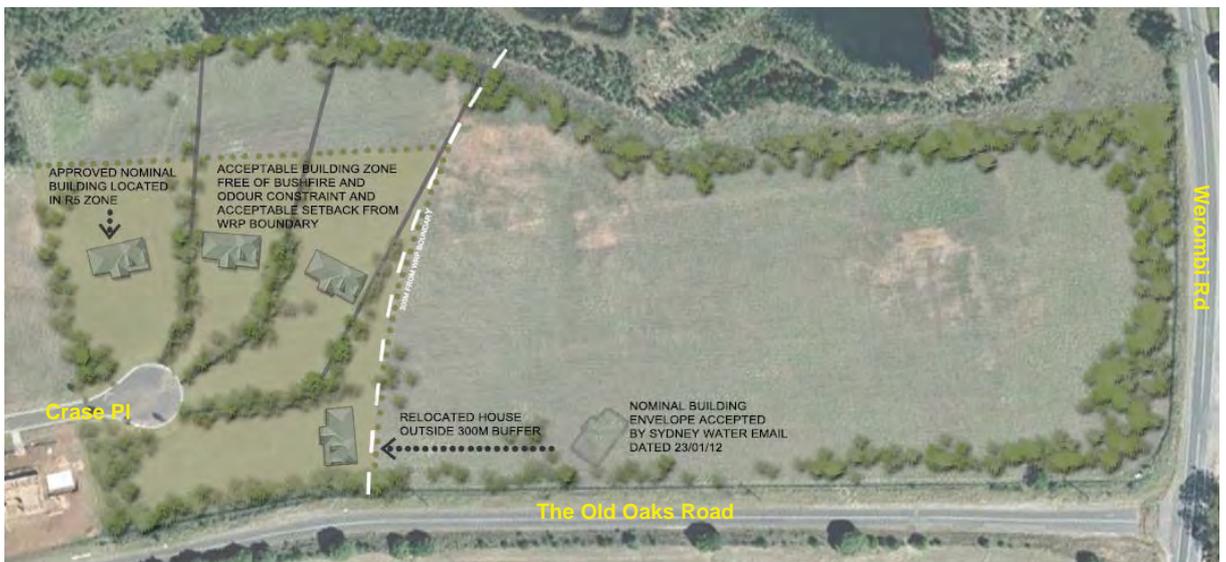
Figure 2: Indicative proposed development layout

Site Plus is currently preparing a rezoning application for the property to accommodate up to four low density residential dwellings outside the 300 metre odour control buffer for West Camden WRP. The indicative layout of these dwellings is shown below in **Figure 2**.

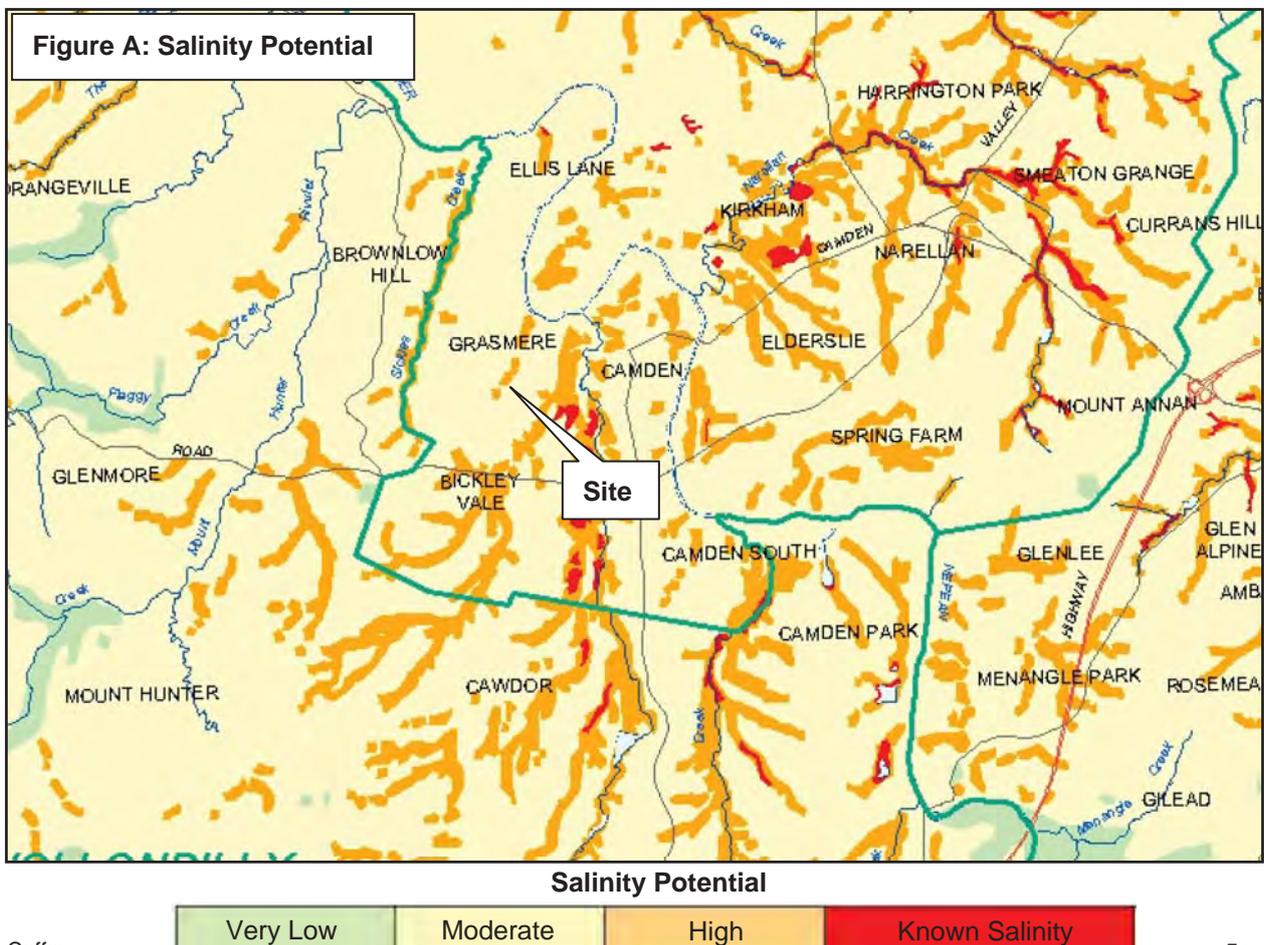
A high salinity potential was mapped in an area adjacent to the site's western boundary and appears to be associated with the three dams and connecting watercourses (Refer to Figure A). The map indicates these areas are predisposed to salinity based on soil, geology, groundwater and topography. This area is also located at the lower slopes of a local rise and forms part of a drainage system where water accumulation is high.

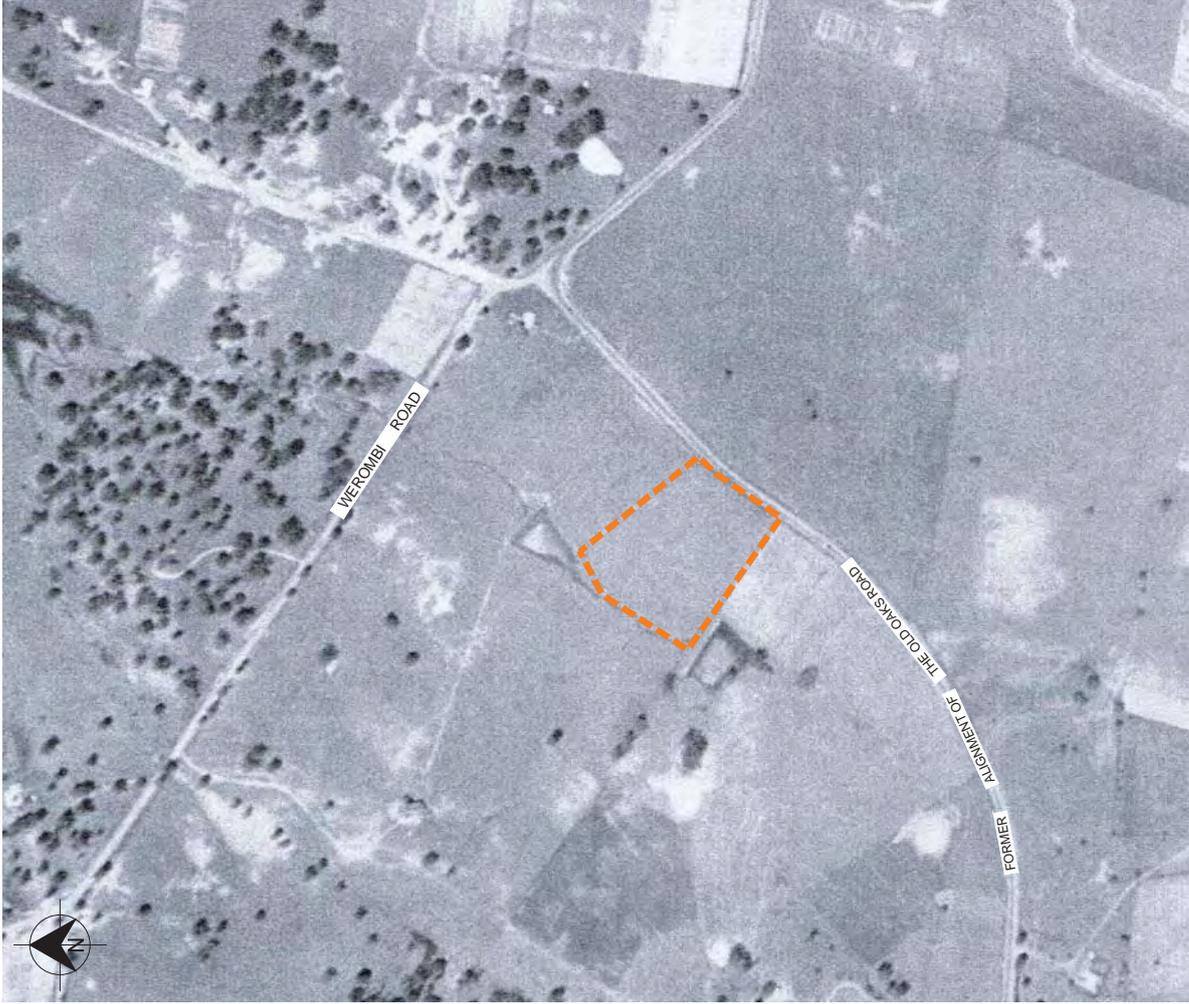
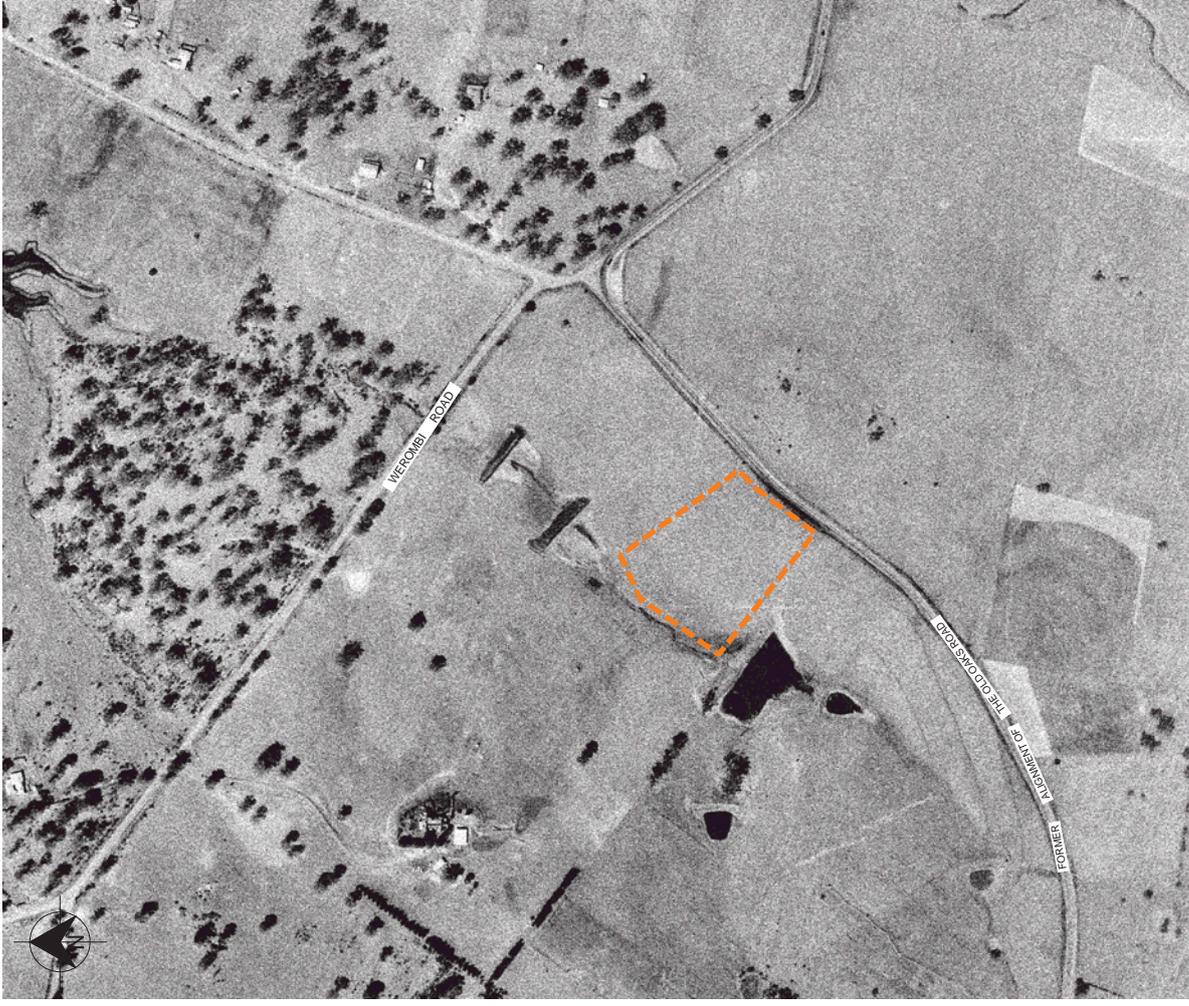
client:	SITE PLUS
project:	PHASE 1 CONTAMINATION ASSESSMENT & SALINITY ASSESSMENT PART LOT 24 DP-1086623, 10 CRASE PLACE, GRASMERE, NSW
title:	AERIAL PHOTOGRAPHS - 1954 AND 1965
project no:	ENAUWOLL04150AA-R01
figure no:	C-1

AERIAL PHOTOGRAPH 1954

AERIAL PHOTOGRAPH 1965

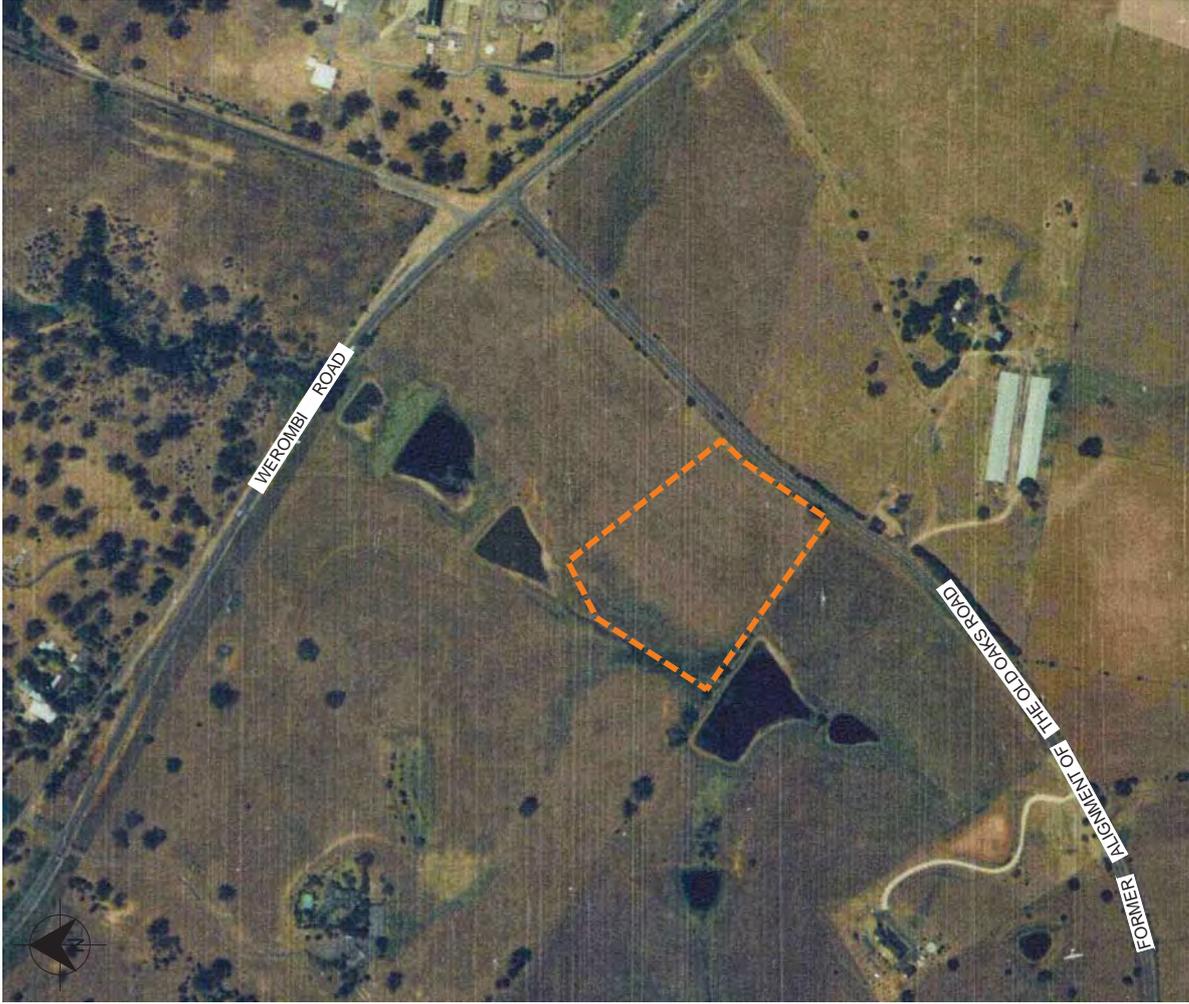
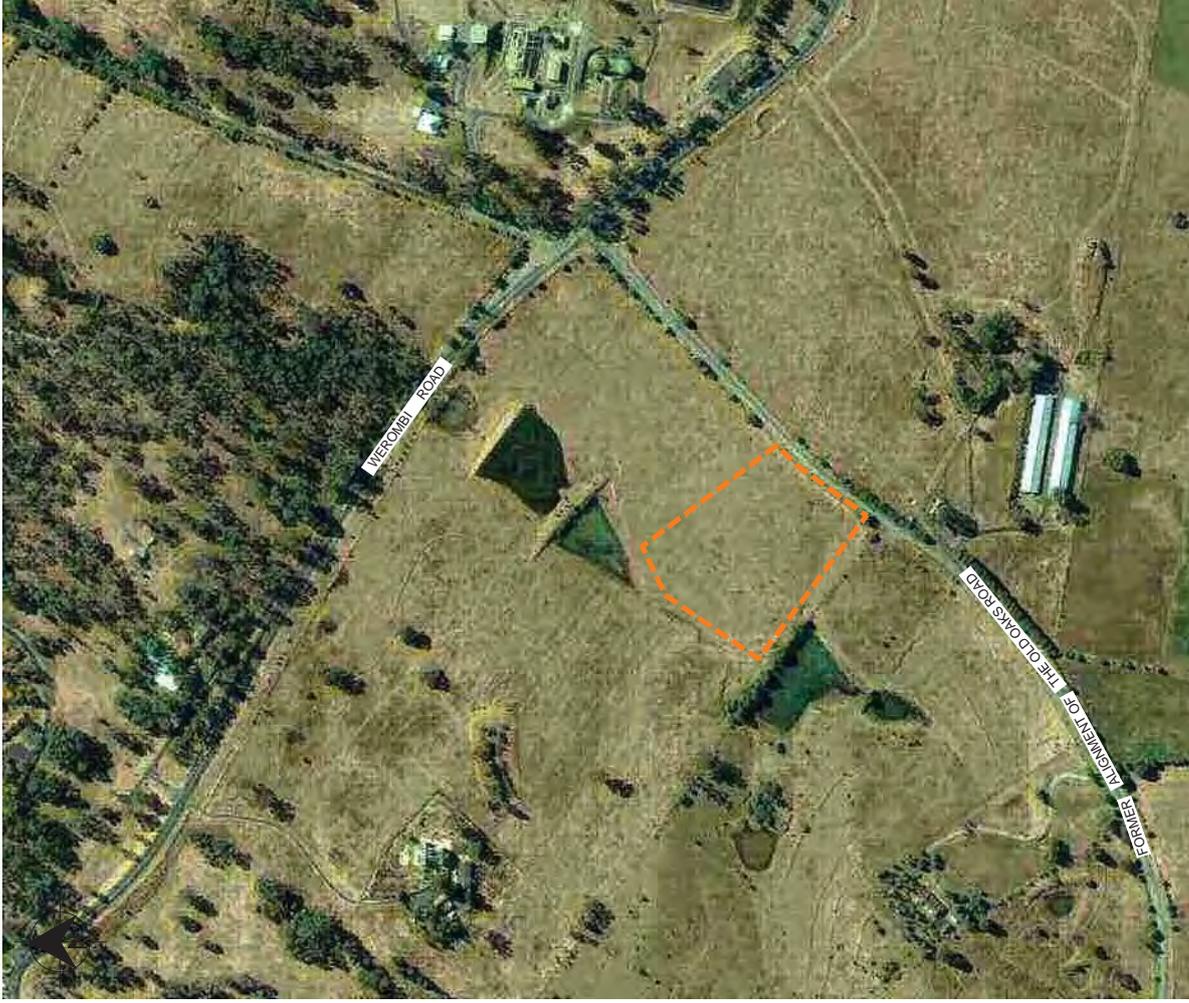
client: SITE PLUS
 project: PHASE 1 CONTAMINATION ASSESSMENT & SALINITY ASSESSMENT
 PART LOT 24 DP-1086823, 10 CRASE PLACE, GRASMERE, NSW
 title: AERIAL PHOTOGRAPHS - 1994 AND 2002
 project no: ENAUWOLL04150AA-R01 figure no: C-3

AERIAL PHOTOGRAPH 1994

AERIAL PHOTOGRAPH 2002
 AERIAL IMAGE SOURCE: GOOGLE EARTH PRO 6.0.1
 AERIAL IMAGE © SINCLAIR KNIGHT MERZ 2013

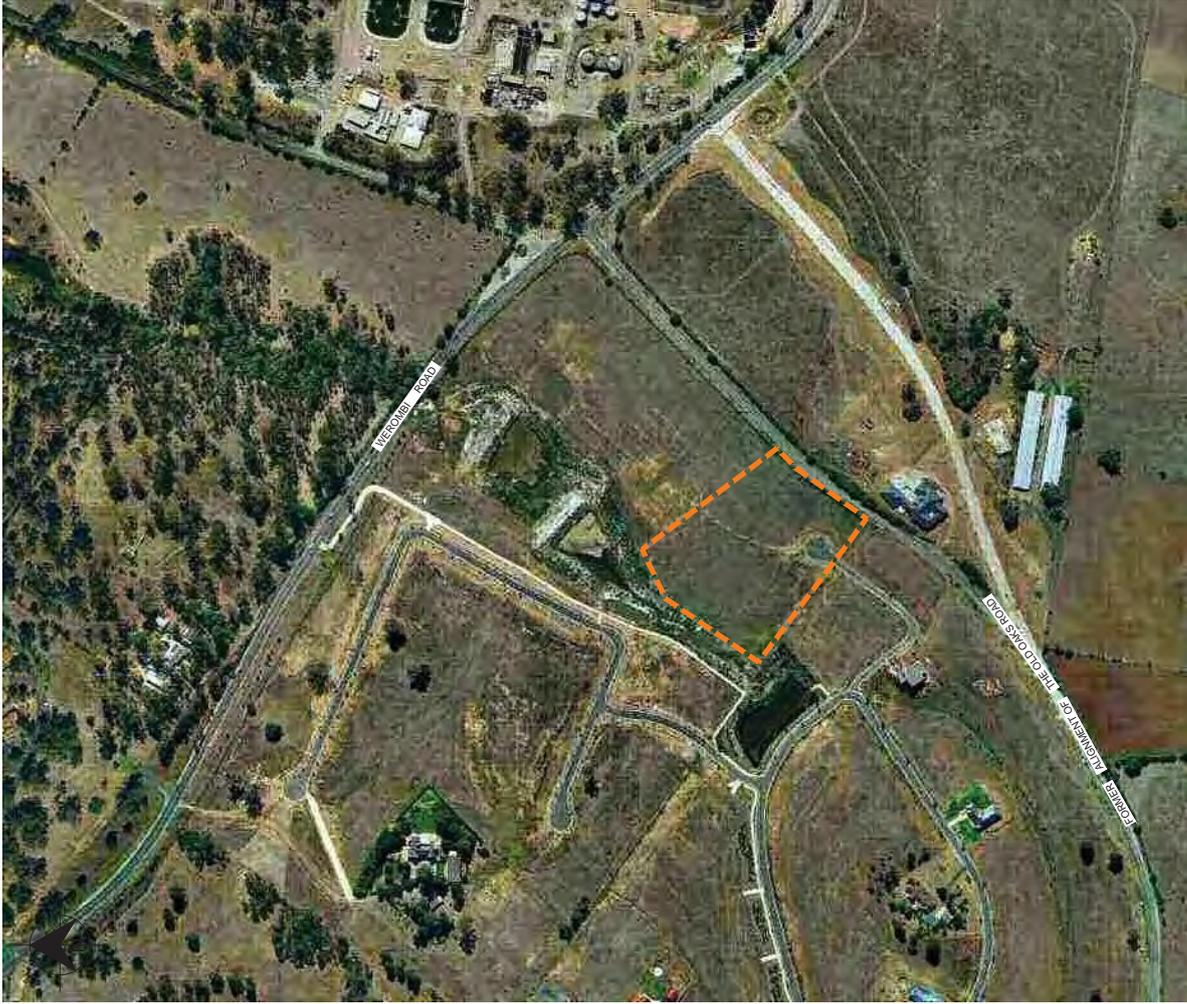
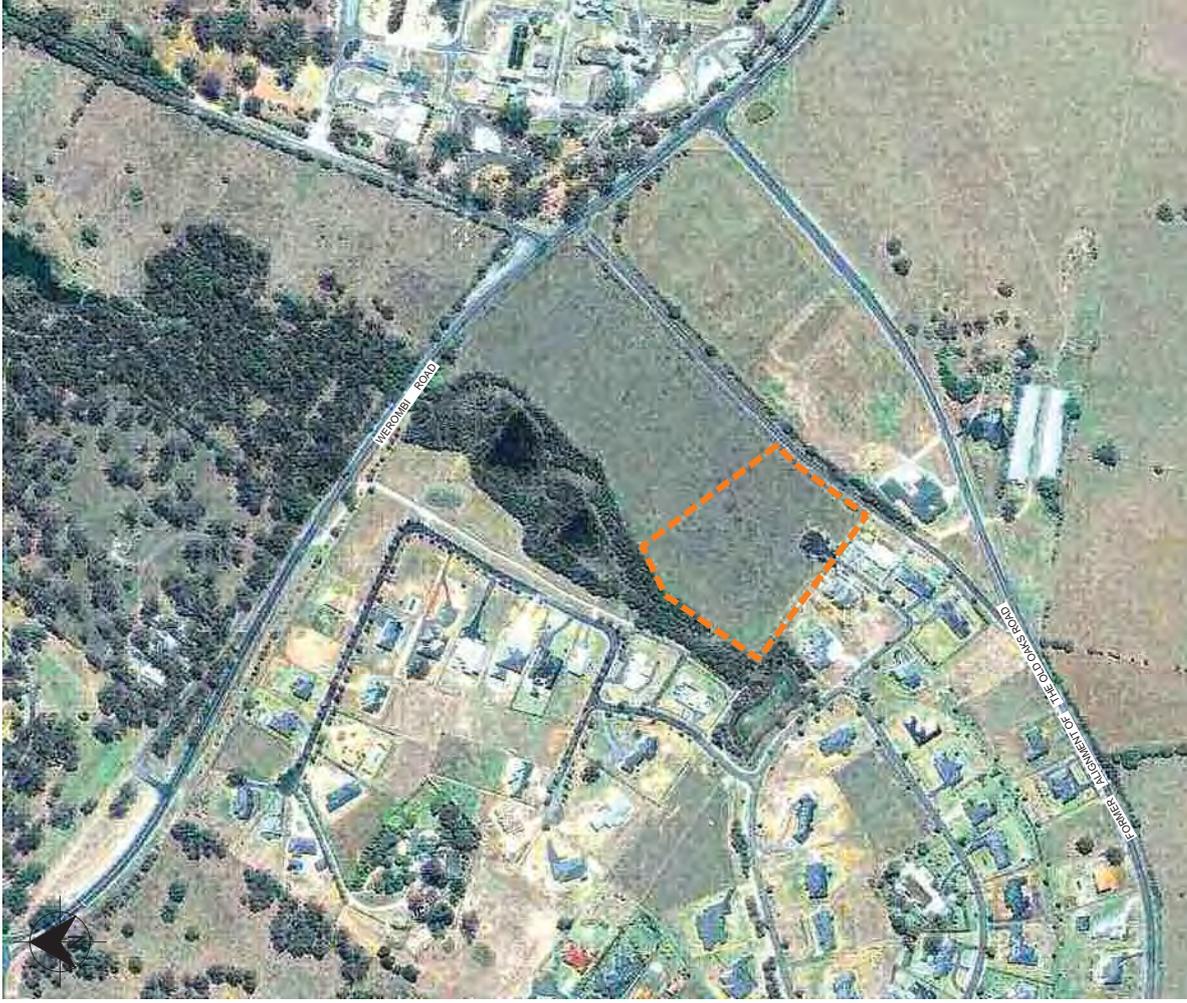
title: AERIAL PHOTOGRAPH - 2007 AND 2012

AERIAL PHOTOGRAPH 2007

AERIAL PHOTOGRAPH 2012

<p>2/11/2012 (Colour)</p> <p>Google Earth Image</p>	<p>On Site: Except for the cul-de-sac, the site continues to remain undeveloped. The remaining features observed in the previous aerial photograph have faded. Sporadic growth of trees and/or shrubs is evident throughout and north of the site.</p> <p>Off Site: The exposed ground and access track extending north of the cul-de-sac are no longer evident. Extensive growth of tree and/or shrubs is evident in along the watercourse and areas surrounding the dams located west and north of the site. Residential developments continue in areas surrounding the site. The former alignment of The Old Oaks Road has been blocked with a fill mound at the intersection with Werombi Road. The realignment of The Old Oaks Road appears complete.</p>

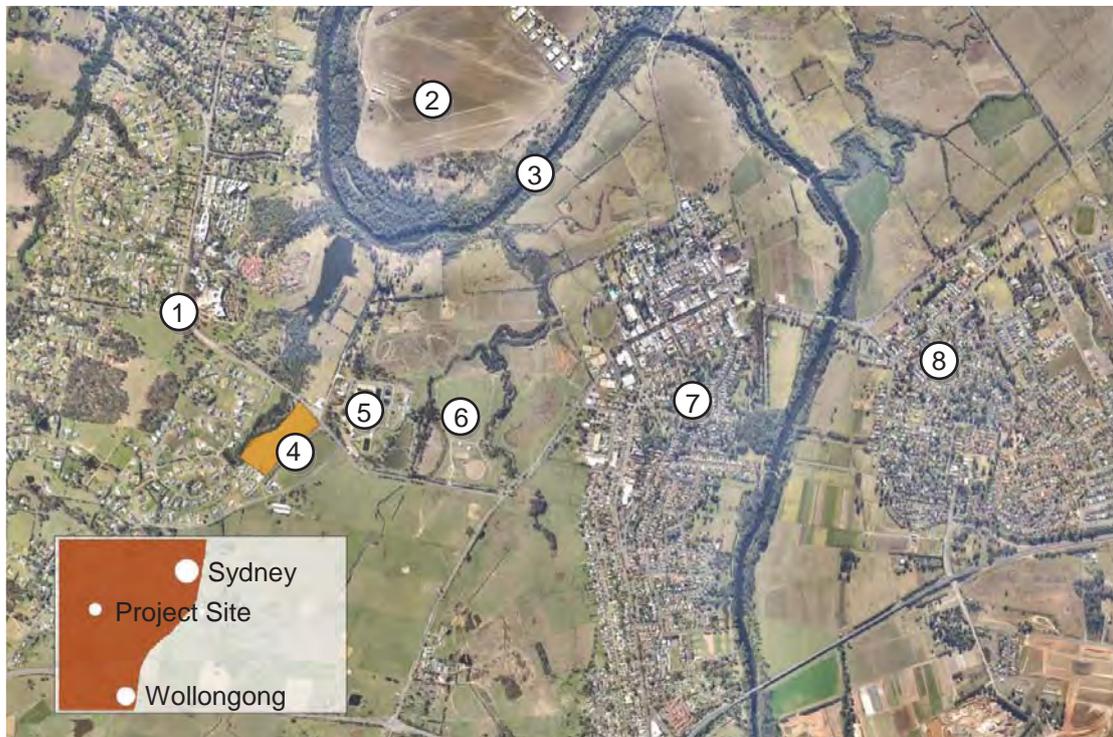
Figure 1.2 Regional Context Overview

1. Grasmere
2. Camden Airport
3. Nepean River
4. Subject Site
5. West Camden Water Recycling Plant
6. Camden Bicentennial Equestrian Park
7. Camden
8. Elderslie

The West Camden WRP is located to the north east of the subject property. Figure 1.2 shows the proposed site and its context.

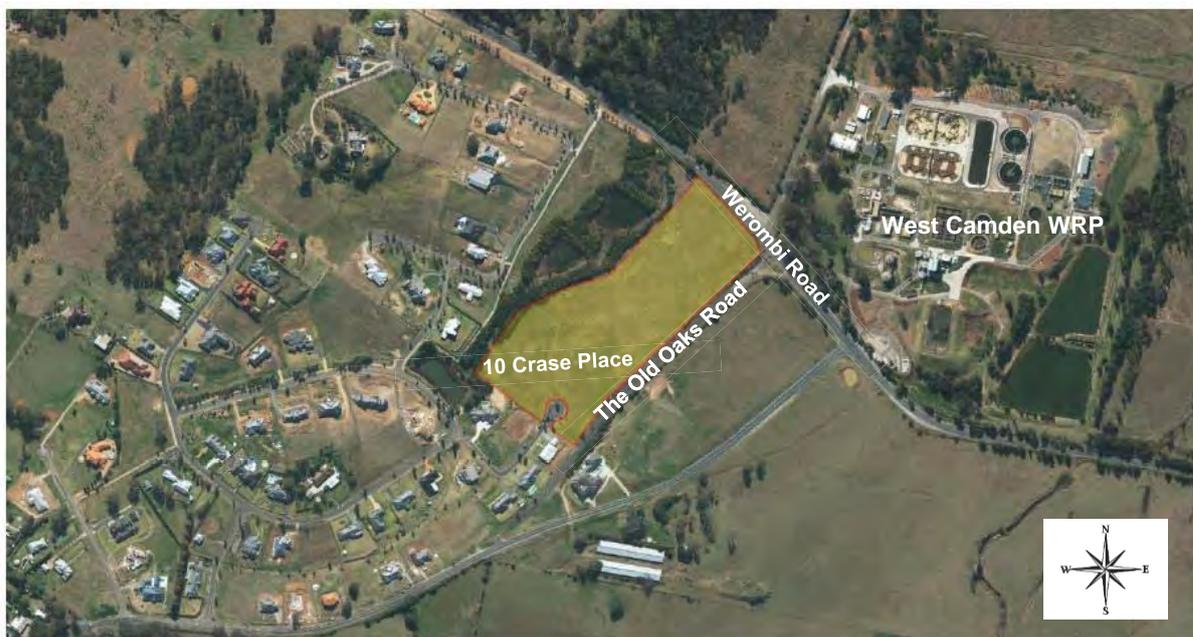
Figure 1 – Location of proposed residential premises [Source: Google Earth, March 2015]

A subdivision and rezoning is proposed at Part Lot 24 DP 1086823, 10 Crase Place, Grasmere, NSW ("the site") having an area of approximately 5.6ha as shown outlined in the middle of Figure 1. The site is located at the end of Crase Place, Grasmere in the Camden Local Government Area (LGA). The property is bound by Werombi Road to the north, The Old Oaks Road to the east, existing residential development to the south and an unnamed watercourse to the west. The West Camden Water Recycling Plant (WRP) is located to the north-east of the site.

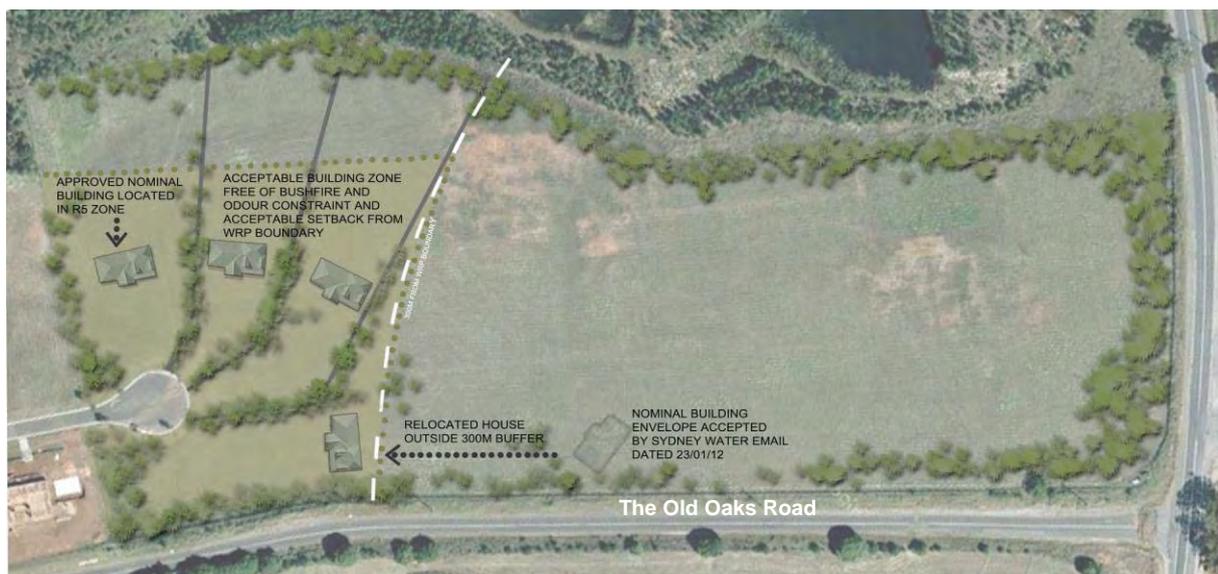
Figure 3 – Location of proposed subdivision plan [Source: Sydney Water 2011b]

Development of the site is currently limited by an odour buffer boundary from West Camden WRP which is owned and operated by Sydney Water Corporation (Sydney Water). Figure 3 shows the odour buffer boundary derived from an iterative process conducted by Sydney Water, represented by a white dotted line. Initially plans had been prepared by Site Plus Pty Ltd (Site Plus) for Sydney Water following the upgrade of the WRP which showed the 'odour boundary' could be adjusted. Sydney Water advised they had no issue with the development of the site if development occurred beyond 300m of the boundary of the WRP. Sydney Water's response essentially amended the odour buffer from 400m to 300m. This enables the indicative development envisaged in Figure 3 from which all investigations have occurred.

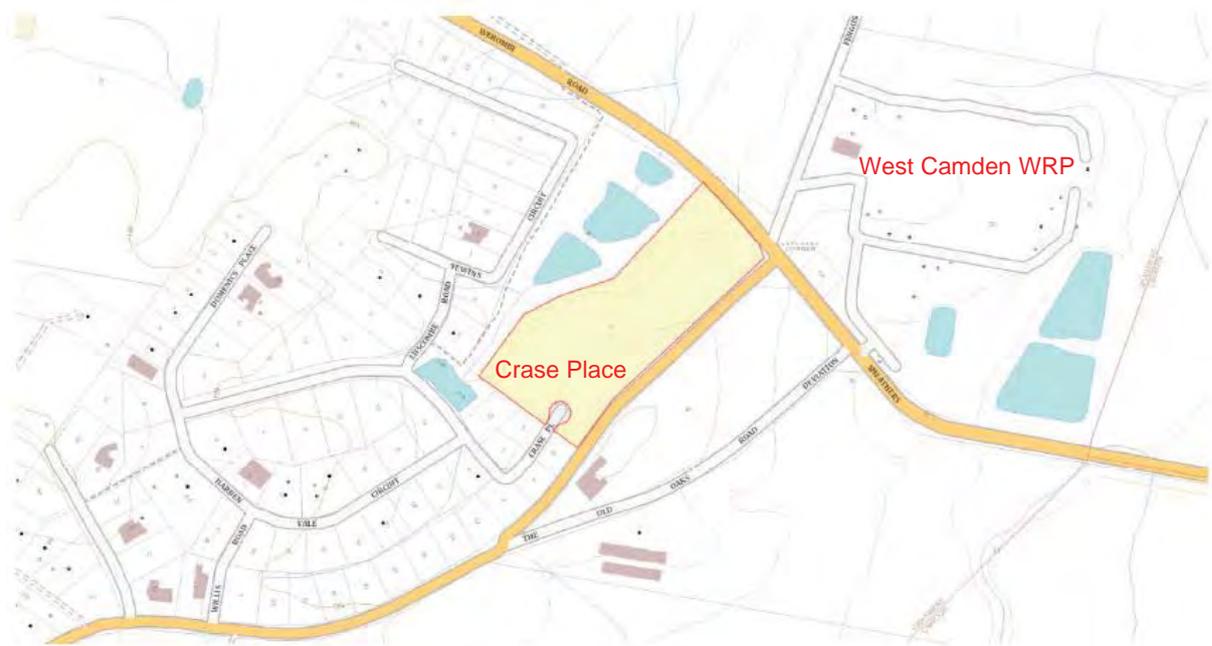
Figure 4 – Location of Proposed Residential Development [Source: Camden Council 2014]

The location of the proposed residential development is Lot 24 DP 1086823 at 10 Crase Place, Grasmere, NSW as shown by the red outline in Figure 4. The objective of the Planning Proposal is to rezone the south-western lots to R5 – Large Lot Residential.

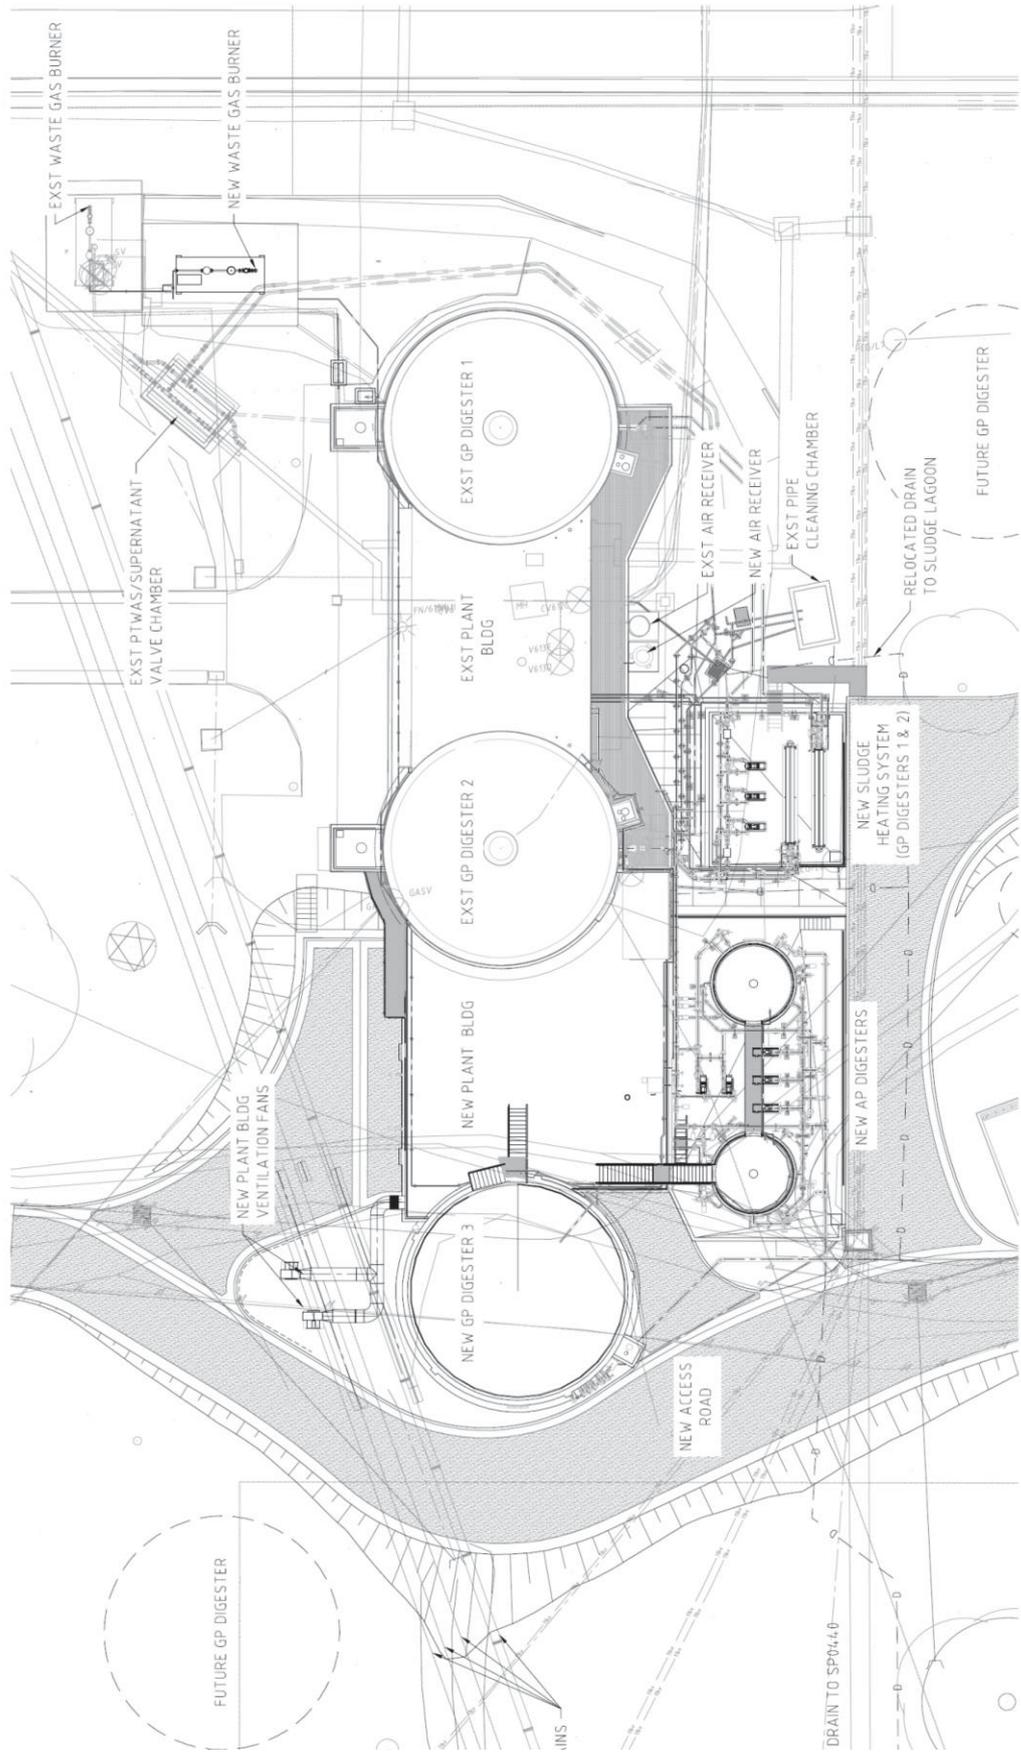
Stack Modelling Parameters	Discharge Stack
Velocity at exit (m/s)	15
Flow rate at exit (L/s)	2.2
Height (m)	4
Area at exit (m ²)	0.0001
Internal diameter at exit (m)	0.014
Temperature at exit (°C)	17

Figure 5 – Location of final ventilation exhaust discharge stack [Source: GHD – West Camden Biosolids Upgrade and Amplification – AWA Seminar 2013]
