Camden Council Business Paper

**ORD08 Proposed Amendments to Camden LEP
2010 (No 32) and Camden DCP 2011 -
Lot 24 DP 1086823 Crase Place
Grasmere
PLANNING PROPOSAL APPENDICES**

BUSHFIRE HAZARD ASSESSMENT FOR PROPOSED
REZONING OF 10 CRASE PLACE, GRASMERE

**Phase 1 Contamination Assessment and Salinity Assessment
Part Lot 24 DP1086823, 10 Crase Place,
Grasmere, NSW**

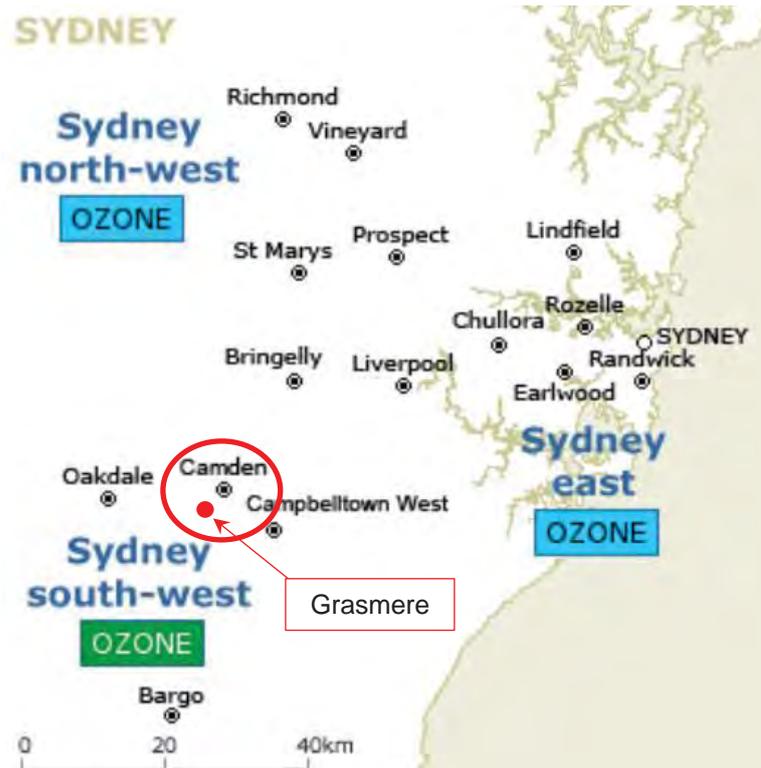
Figure 6 – Air quality monitoring station network [Office of Heritage and Environment website, 2015a]

The New South Wales Environment Protection Authority (NSW EPA) operates a number of air quality monitoring stations around the greater metropolitan Sydney area. There is no monitoring station in Grasmere itself. The nearest monitoring station is located in Camden, approximately 2.7 km north-east from the site. The location of Camden monitoring station is shown in the map below (see Figure 6).

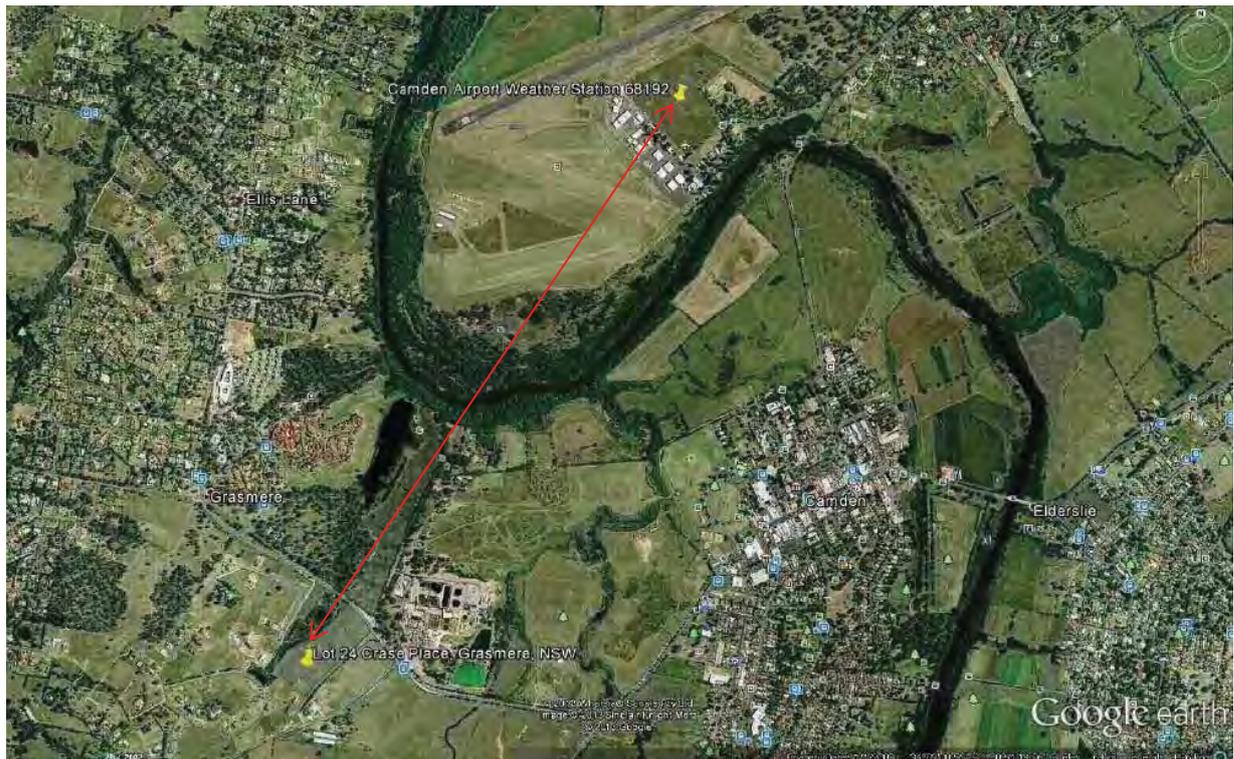
Figure 7 – Camden Airport Weather Station AWS Relative to the Site [Source: Google Earth, March 2015]

The Bureau of Meteorology (BoM) operate a weather monitoring station at Camden Airport AWS (Station No. 68192), which is located approximately 2.7 km north-east of the site (see Figure 7). The average climate and rainfall statistics since 1943 are presented in Table 3. No information was available on evaporation.

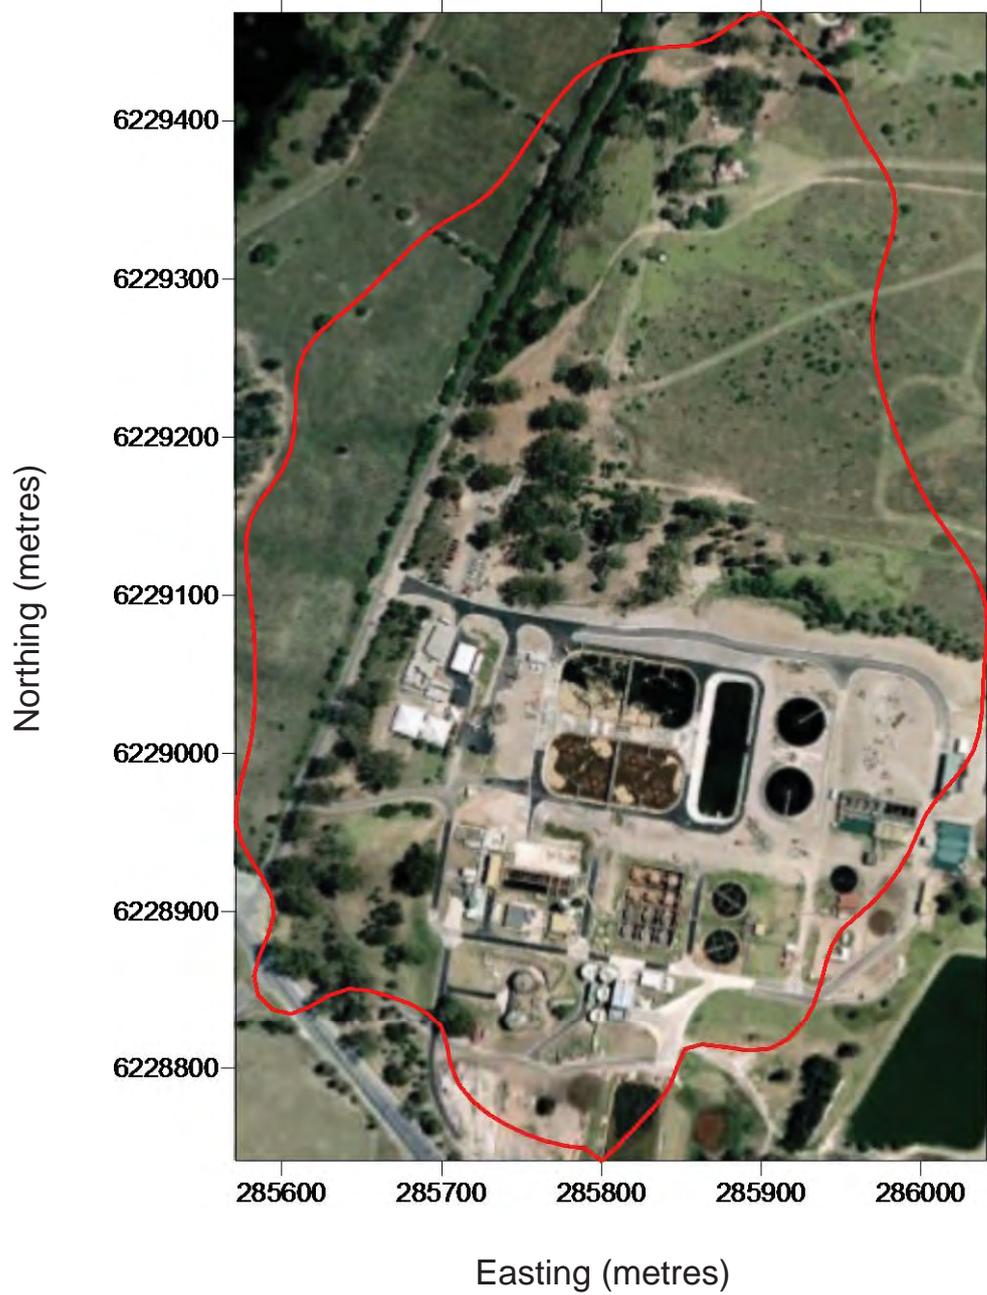
Figure 8 – Sydney Water’s West Camden WRP 2 odour unit contour line modelled using Ausplume 6.0 - including contribution by the new digester

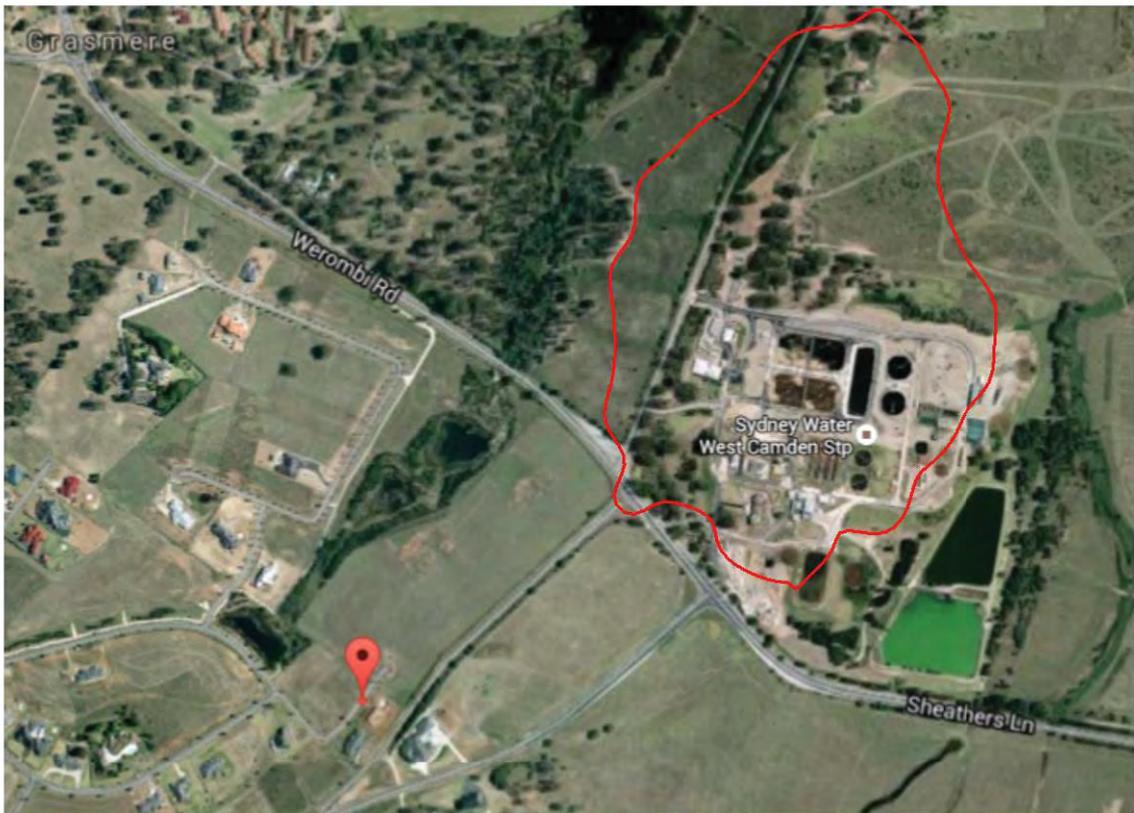
Figure 9 – Sydney Water’s West Camden WRP odour impact on the site as modelled using Ausplume 6.0 – in relation to the proposed development site

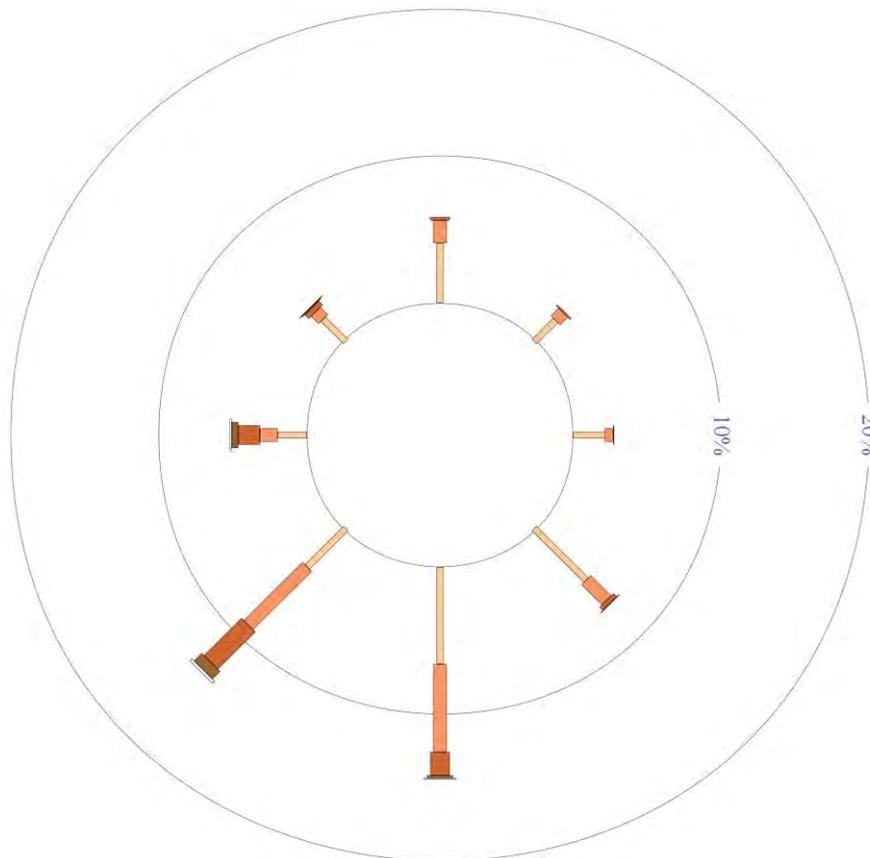
Figure 10 – Rose of Wind direction versus Wind speed in km/h at 9 am (01 Jan 1943 to 30 Sep 2010) Camden Airport AWS [source: Bureau of Meteorology, 2014]

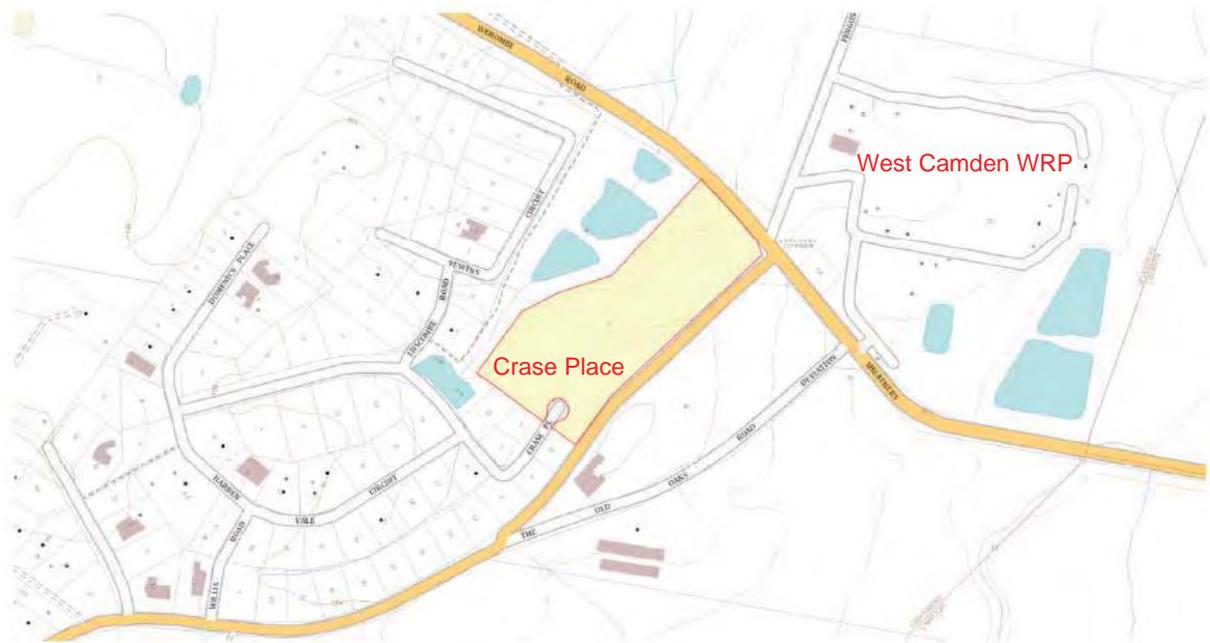
Figure 4 – Location of Proposed Residential Development [Source: Camden Council 2014]

The location of the proposed residential development is Lot 24 DP 1086823 at 10 Crase Place, Grasmere, NSW as shown by the red outline in Figure 4. The objective of the Planning Proposal is to rezone the south-western lots to R5 – Large Lot Residential.

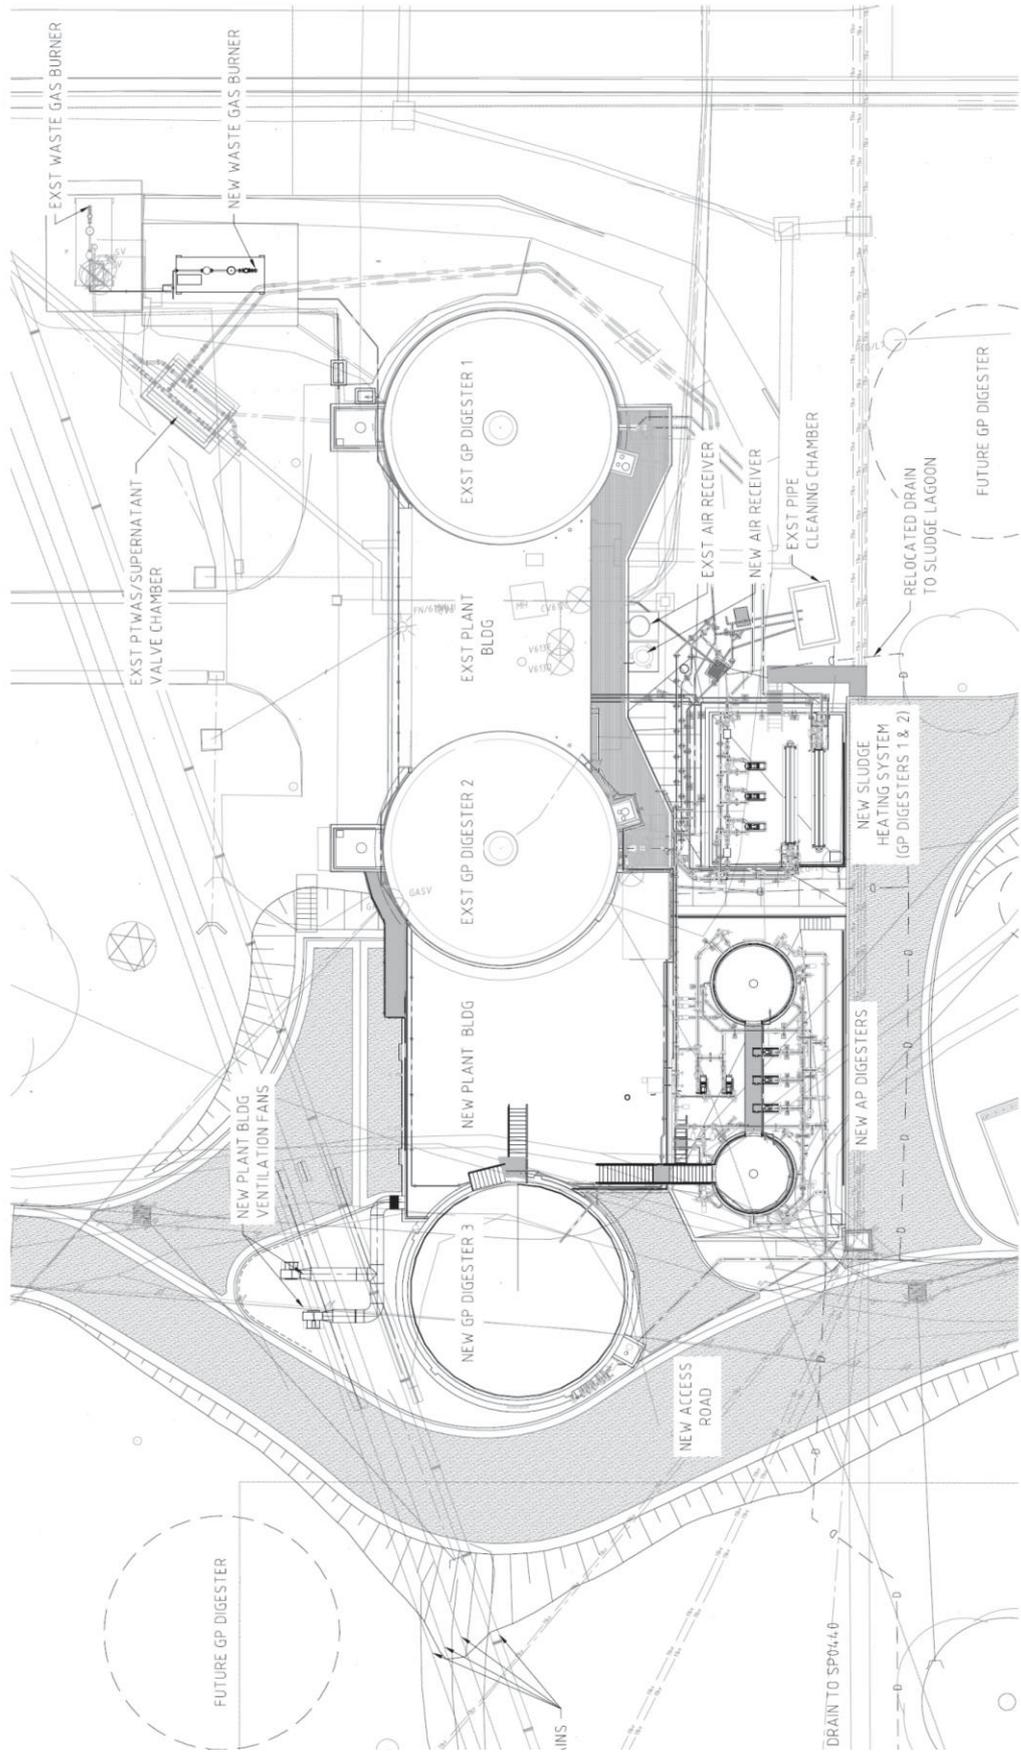
Stack Modelling Parameters	Discharge Stack
Velocity at exit (m/s)	15
Flow rate at exit (L/s)	2.2
Height (m)	4
Area at exit (m ²)	0.0001
Internal diameter at exit (m)	0.014
Temperature at exit (°C)	17

Figure 5 – Location of final ventilation exhaust discharge stack [Source: GHD – West Camden Biosolids Upgrade and Amplification – AWA Seminar 2013]

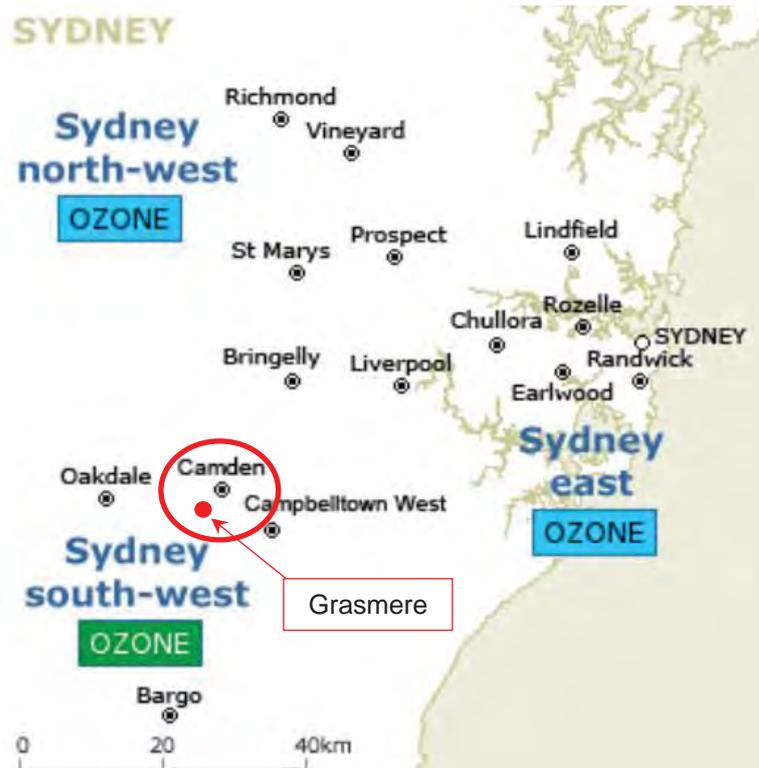
Figure 6 – Air quality monitoring station network [Office of Heritage and Environment website, 2015a]

The New South Wales Environment Protection Authority (NSW EPA) operates a number of air quality monitoring stations around the greater metropolitan Sydney area. There is no monitoring station in Grasmere itself. The nearest monitoring station is located in Camden, approximately 2.7 km north-east from the site. The location of Camden monitoring station is shown in the map below (see Figure 6).

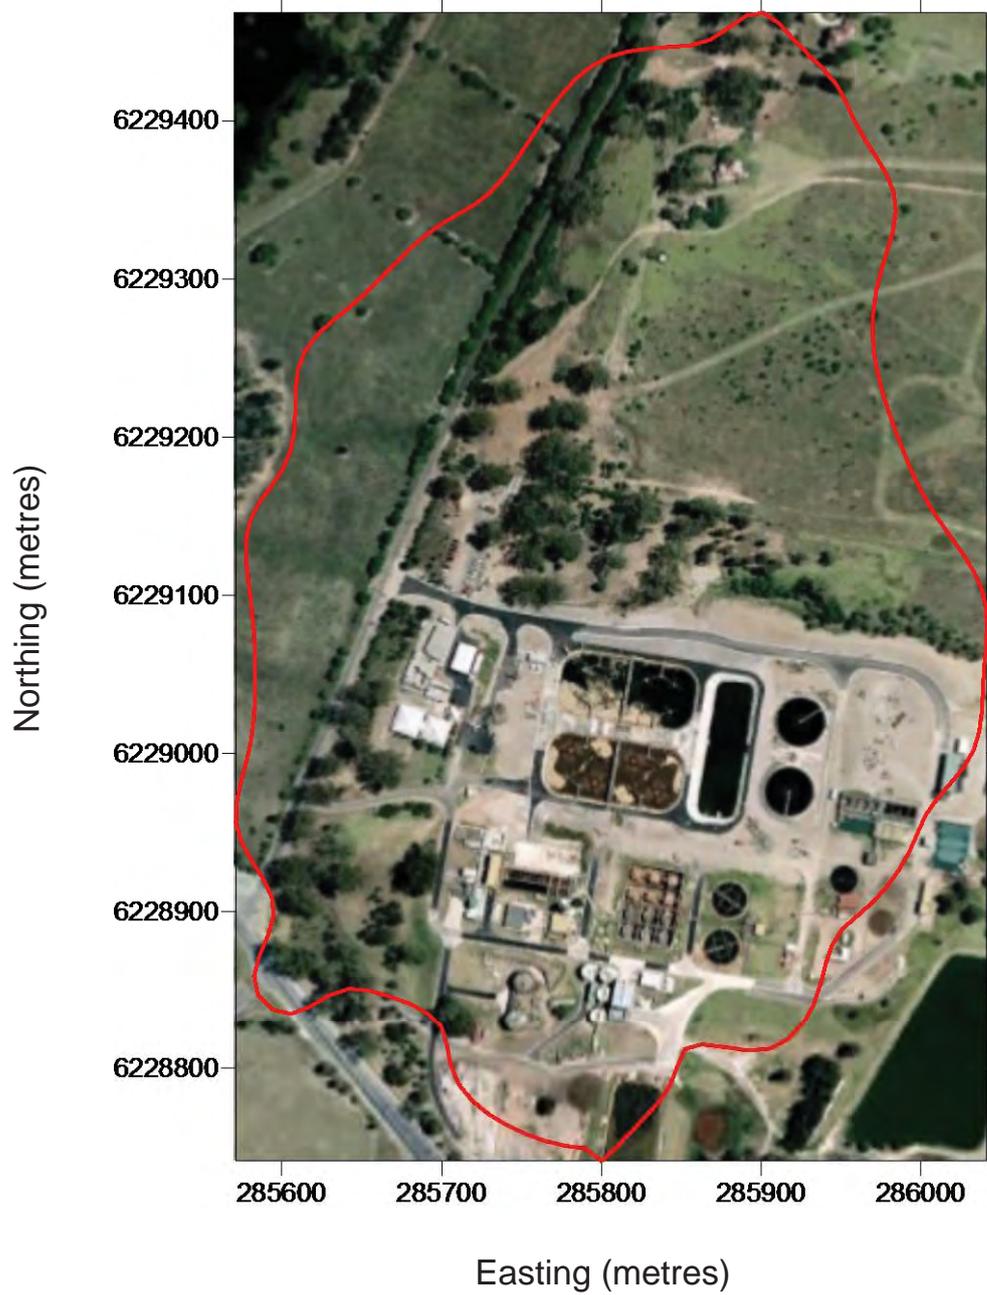
Figure 8 – Sydney Water’s West Camden WRP 2 odour unit contour line modelled using Ausplume 6.0 - including contribution by the new digester

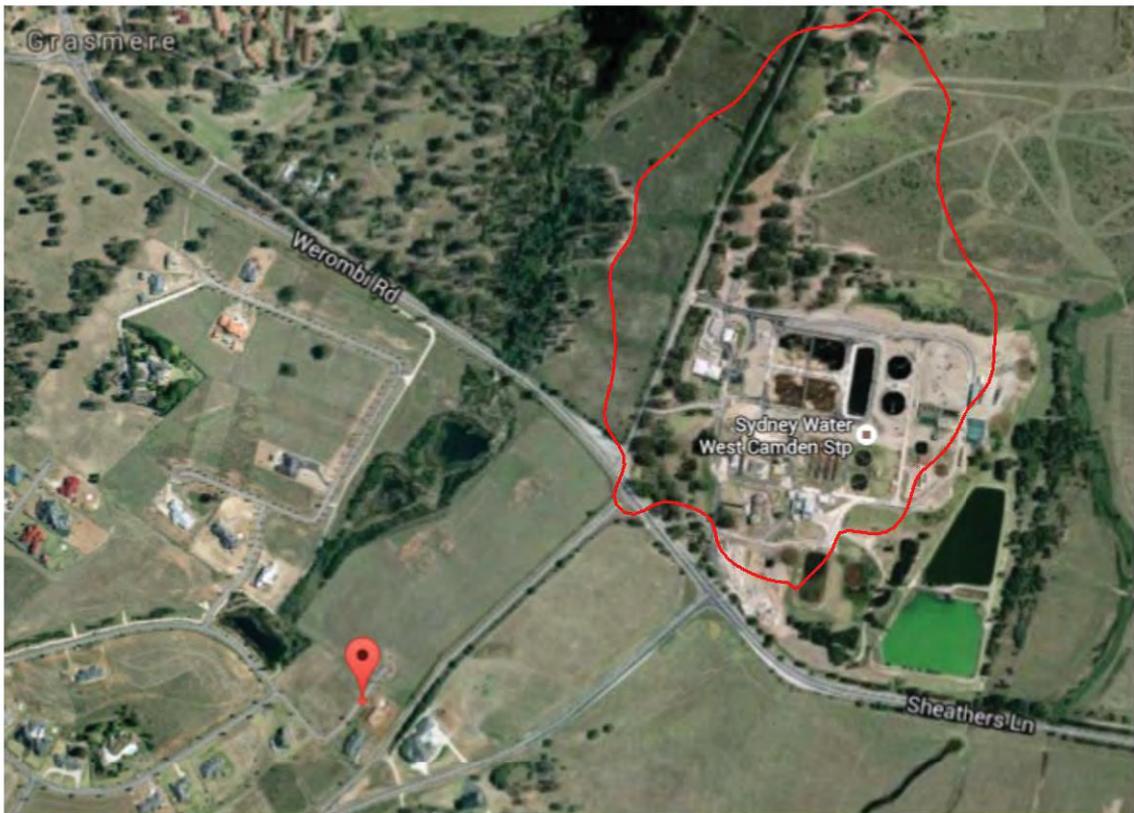
Figure 9 – Sydney Water’s West Camden WRP odour impact on the site as modelled using Ausplume 6.0 – in relation to the proposed development site

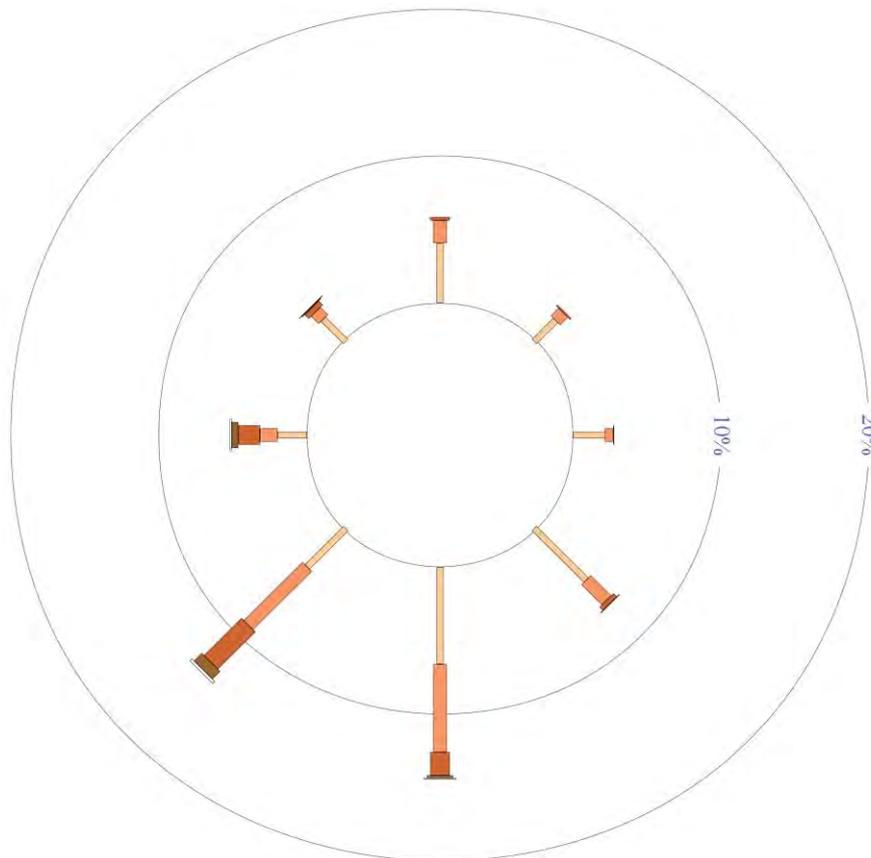
Figure 10 – Rose of Wind direction versus Wind speed in km/h at 9 am (01 Jan 1943 to 30 Sep 2010) Camden Airport AWS [source: Bureau of Meteorology, 2014]

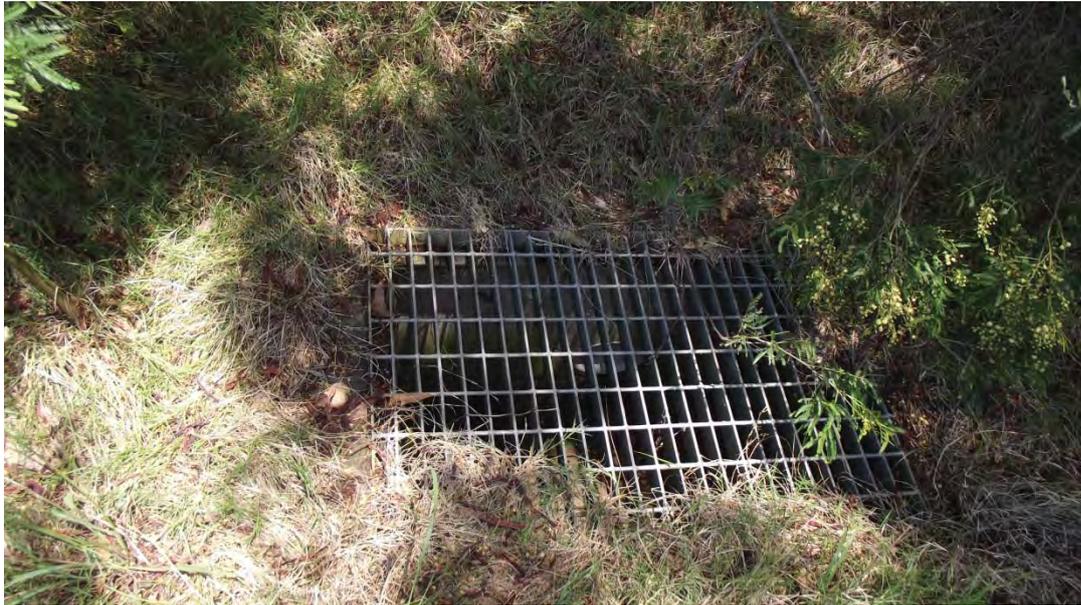
GRADED PIT AT THE END

Assuming 500 sqm impervious area per lot, the net increase in stormwater flow from the total site is only 2 to 3 percent (2000 sqm :56,500 sqm total) which is negligible but if required it can be addressed at DA stage.

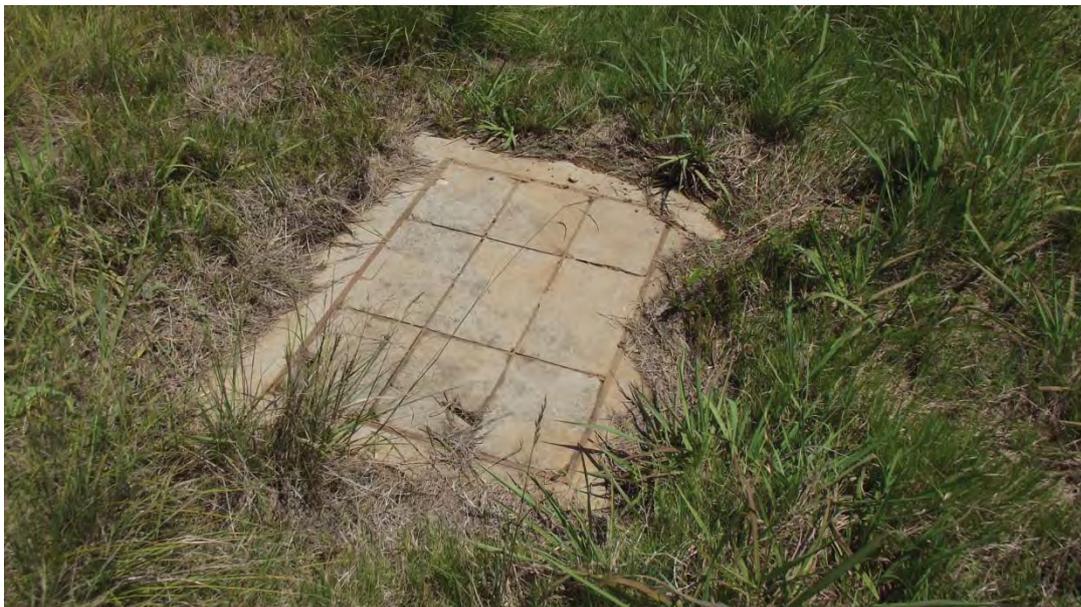
SEALED PIT 2 OFF

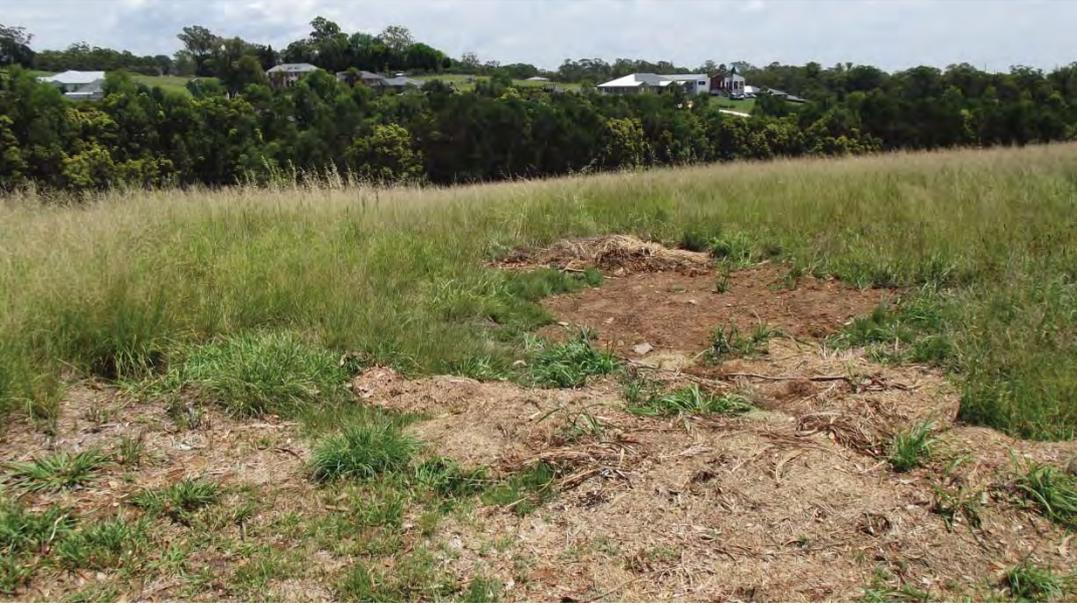
FLOW PATH ALONG

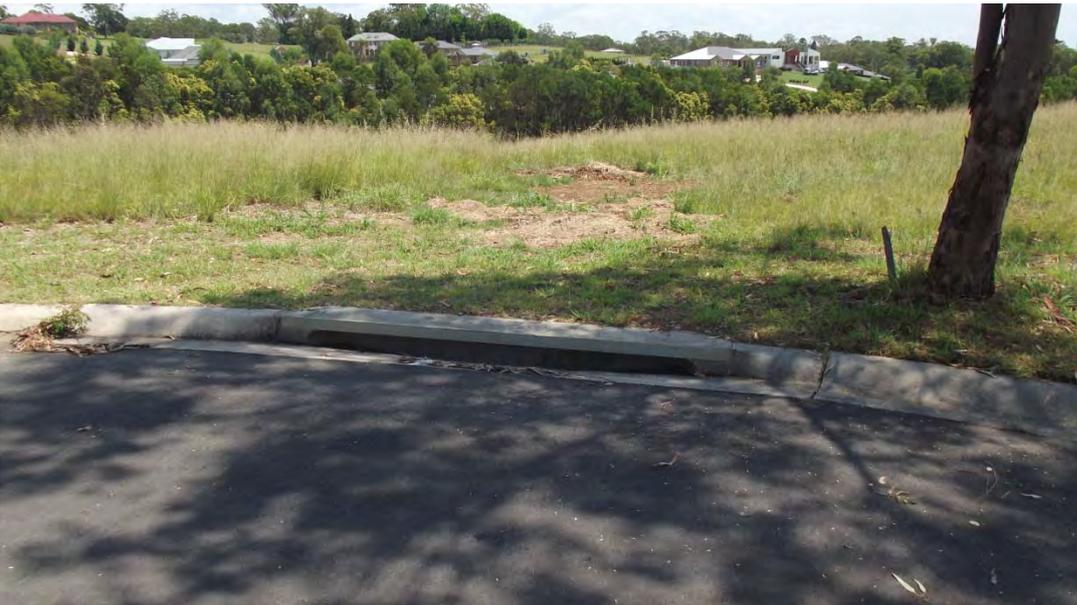
KIP AT THE UPSTREAM

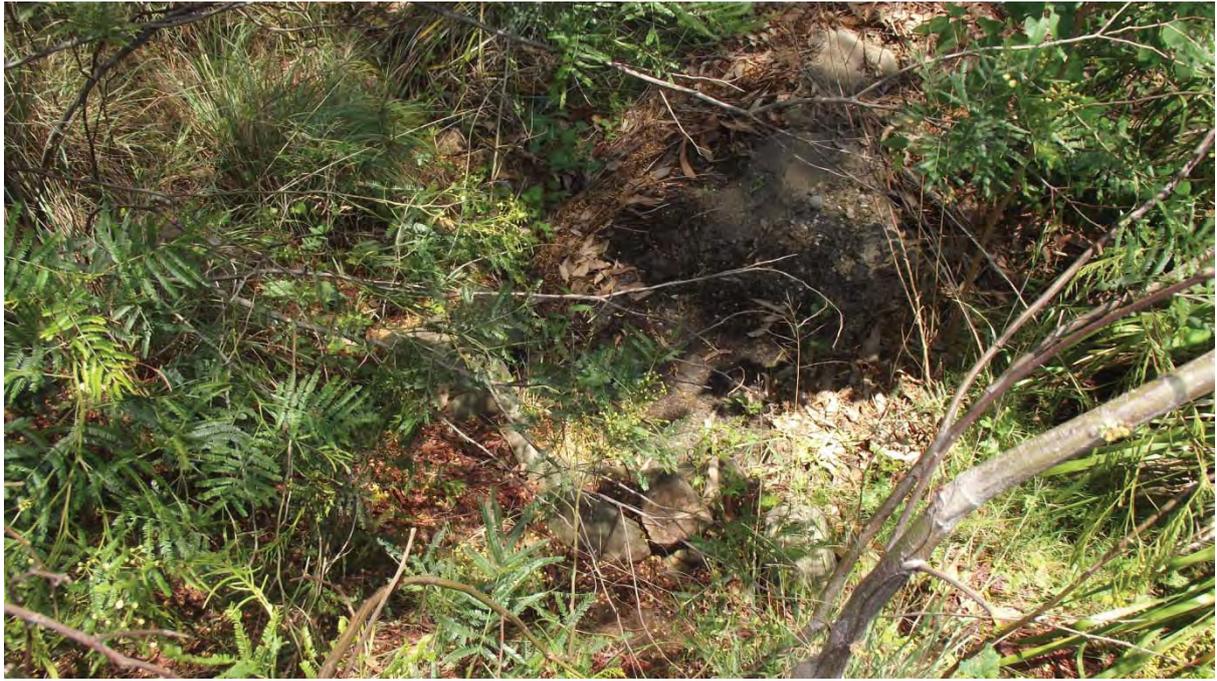
HEAD WALL AT DOWNSTREAM

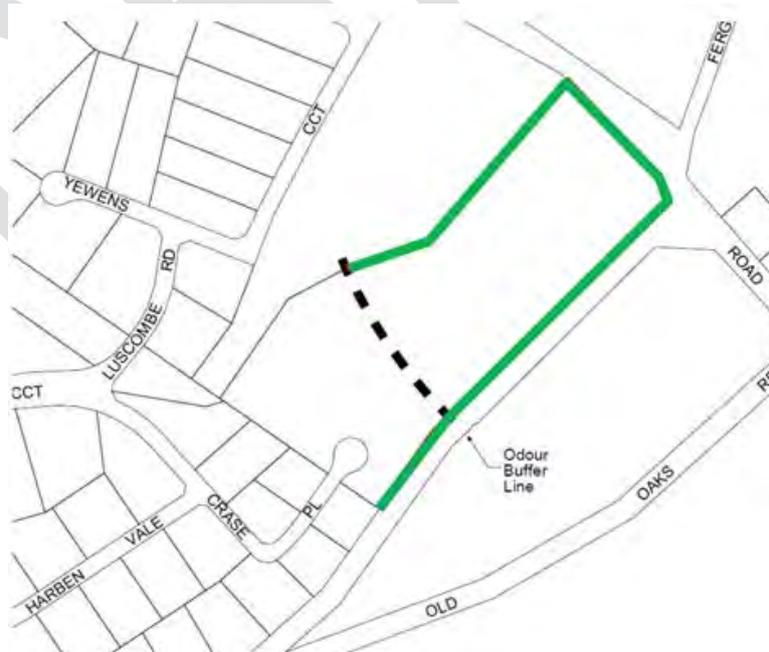
Figure D46A– Crase Place, Grasmere

- 1) Native screen landscaping, incorporating trees and shrubs, must be planted along the area marked red in Figure D46A to screen development.
- 2) Building materials and colours (of dwellings, outbuildings and hard landscaping) are to be restricted to recessive, mid-dark earth tones to blend in with the rural setting. White, cream, red, terracotta, or contrasting and reflective colours are not acceptable. Uncoloured or light concrete driveways are not acceptable.
- 3) All structures shall have a front boundary setback of 12m

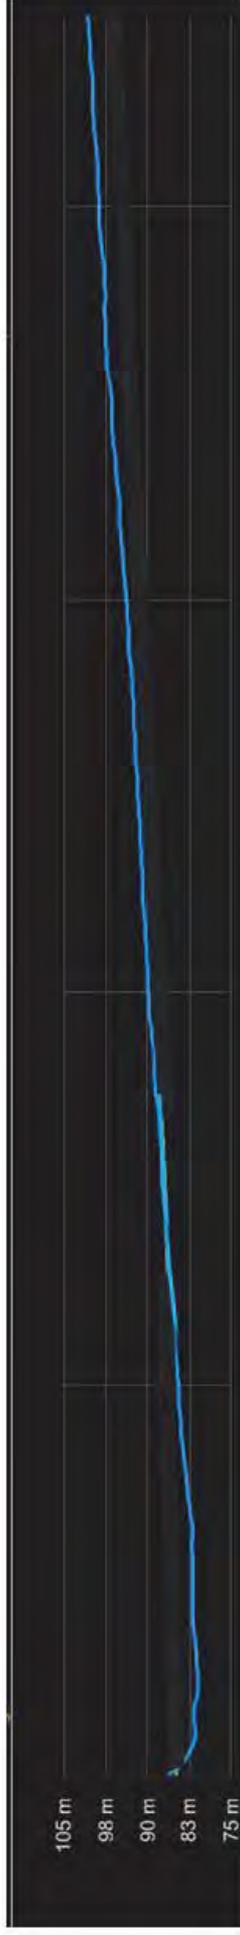
Landform Cross Section

Landform cross-section - east to west of subject site (Source: Nearmaps, 2015).

Minimum elevation: 82.5m Maximum elevation: 101m
